Eyak Lake Weir Assessment

This photo report was prepared by Luca Adelfio, Hydrologist, and Will Schreck, Hydrology Technician, on April 8, 2020.

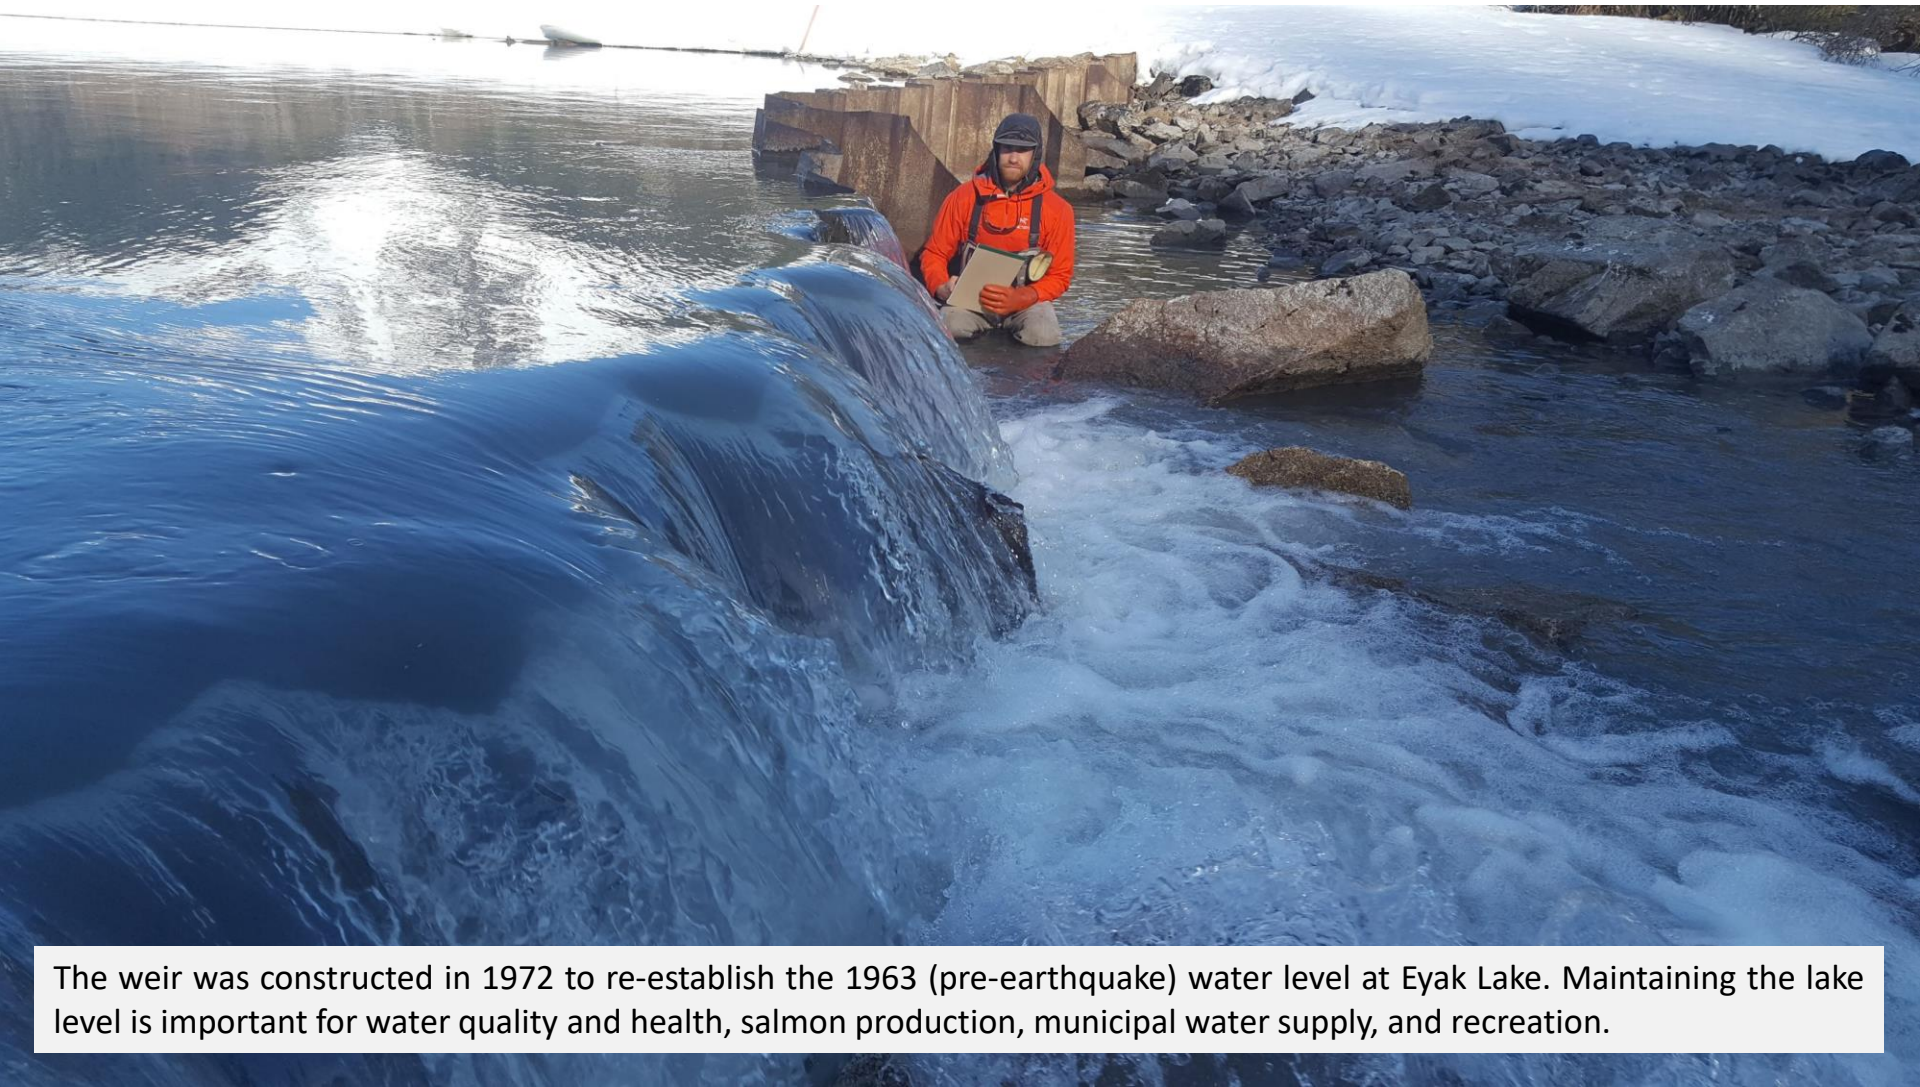
We assessed the condition of the weir on 2 April 2020 during low water conditions. Most of the weir's crest was 8" above the water level at the time of survey. This picture shows the damaged section of the weir that has been displaced downstream, lowering the level of the lake during low water conditions.

Repair “the bulge” and the boat slot to restore the target crest elevation at 17.5’ above MLLW. This action would raise the lake level during low flow conditions, benefitting salmon, recreation, and watershed health.

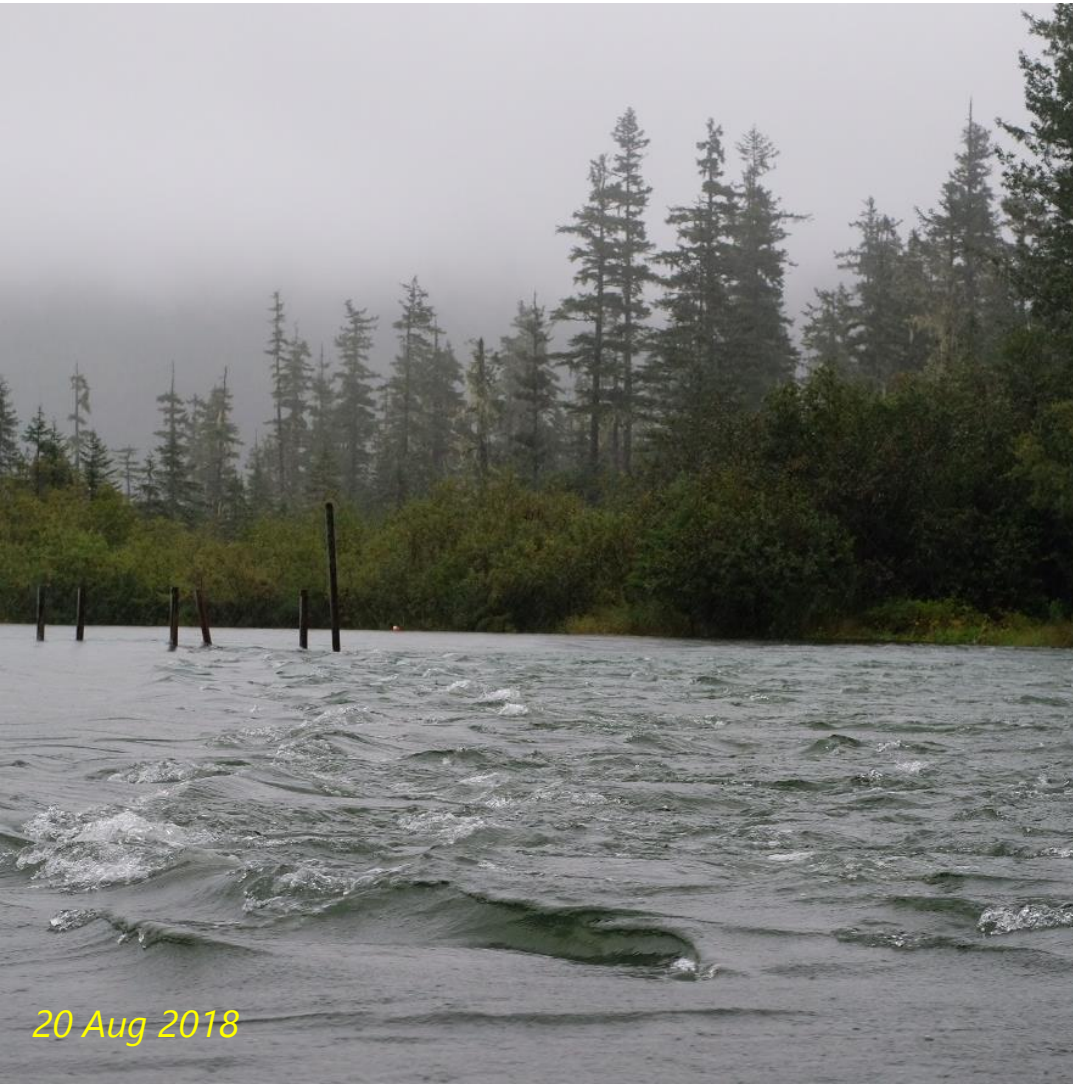
20 Aug 2018

Here is an example of the shifting control on discharge at different water stages. Note how the weir has nominal effects on water level at high water (left). The low water photo was taken one month later, demonstrating how lake surface level and juvenile fish passage are insufficient after just a few weeks of dry weather without snowmelt.

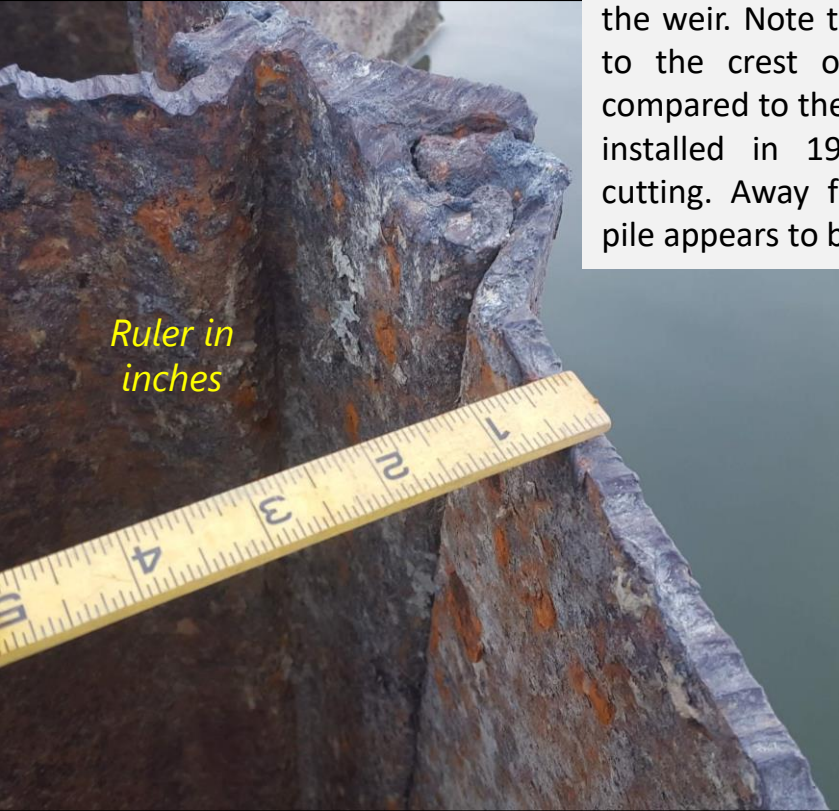
Based on a surface area of 2,432 acres, State of Alaska estimated 5.3 feet of storage behind the weir. Note the substrate is 2' to 3' closer to the crest on the downstream side as compared to the upstream side due to rip-rap installed in 1978 in response to undercutting. Away from the thalweg, the sheet pile appears to be in good shape.

Un-wadable on upstream side (5'+) at time of assessment

Rip-rap added to support downstream side in 1978.

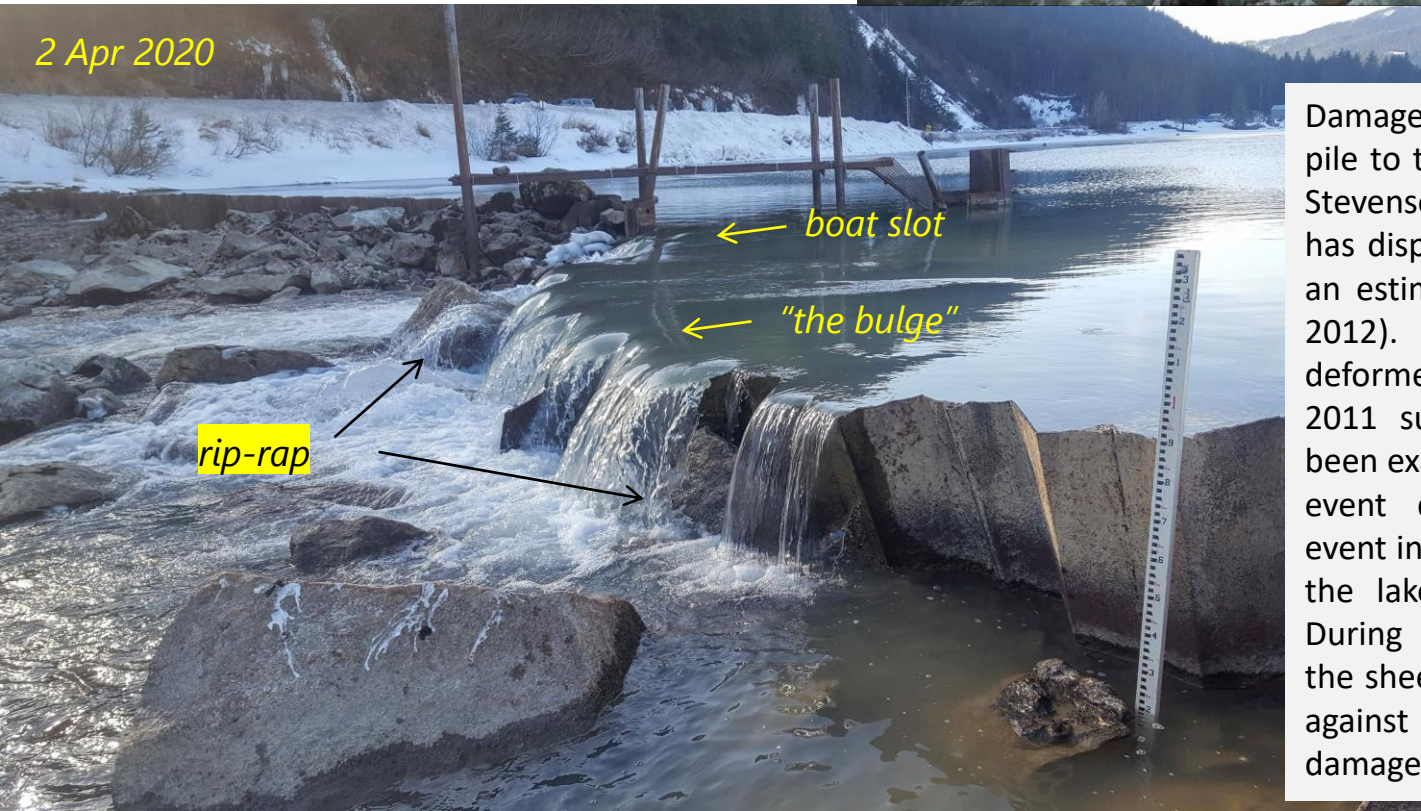
2 Apr 2020

Damage at the boat slot and the sheet pile to the east, likely caused by ice (J. Stevenson, personal communication), has displaced the weir downstream by an estimated 5' to 6' (State of Alaska 2012). Although this section was deformed before the State of Alaska's 2011 survey, the damage may have been exacerbated by a dramatic ice-out event during a large rain-on-snow event in January 2014, further lowering the lake level (working to confirm). During our assessment, we observed the sheet pile at this "bulge" is leaning against large rip-rap. We measured the damaged section to be 41 feet wide.

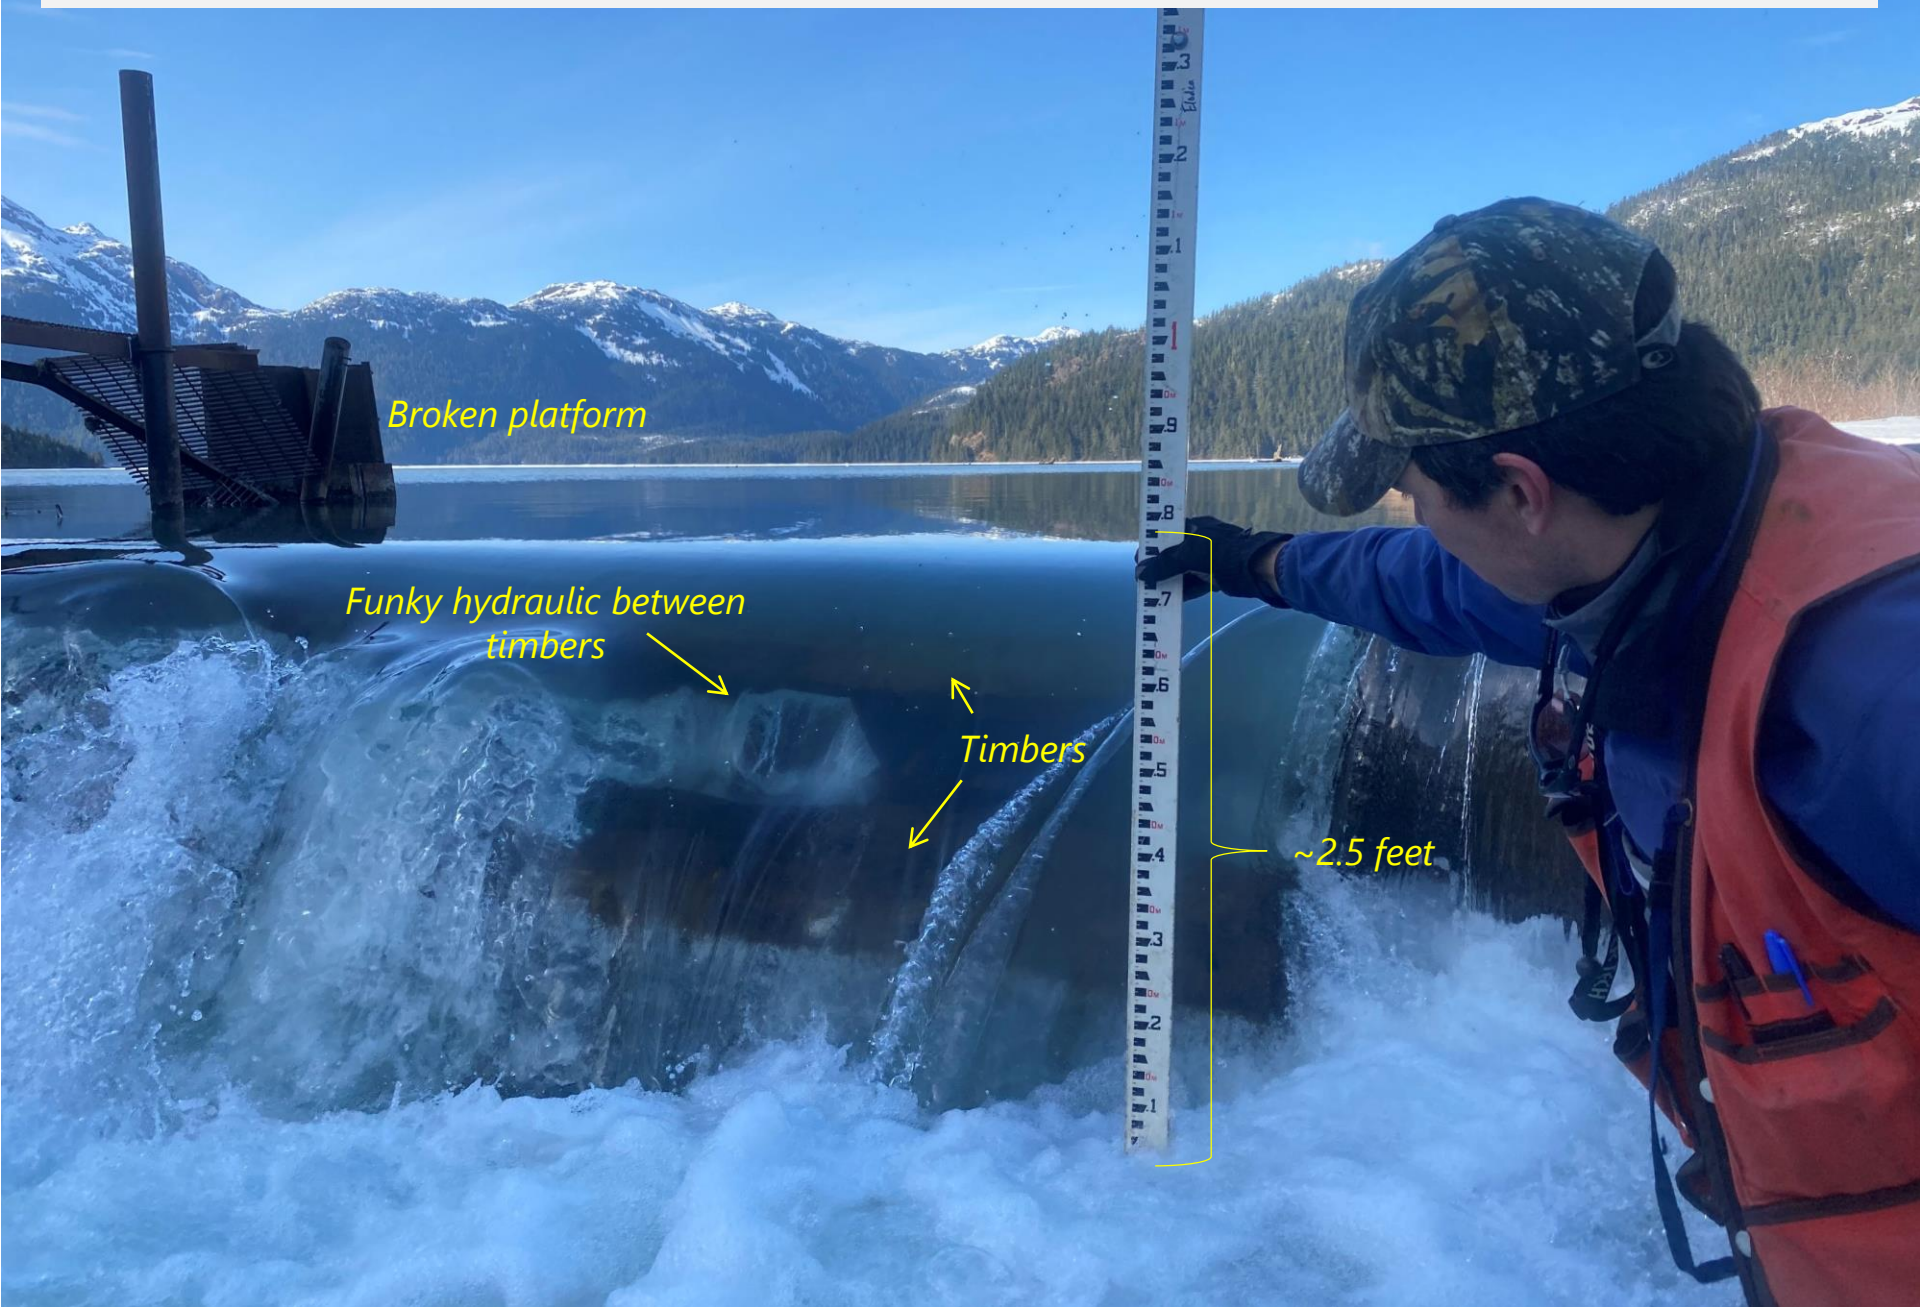
A close up of the boat slot. Note the timbers have been displaced and skewed downstream (We haven't confirmed yet, but we suspect the timbers were likely originally installed horizontal relative to the water's surface).

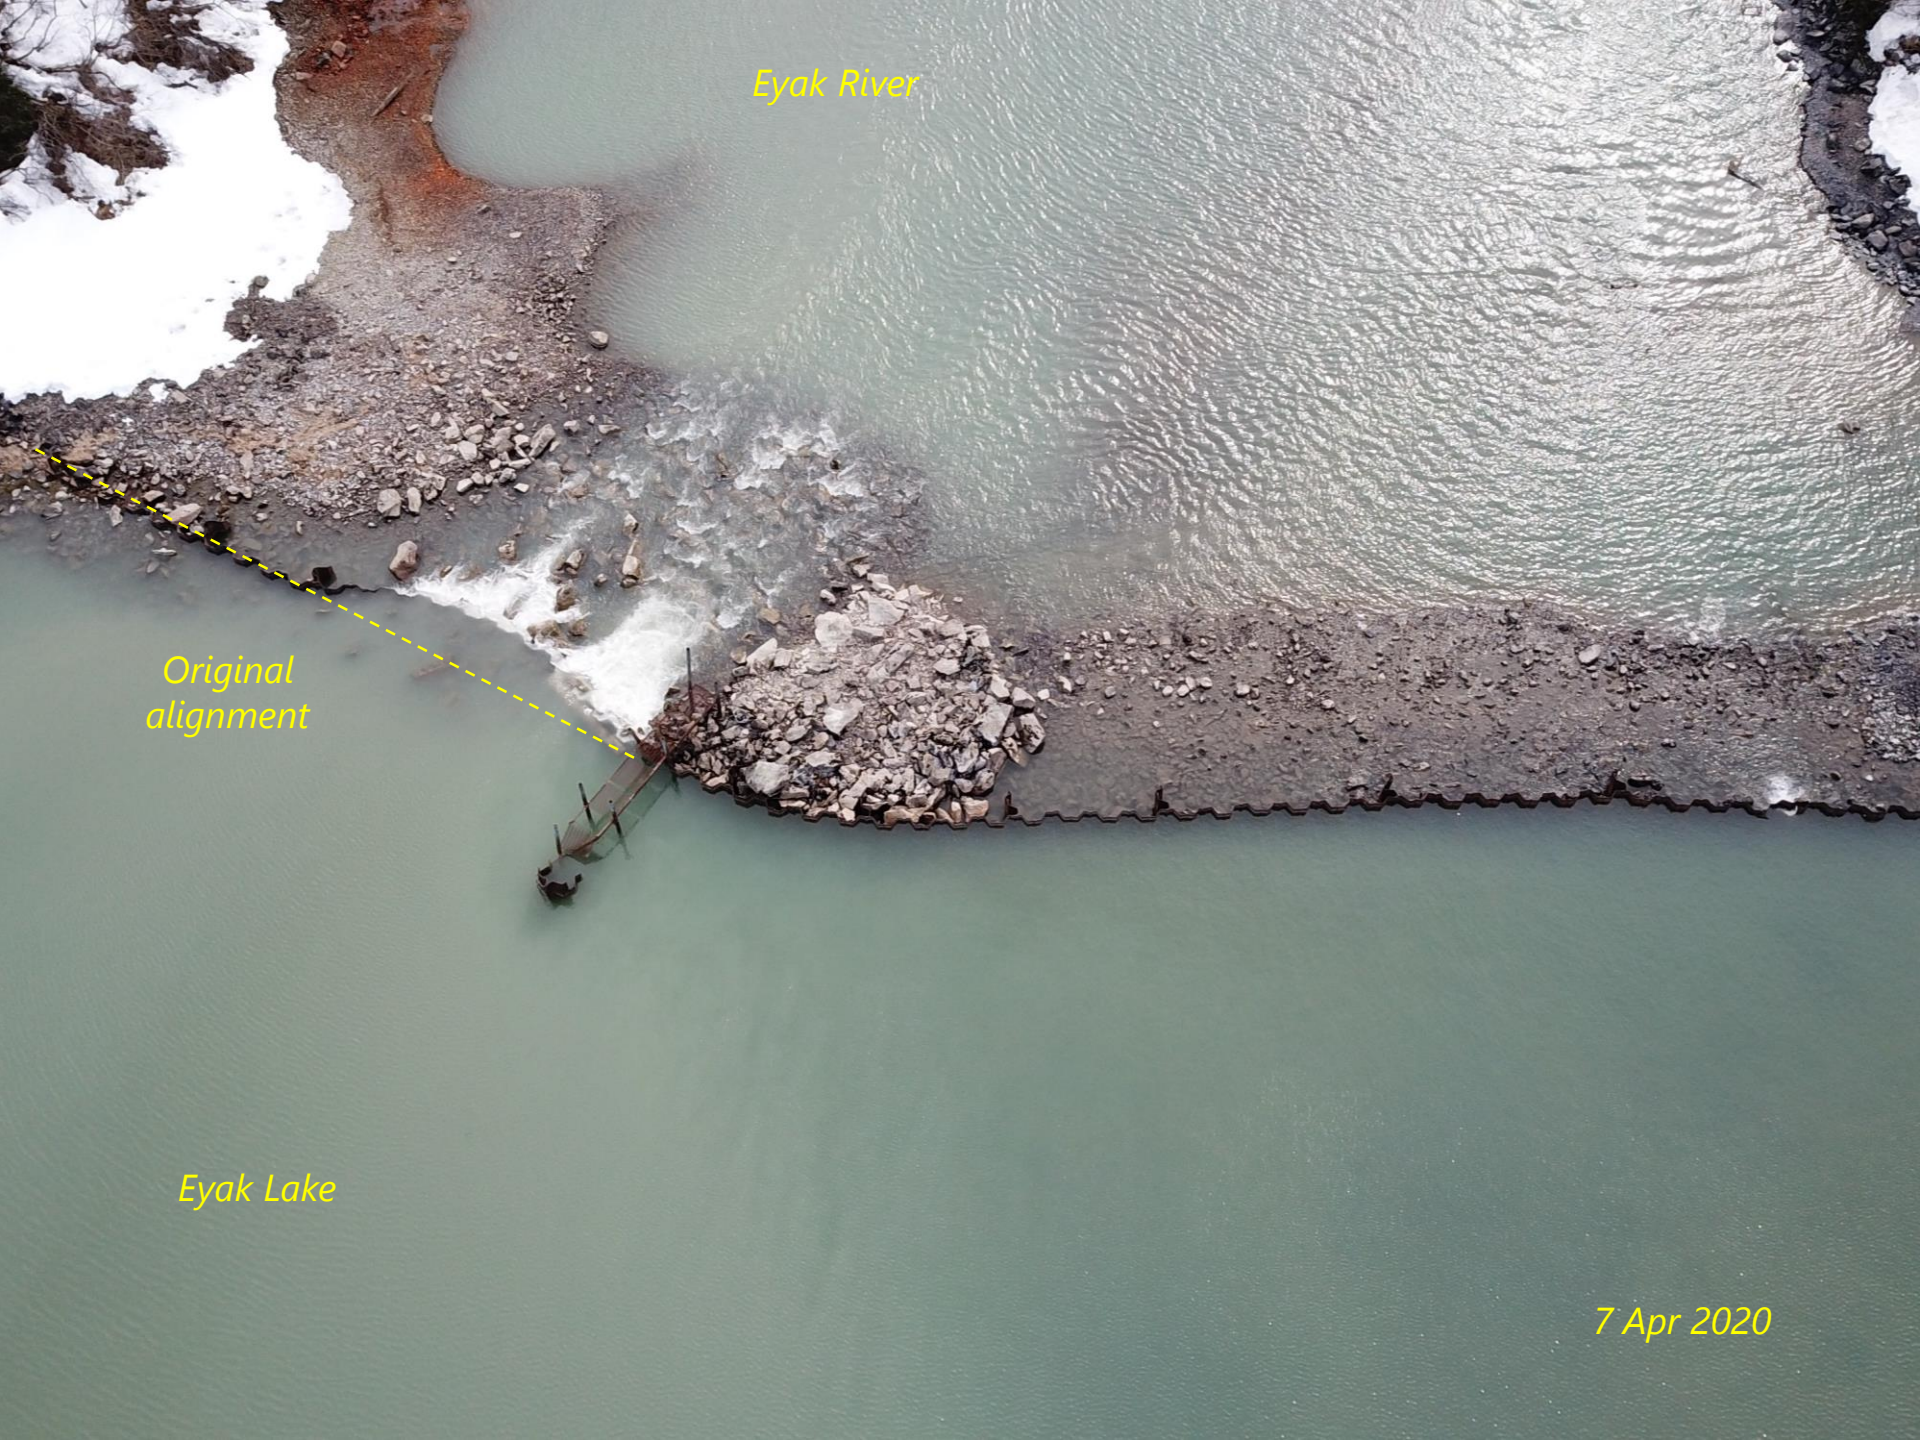
7 Apr 2020

*Original
alignment*

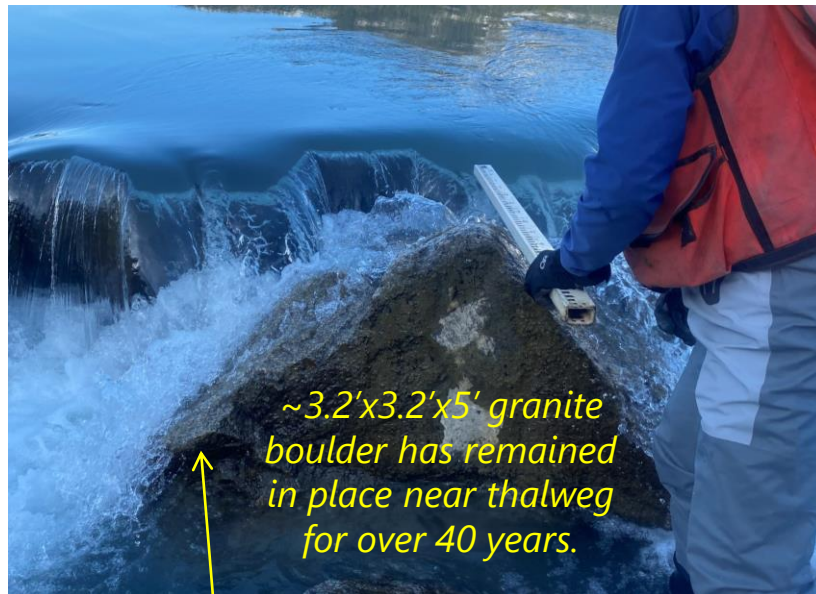
~3.2'x3.2'x5' granite boulder has remained in place near thalweg for over 40 years.

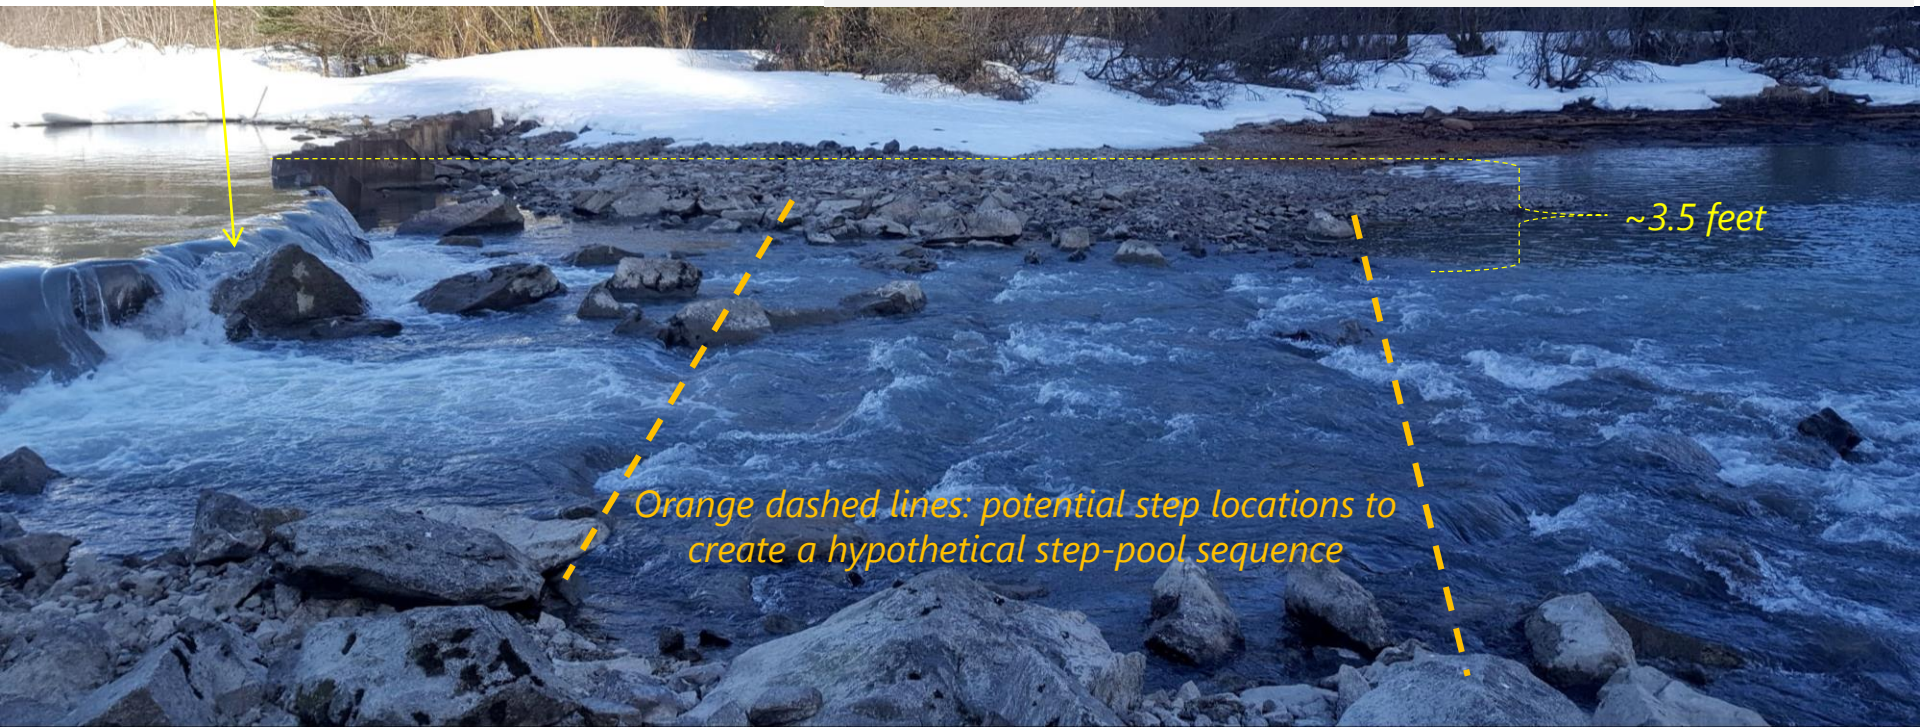
~3.5 feet

Orange dashed lines: potential step locations to create a hypothetical step-pool sequence

Establish a step-pool sequence immediately downstream from the weir to improve juvenile fish passage by dividing the 3.5’ of elevation change into three steps.
