**APPENDIX B: ADNR ALASKA DAM SAFETY PROGRAM 2012
DEREGULATION REPORT**

FIELD INSPECTION AND DEREGULATION REPORT EYAK LAKE DAM (AK00049)

Inspection Date: June 6, 2011
Report Date: March 21, 2012
Weather: Clear and Sunny
Inspection Objectives: Site visit
ADNR Personnel: Charles Cobb and Chandler Engel, ADNR
Documentation: Photos and field book notes were taken and are available for review at DNR-DMLW in Anchorage.

PERIODIC SAFETY INSPECTION REPORT No. 1

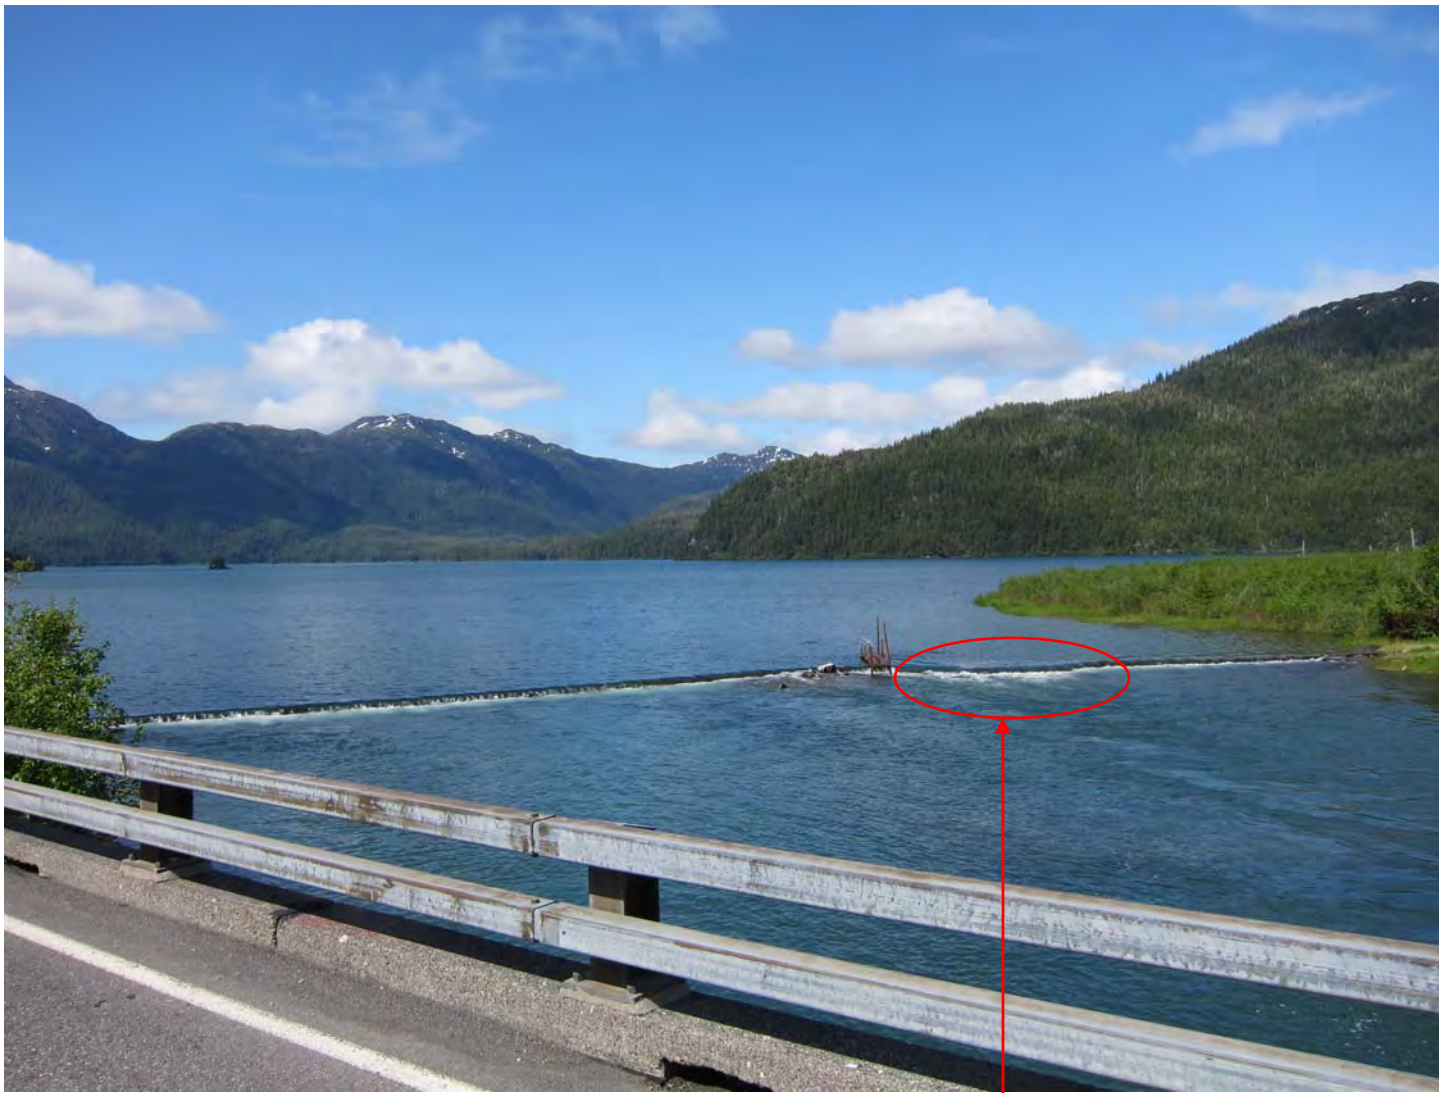
Figure 1 EYAK LAKE DAM

Dam Description: The sheetpile weir is composed of two approximately linear sections joining in a shallow “V” shape pointed into the lake. A metal walkway platform is located near the center of the structure, but above the left span looking downstream. According to proposed drawings and a description found the 1985 PSI, a 12 foot wide, 1.5 foot deep slot was constructed to the left of the walkway to allow for the passage of small boats (see Figure 1).

The weir exhibits signs of deterioration, most obviously to the left of the walking platform, perhaps coincident or adjacent to the boat slot. The sheetpile in that section is bowed significantly downstream as much as 5 or 6 feet, estimated visually from the left abutment, shown in Figure 2. It was not immediately clear what the cause of the displacement was, but it seems likely that downstream material originally buttressing the sheetpile had been scoured by the overflow at the boat slot, resulting in a partial failure of the wier.

Boat Slot and Partially Failed Section

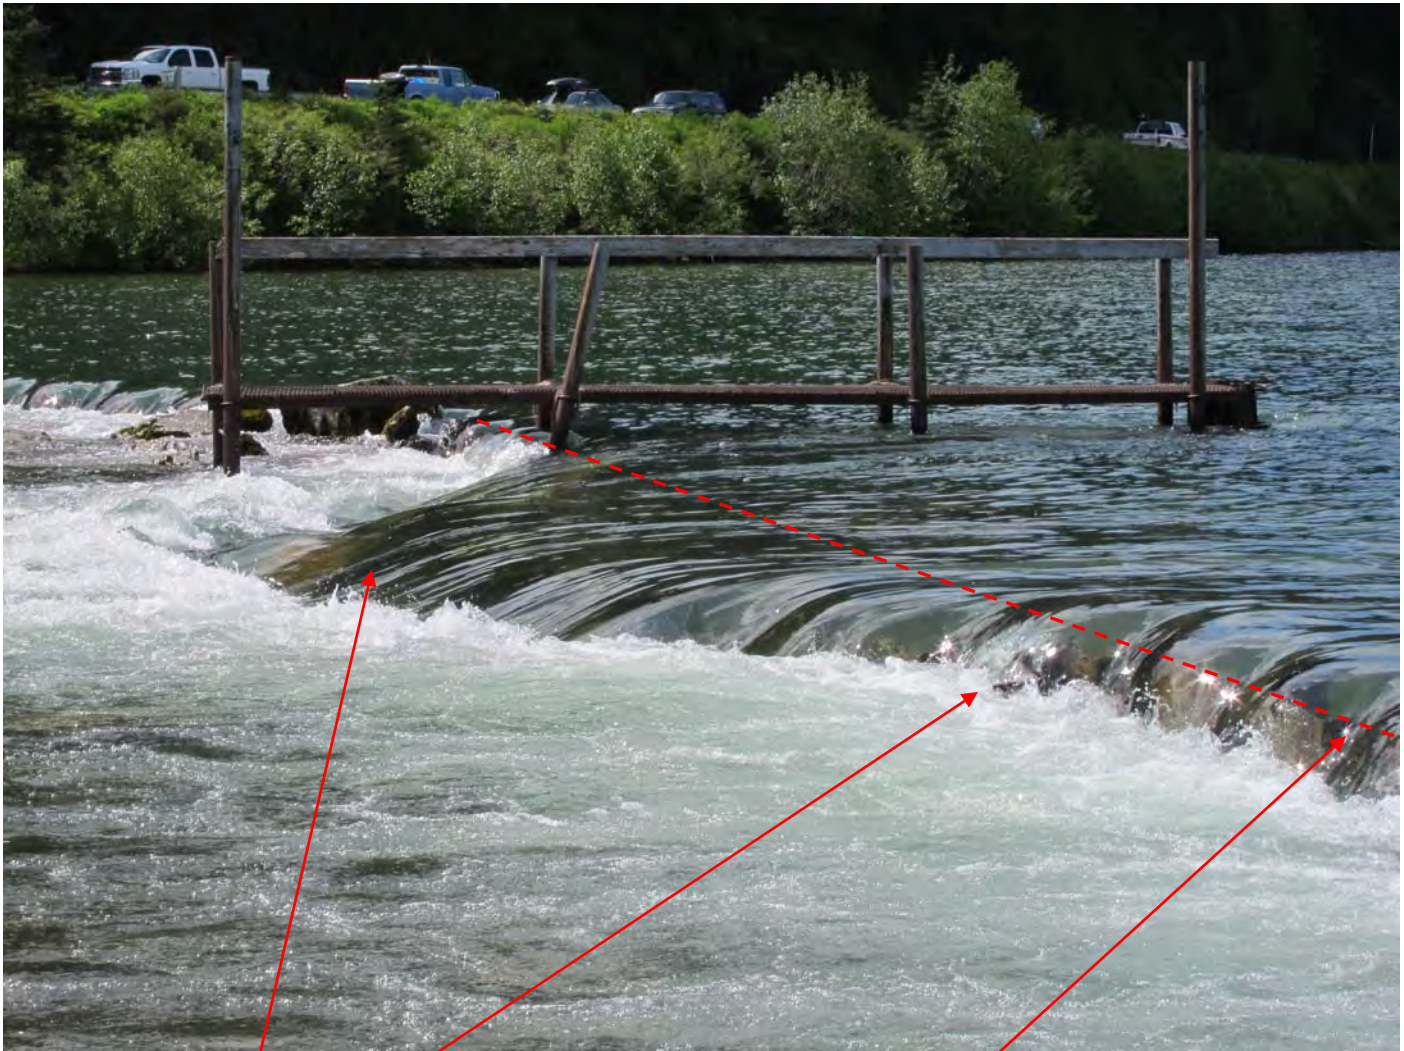
Figure 2
PARTIALLY FAILED SECTION

Discussion of Failure Mode: Due to the driven sheetpile method used to construct the wier, the most likely failure mode is continued local erosion of buttress and embedment material, resulting in loss of downstream support and progressive failure of discrete segments of the structure. It appears unlikely that the structure would fail completely, other than during a large flood event when the effects of the failure would be significantly muted by the flood flows.

Based on observations made during the field visit in 2011, the limited conveyance capacity of the Eyak River creates significant tailwater with only a few inches of discharge head over the weir (see Figure 2). It seems likely that the weir would be nearly completely submerged with 2.5 feet of water above the crest, thus reducing the potential marginal increase in downstream flooding from a failure.

Partially Failed Sheetpile Section

Approximate Original Alignment

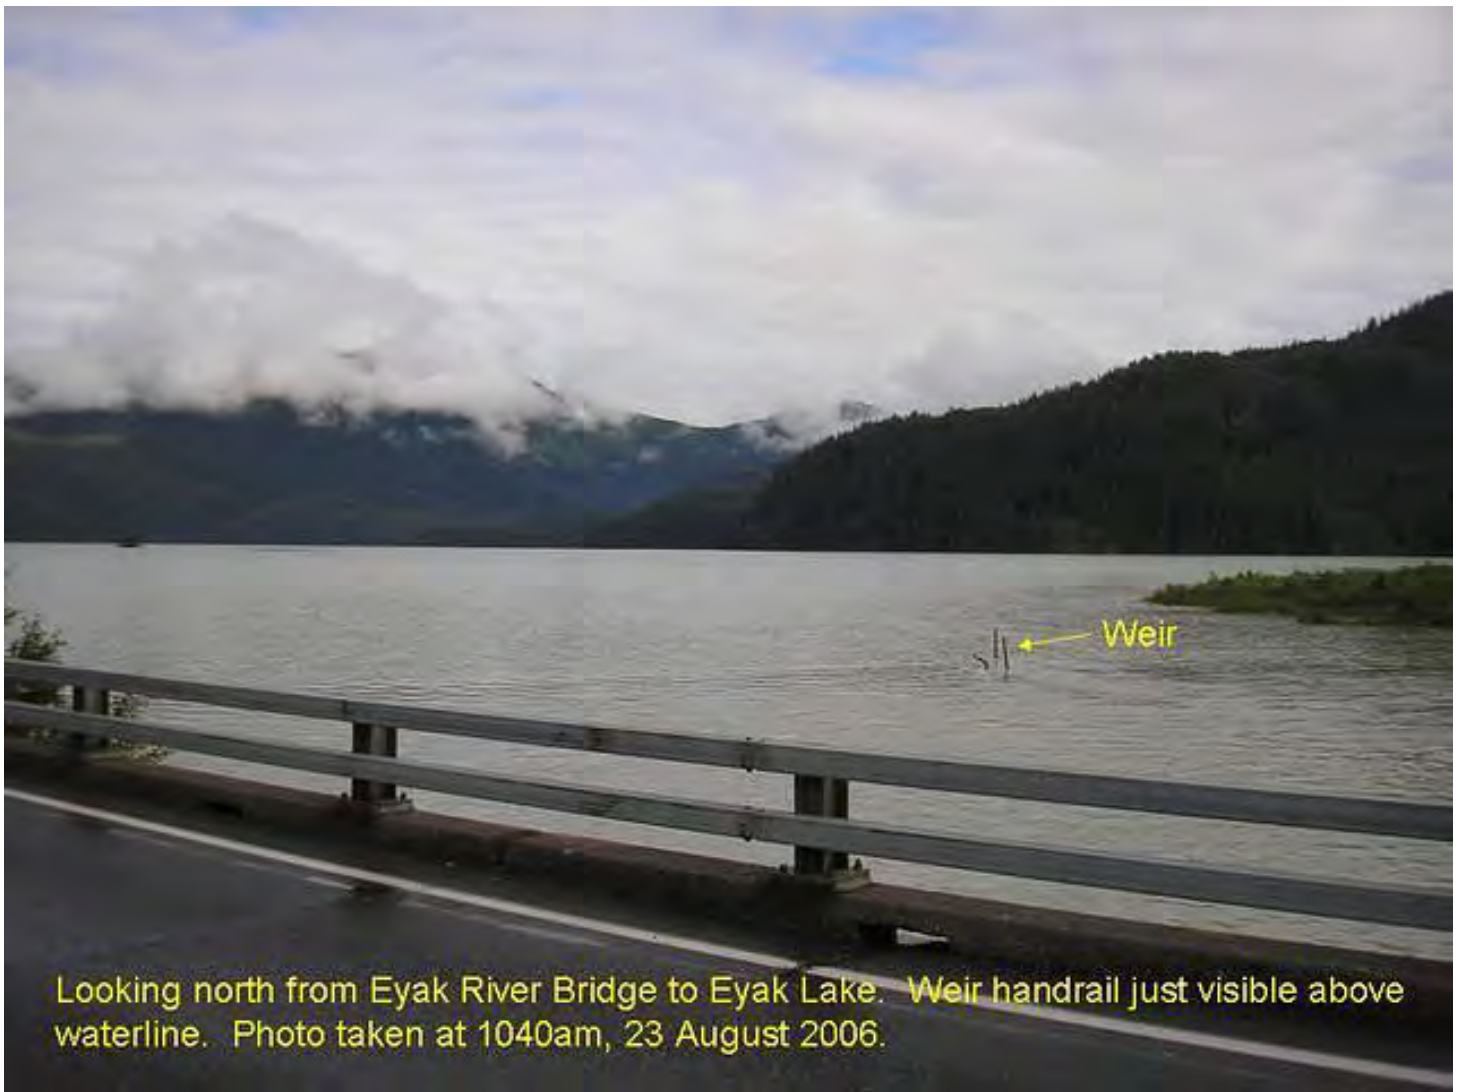
Figure 4 EYAK LAKE AT FLOOD STAGE

The Eyak River Bridge is unlikely to be damaged by an unexpected failure of the Eyak Lake Dam, due to the likely progressive failure mode of the weir, and the fact that the bridge has withstood significant natural flooding, as shown in Figure 4.

In the record of the flood event, the NWS included a photograph of the submerged weir at stage 24.52 feet (Figure 4). The caption of the photograph indicates that the handrail on the weir platform is just visible. According to the design drawings the bottom of the handrail was to be installed at approximately elevation 22 feet above MLLW, 4.5 feet above the crest of the weir, assumed to be at 17.5 feet above MLLW. Based on a review of photographs taken during the 2011 field visit, this value seems reasonable. Using this interpretation establishes a 2.5 foot differential between the NWS datum and the MLLW datum referenced in the design drawings.

Weir Submerged at Stage 24.52' Unknown Datum (Photo Courtesy of National Weather Service)

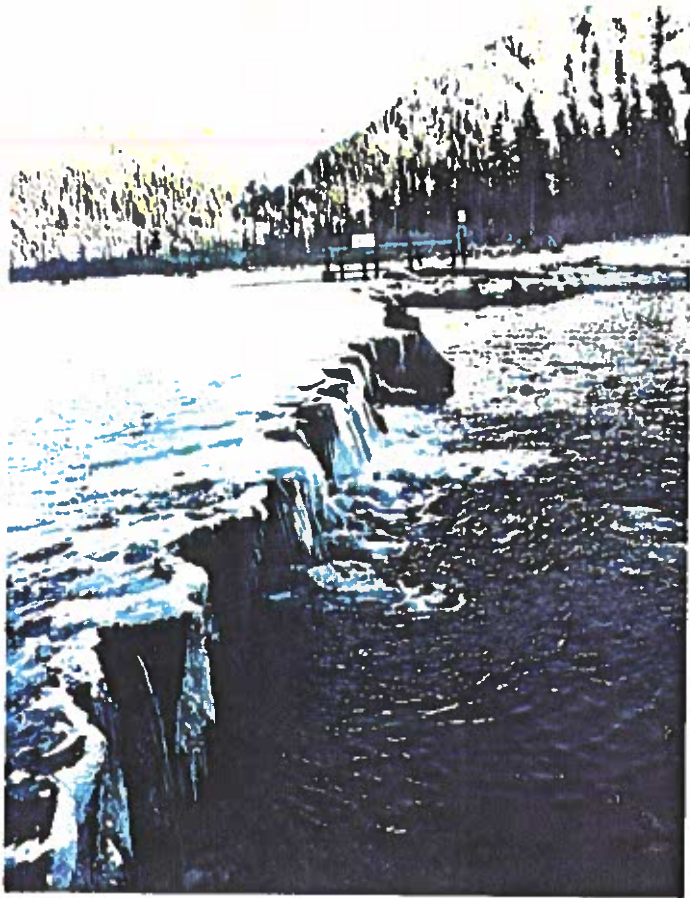
Photo No. 1
Easterly View of Dam

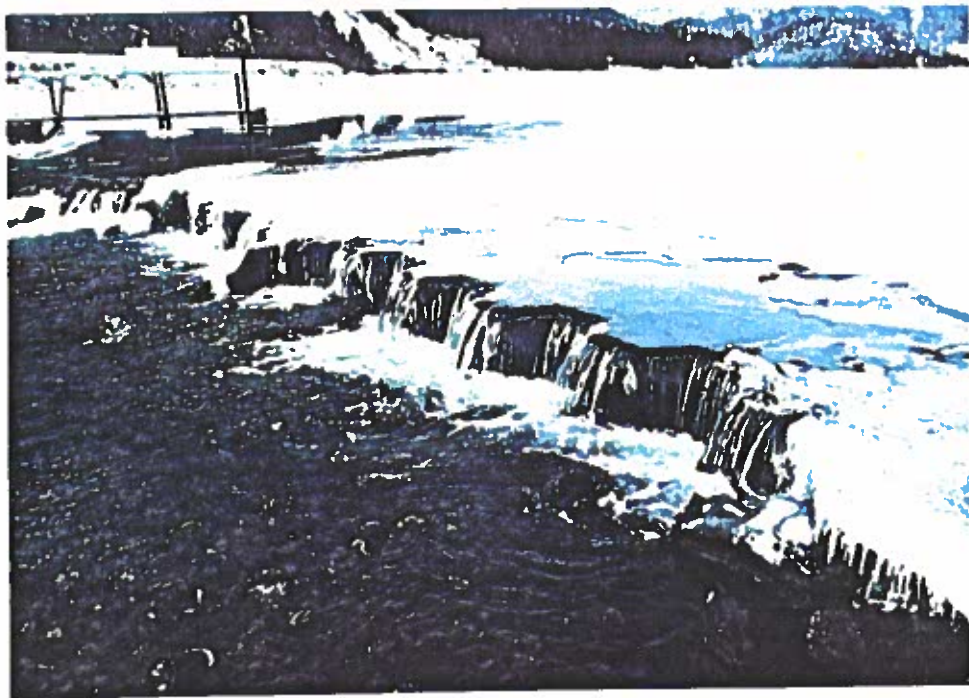
Photo No. 2
Westerly View of Dam
Boatway - Upper Left

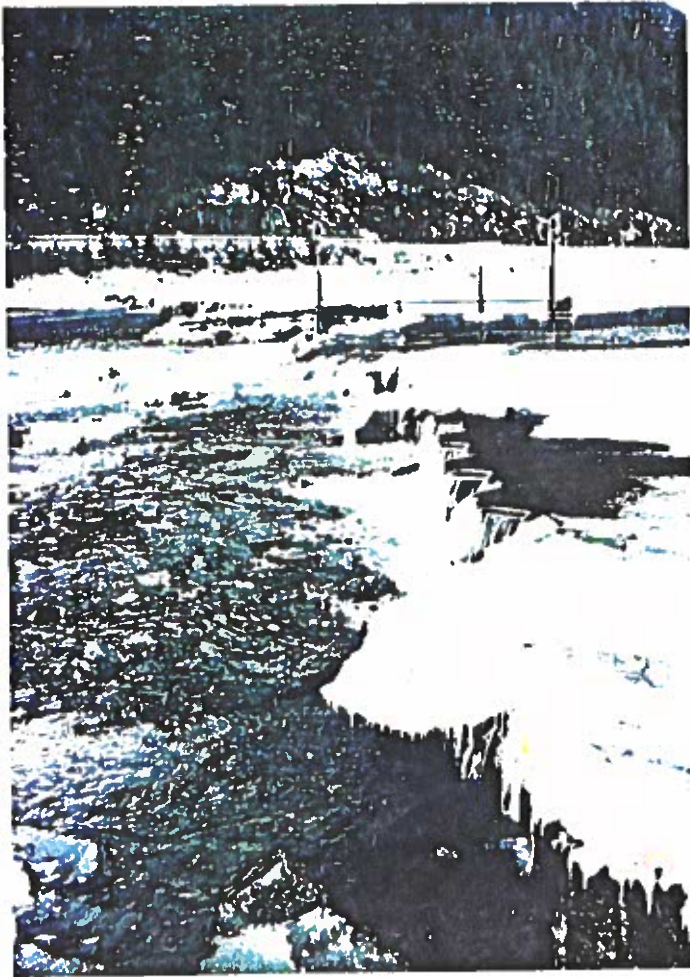
Photo No. 3
Westerly View of Dam
from left abutment.

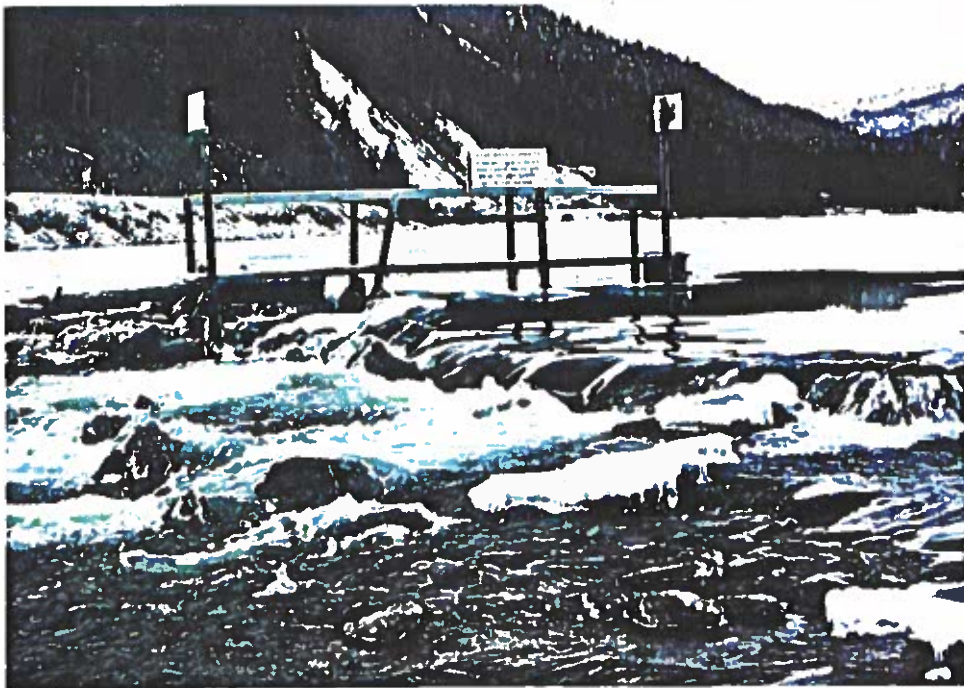
Photo No. 4
Close-up view of Boatway

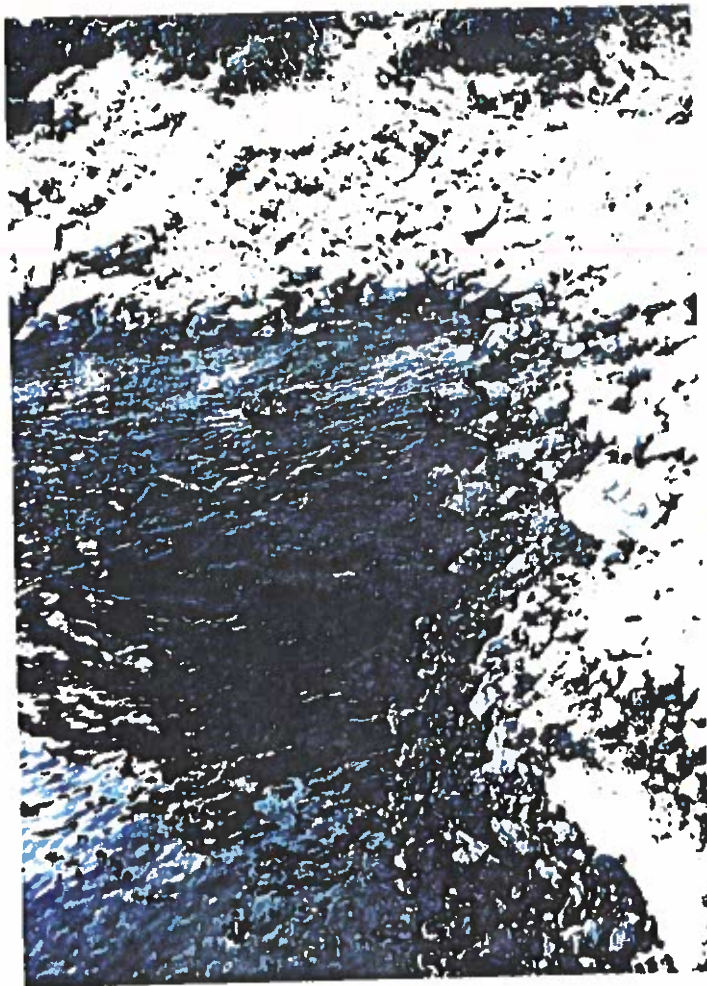
Photo No. 5
Seepage at right Abutment.

1. The water seepage at the right abutment should be monitored each winter when there is low flow and the water clear from lack of glacial melt.
2. The quarry rock placed in 1978 should be monitored after each major storm and replaced as required.
3. Periodic inspections should be conducted during the winter season. Inspection of the dam cannot be properly accomplished when a large volume of water is passing over the structure.

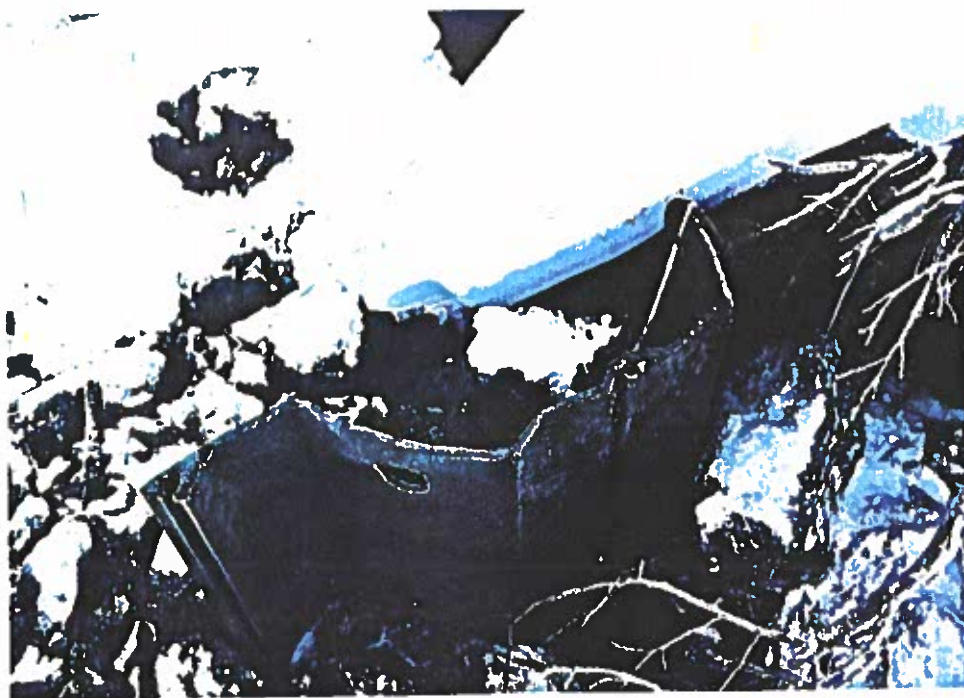
3.3 Dam: The quarry rock placed downstream of the sheet pile has stabilized the structure. The steel piling shows very little corrosion and the structure should continue to function satisfactorily for many years. Since this structure is more of an overflow weir than a dam, there are no outlet works, spillway and other features normally associated with a dam.

Photo No. 6
Close-up view showing
type of sheet pile used
