Subject: RE: Burma Pit Road culvert

USGS released a new report and regression equation in 2016 that, for this area, no longer takes into account the percent of the basin area covered by forest, and the percentage occupied by lakes and ponds. The 2 percent Exceedance (Q_{50}) discharge increased from 2,310 cfs using the 2003 equation, to 3,070 cfs using the 2016 equation. A discharge of this magnitude will either require a bridge, or a long-span, corrugated steel structure that is classified as a bridge.

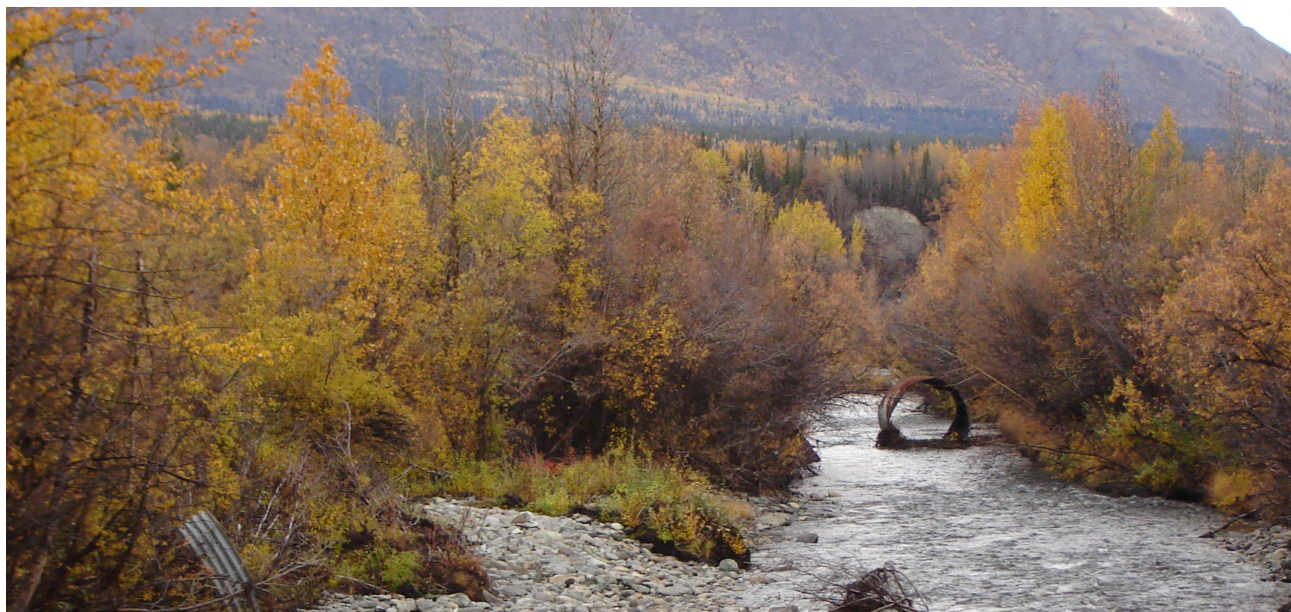
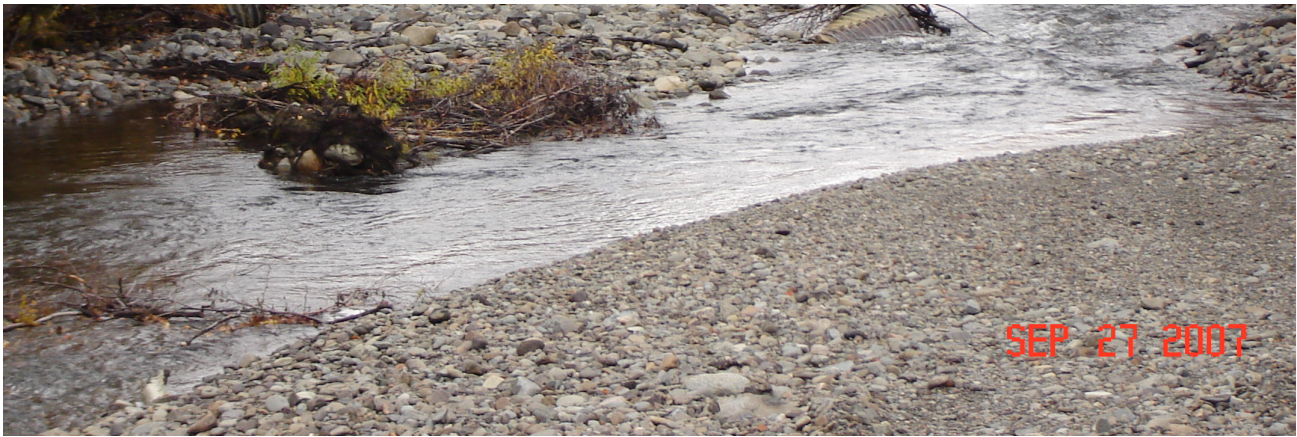
I found old emails and a computations sheet that size the culvert, which washed out during the 2006 flood event, as an 11-foot diameter round pipe. Also, found a damage report by DOT that stated a 14-foot diameter culvert was washed away. After reviewing the attached plans sets from previous projects, I can find no indication when an 11-foot or a 14-foot diameter culvert was installed. There may be another plan-set somewhere, or it is possible that Alyeska or DOT M&O installed the culvert(s) that washed out.

2007 attached photo shows pipe that was transported downstream during flood event
