# Hydraulic and Hydrologic Report

Copper River Watershed Fish Passage  
Improvement Project

*Copper River Highway, Cordova, Alaska*  
December 21, 2018

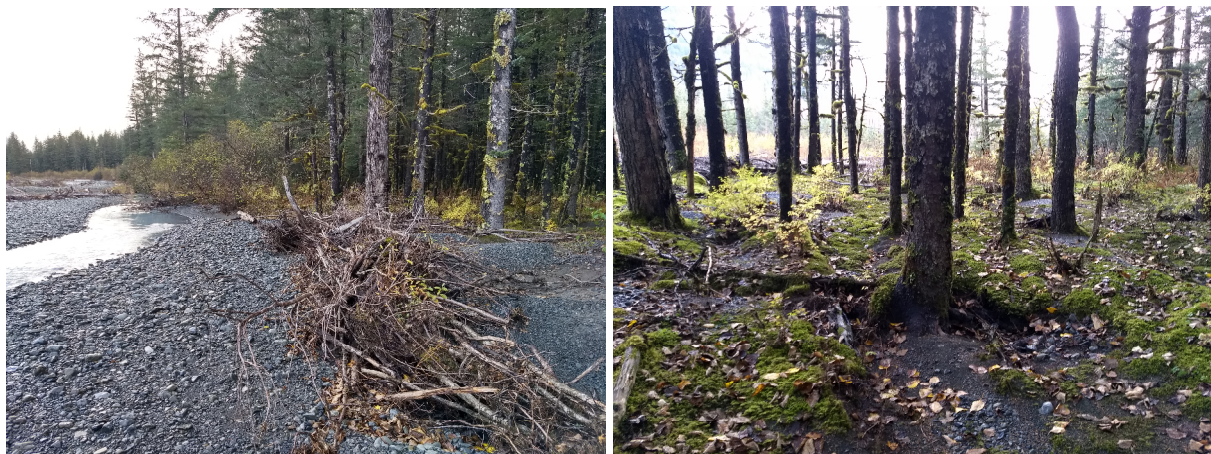
The point at the river bend is still active and showed evidence of overtopping in the past summer but once waters subsided the river has gone back to its main channel. The following photos are of this river bend and the sediment deposits in the adjacent forest. Note that there is no high bank for the flood waters to overcome, almost any high flow event floods out into the forest. Although the forest floor trends downhill toward the east from this point it appears that the gradient of the existing thalweg is steeper than the alternative routing into the forest and the river has historically settled back to the westerly channel after significant flood events.

The first tipping point is an outside bend in the Saddlebag River where high flows jump the banks course out into the timber to join channels that cross back into the site basin. A field reconnaissance of the area confirmed that this is a relatively common occurrence but photo records appear to indicate that at least since 1907 the Saddlebag River has never been completely rerouted at this point. Such an event would have washed out the rail bed and the 3 small trestles seen in the 1950 aerial would have been replaced with a larger river crossing. The Saddlebag River has not always been contained entirely within its current banks and channel. In fact, these images show that in the past the river has had multiple active side channels that run parallel to the existing US Forest Service road that is adjacent to the project area but none of these channels has rerouted the river and it continues to hug the west side of the valley and carry most of the larger drainage to the larger existing bridge west of the culvert sites.

Using IfSAR data, the upstream drainage basin for the Saddlebag River at the bend of interest is approximately 11.13 square miles, and would produce an additional 3,680 cubic feet per second (cfs) of

flood flow during the 100 year event. A flood of this magnitude would likely wash out the highway and significantly alter the drainages in this valley. Rebuilding would require a bridge or very large box culvert. Because of the high degree of uncertainty for this occurrence and the non-critical nature of the transportation connection we have recommended that these flows be ignored until the improbable occurs.
