# Hydraulic and Hydrologic Report

Copper River Watershed Fish Passage  
Improvement Project

*Copper River Highway, Cordova, Alaska*  
July 17, 2019

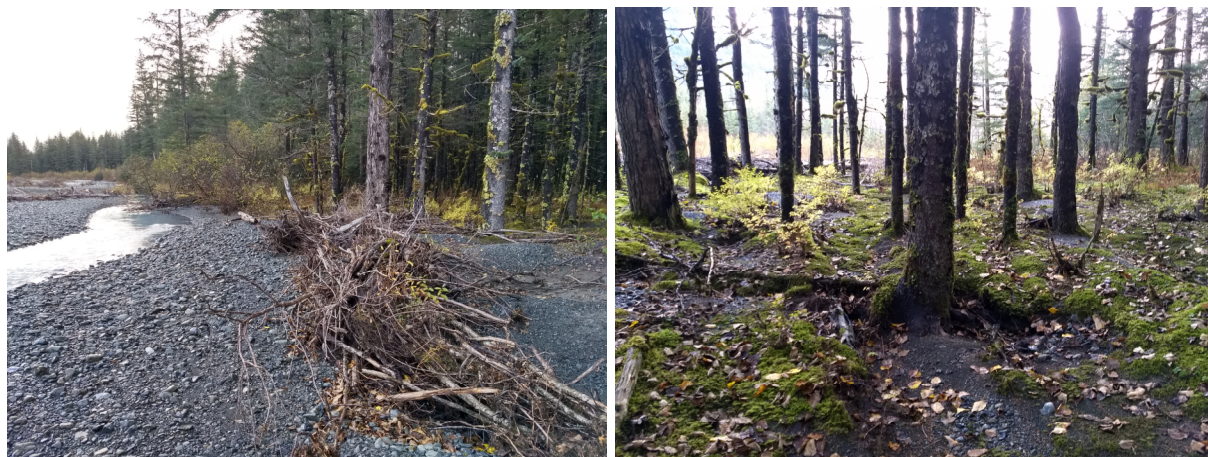
**Photographs 1 and 2: Saddlebag River overtopping point**

The first tipping point is an outside bend in the Saddlebag River where high flows jump the bank and course into the adjacent wooded area to join channels that cross back into the site basin. A field reconnaissance of the area confirmed that this is a relatively common occurrence but photo records appear to indicate that the Saddlebag River has never been completely rerouted at this point, at least since 1907. Such an event would have washed out the rail bed, and the three small trestles seen in the 1950 aerial would have been replaced with a larger river crossing. The Saddlebag River has not always been contained entirely within its current banks and channel. In fact, these aerial images show that the river has historically had multiple active side channels that run parallel to the existing U.S. Forest Service (USFS) Saddlebag Glacier road that is adjacent to the project area. However, none of these channels have rerouted the river permanently, and it continues to hug the west side of the valley and carry most of the larger flows to the larger existing bridge west of the culvert sites.

The point at the river bend is still active and shows evidence of overtopping in the past summer; however, once the waters subsided, the river went back to its main channel. The following photographs are of this river bend and the sediment deposits in the adjacent forest. Note that

there is no high bank for the flood waters to overcome, with high flow events flooding into the forest. Although the forest floor trends downhill toward the east from this point, it appears that the gradient of the existing thalweg is steeper than the alternative routing into the forest, and the river has historically settled back to the westerly channel after significant flood events.

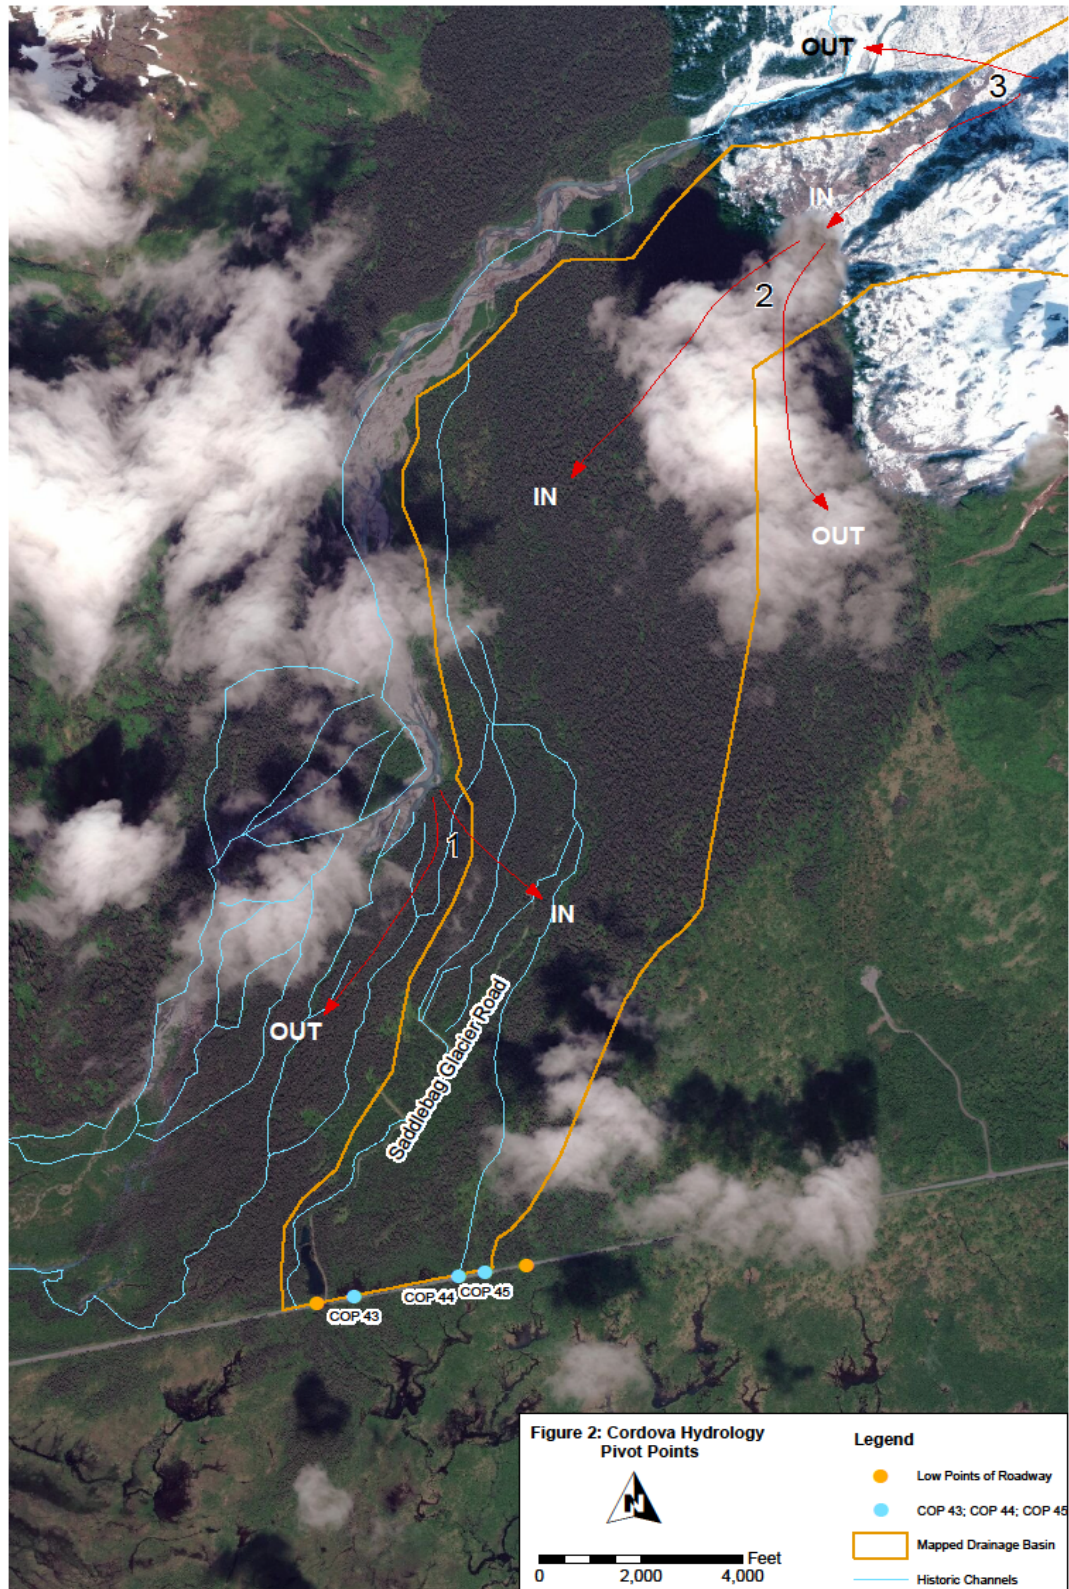
Figure 2: Drainage Basin Mapping

Looking at the delineated basin as a whole, there are three points of uncertainty where there is either insufficient data to determine drainage flows or alluvial fan features have led to different drainage paths over time. The inclusion or exclusion of drainage above these “tipping points” significantly alters the area of drainage basins and subsequent flows. The Saddlebag River of which these smaller drainages are sub-basins contains a large active glacier, glacial lake, and significant alluvial features. It is these alluvial fan features that, through continued sediment deposition over time, have moved the basins flows between channels and have altered the geometry of the basins feeding the three crossings. Figure 2 shows the larger basin and tipping points. It also shows the complexity of the historic stream channels digitized from available aerial photography dated 1950, 1976, 1983 and the present. The following paragraphs describe the tipping points in more detail.

Using IfSAR data, the upstream drainage basin for the Saddlebag River at the bend of interest is approximately 11.13 square miles, and would produce an additional 3,680 cubic feet per second (cfs) of flood flow during the 100-year event. A flood of this magnitude would likely wash out the highway and significantly alter the drainages in this valley. Rebuilding would require a bridge or very large box culvert. Because of the high degree of uncertainty for this occurrence and the non-critical nature of the transportation connection, HDR recommends that these flows be ignored until the improbable occurs. The possible inclusion of a high water ford crossing with reinforced road prism was also explored but because of the increased road bed elevation over the new culverts, high flood waters will tend to follow the ditch lines east and west and carry those flows to other cross culverts away from these sites. As the rest of the culverts to the east and west (COP 042 and COR 046) are eventually replaced, the hydraulics of the entire road section should be reevaluated.

In summary, for flood flow analysis the delineation of the project basin includes the smaller additions to the basin represented by the two latter unknowns but does not include flood flows from the Saddlebag River. Saddlebag River flows are known to occur, but their frequency and volume have not been included here.

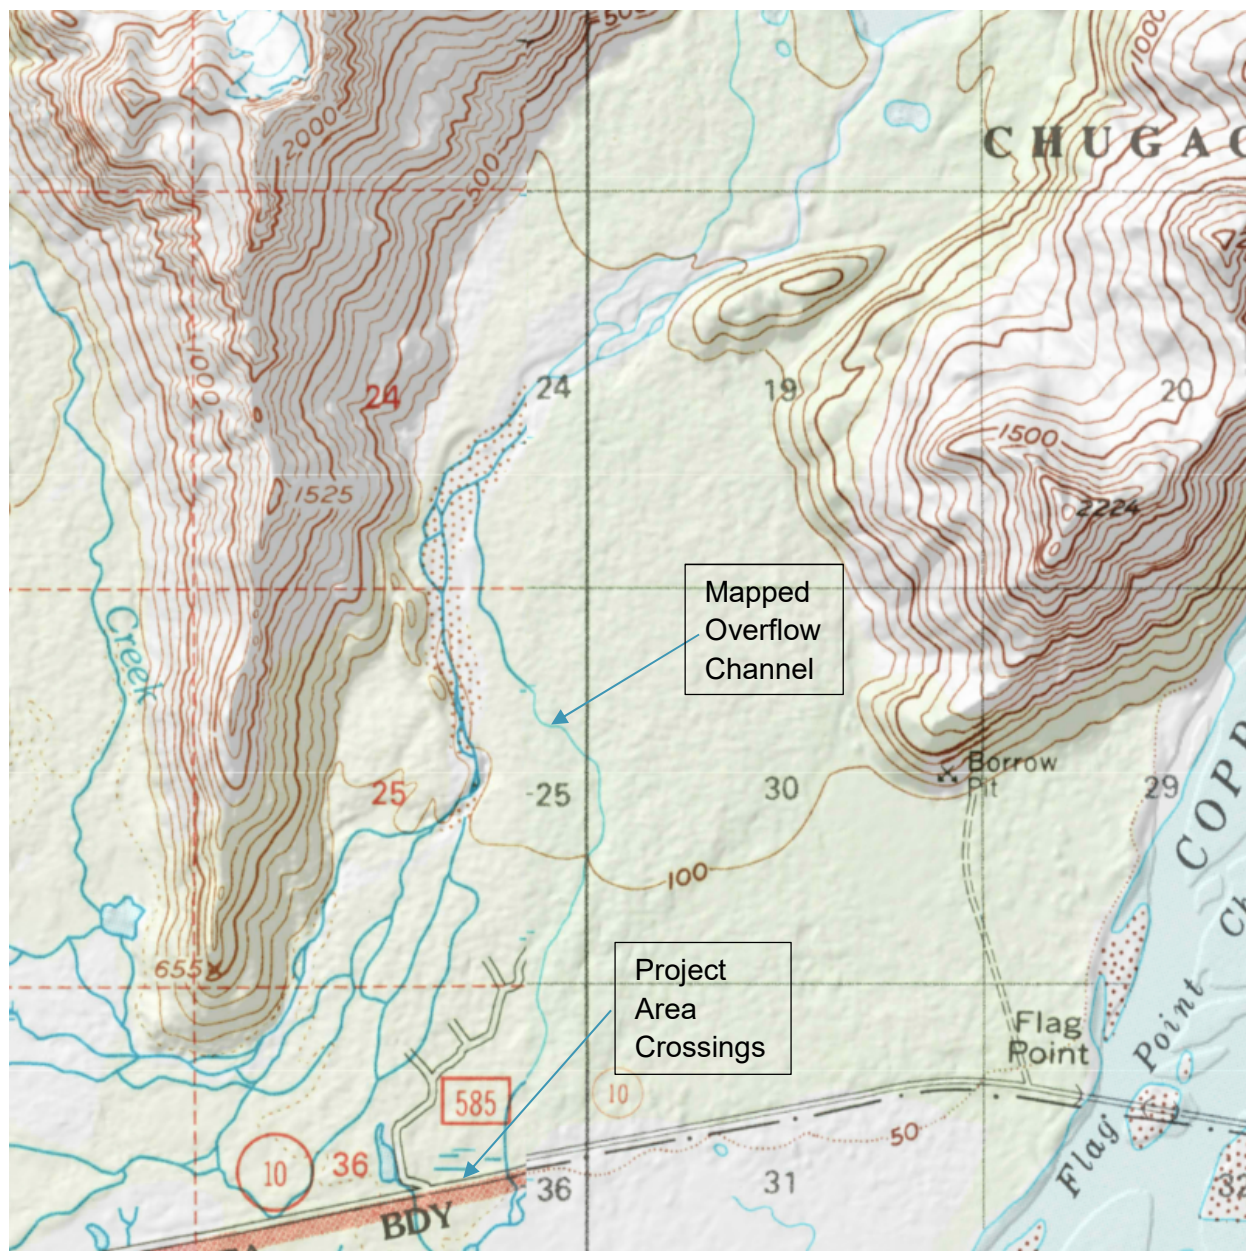
Figure 3: USGS Drainage Mapping

Additionally, the USGS topographic mapping of this area shows a small side channel of the Saddlebag River diverting from the main river even further upstream and making its way to the sites COP 46 east of the project area (Figure 3). HDR found this channel during their field investigation but were unable to walk to its upstream connection point due to time constraints. Field observations show it to be well grown in, and it contained no sustained flow or evidence, in the form of sediment deposition, of recent flooding events.

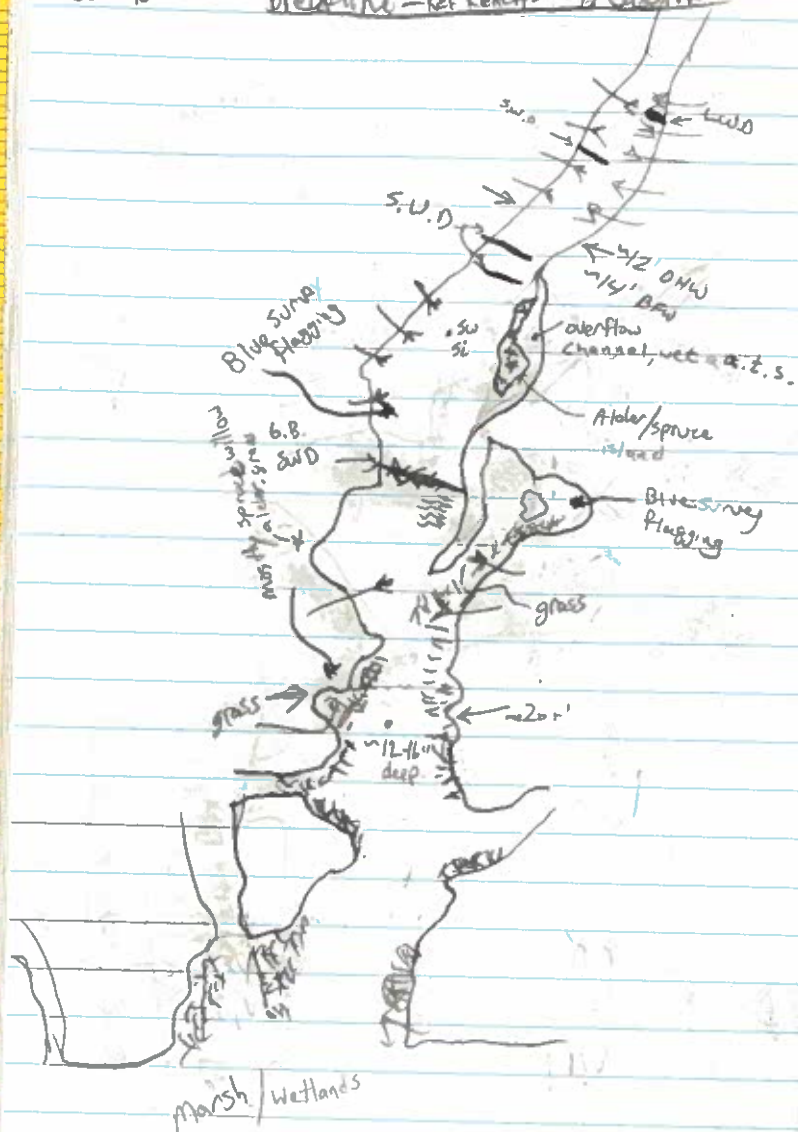
COP 43 Ref. Reach Sketch

No PEBBLE GWT, Bottom MUD/SAND

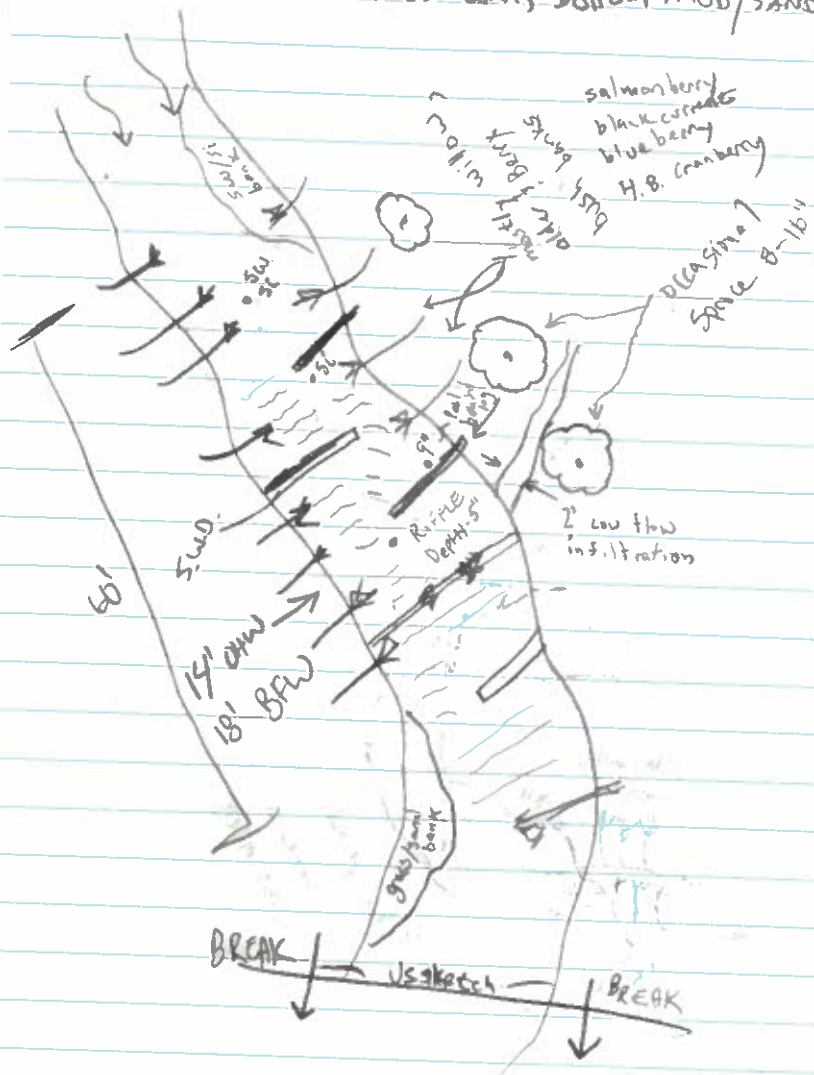
# COP 43 Downstream Sketch

No Pebble Count,  
Bottom Mud

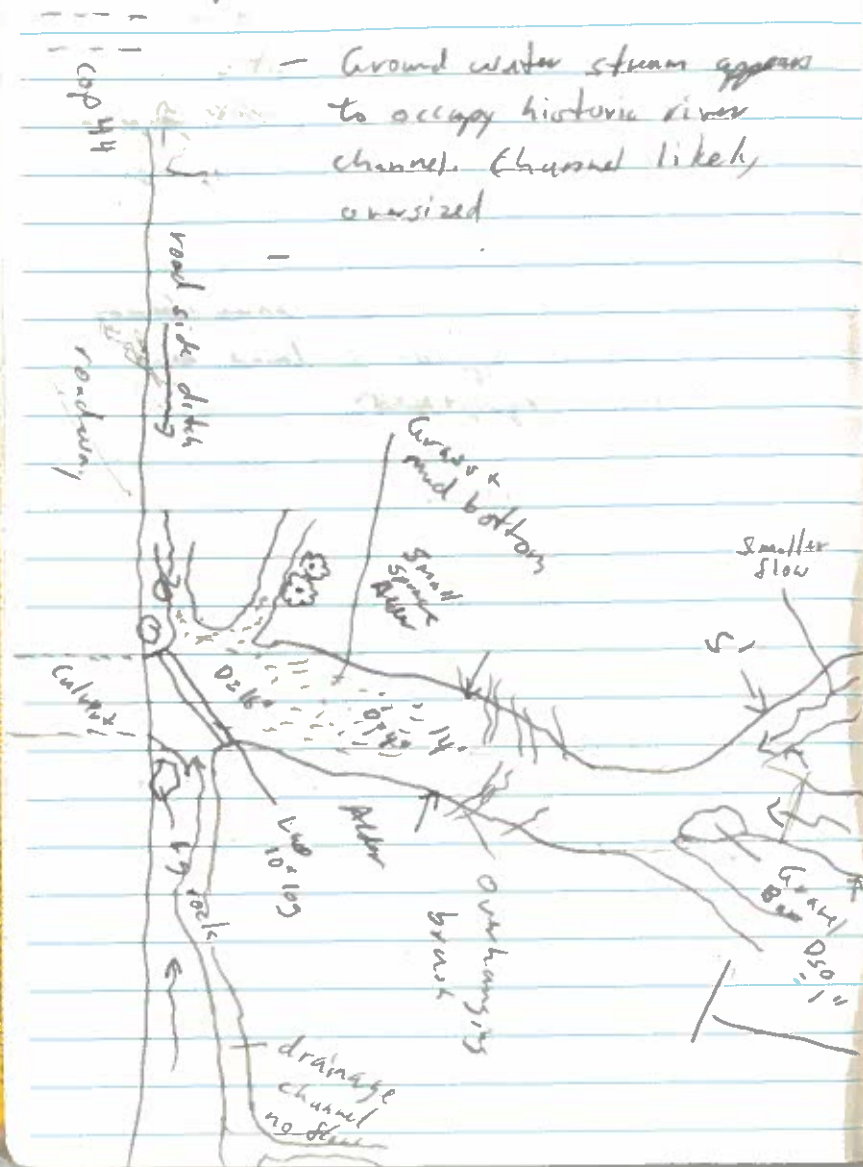
Cap 45  
upstream sketch

- culvert is a 36" x 48" pipe-arch
- badly corroded and damaged
- collapsing under road
- cover < 6"
- both upstream and downstream  
channels appear widened by  
heavy equipment

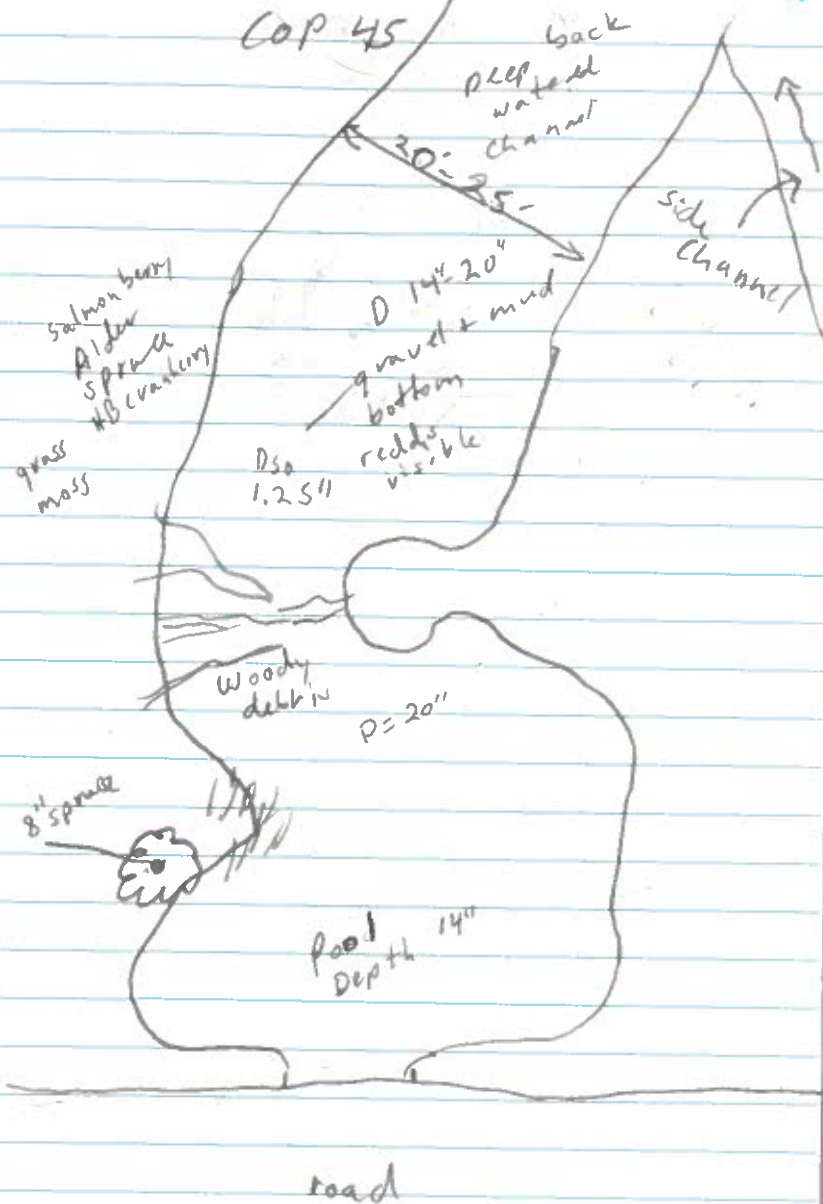
10-11-18 11:30 AM Cor 45 DOWNSTREAM SKETCH  
 Sunny, 45° F

Probable Culvert low box culvert  
8'-10' width

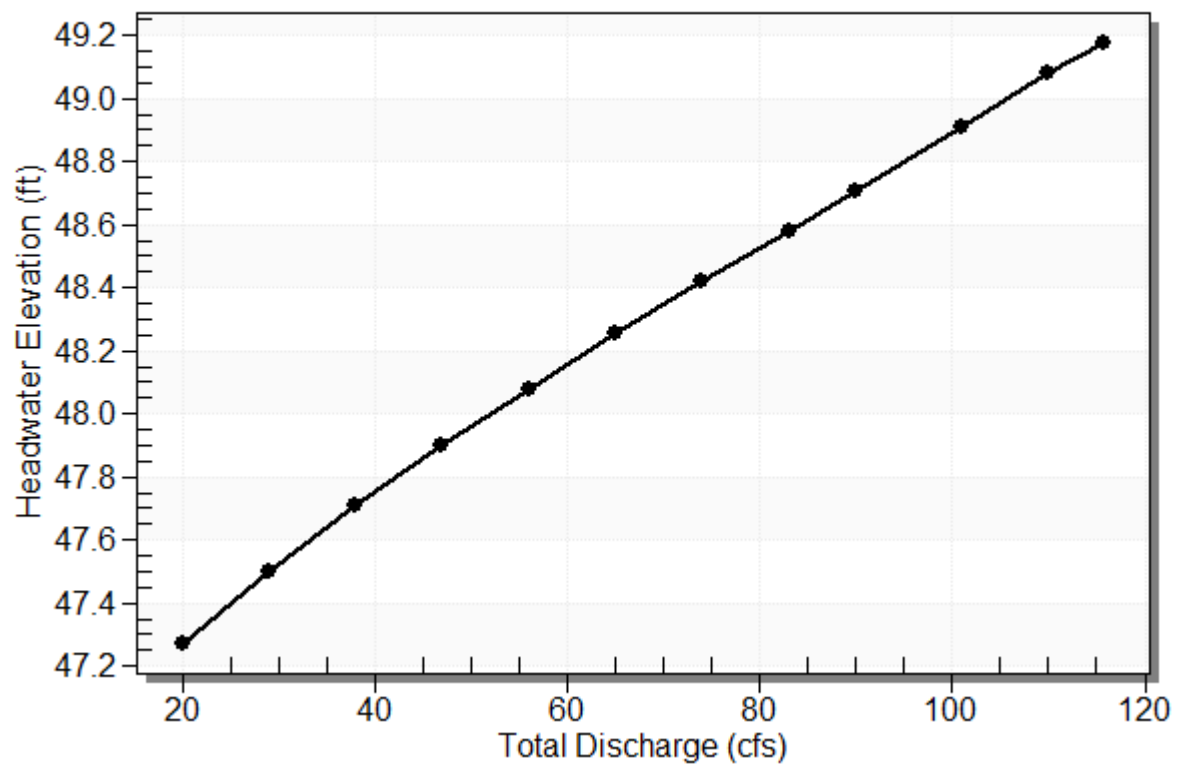
### Total Rating Curve

Crossing: Existing Combined

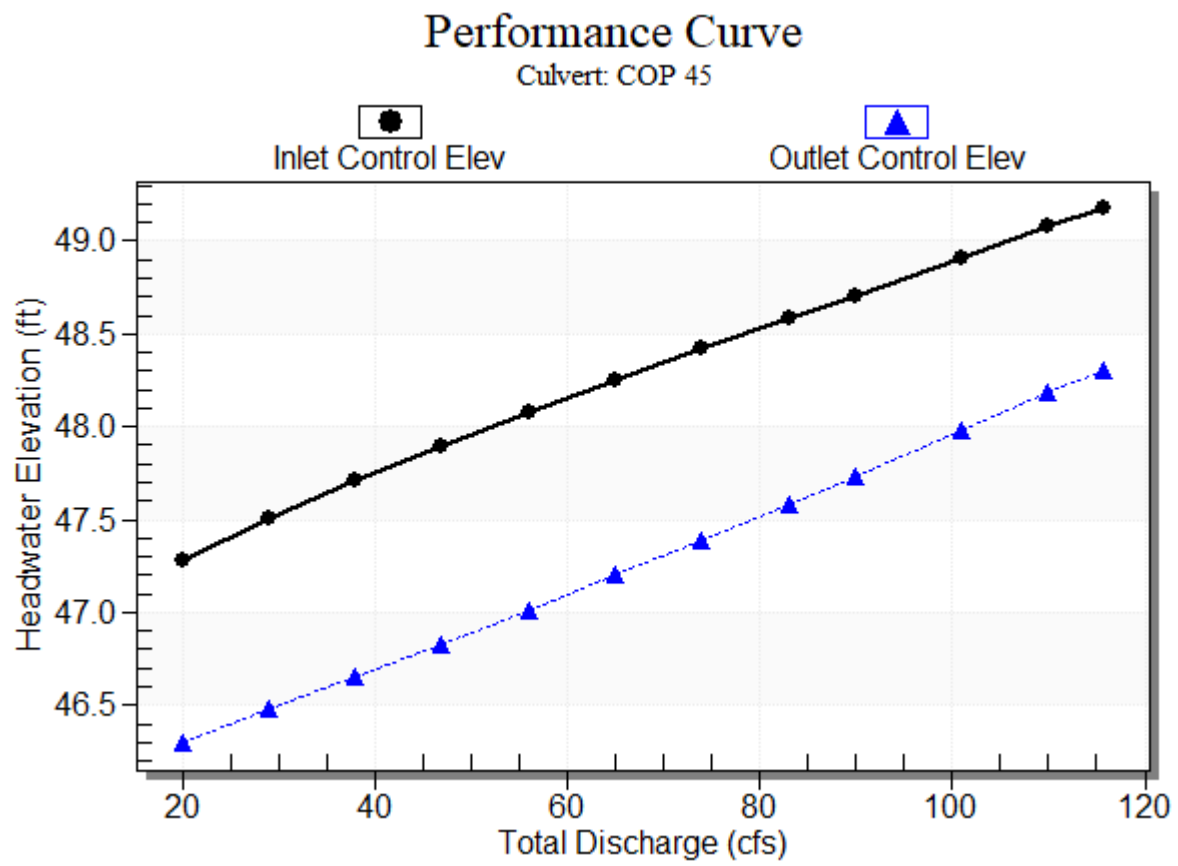
# Culvert Performance Curve Plot: COP 45

\*\*\*\*\*  
Straight Culvert  
Inlet Elevation (invert): 46.18 ft,    Outlet Elevation (invert): 45.55 ft  
Culvert Length: 38.51 ft,    Culvert Slope: 0.0164  
\*\*\*\*\*

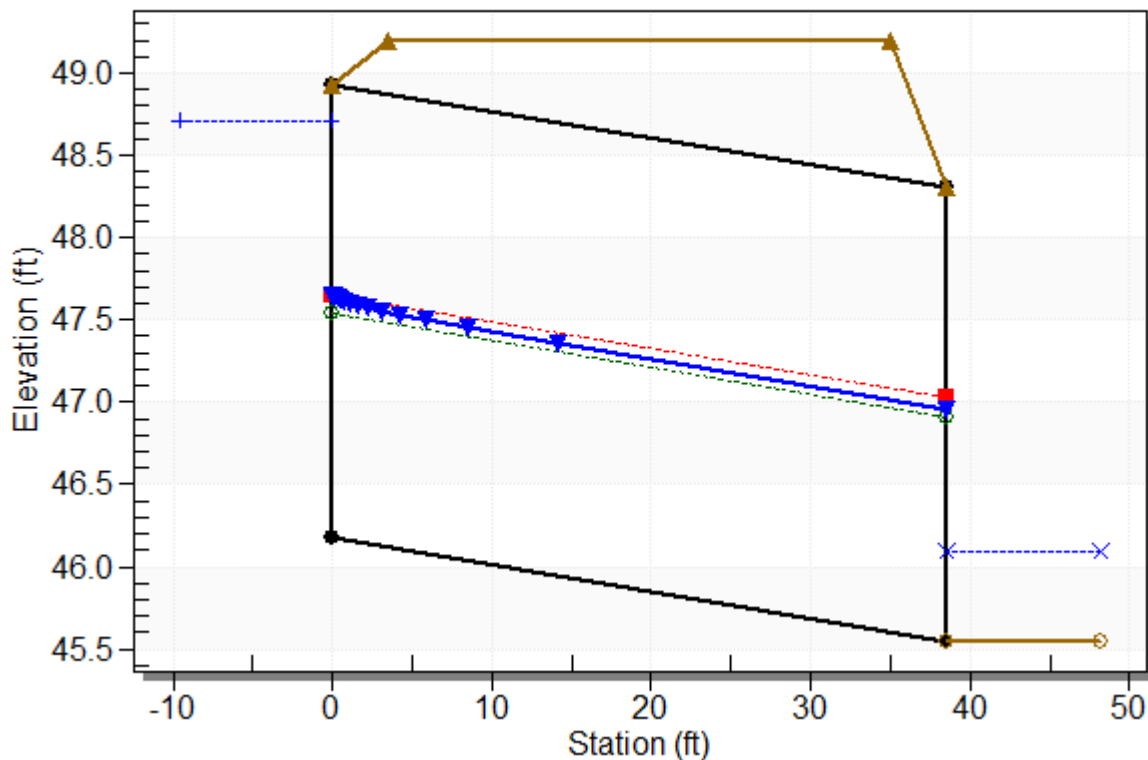
## Water Surface Profile Plot for Culvert: COP 45

Crossing - Existing Combined, Design Discharge - 90.0 cfs

Culvert - COP 45, Culvert Discharge - 36.2 cfs

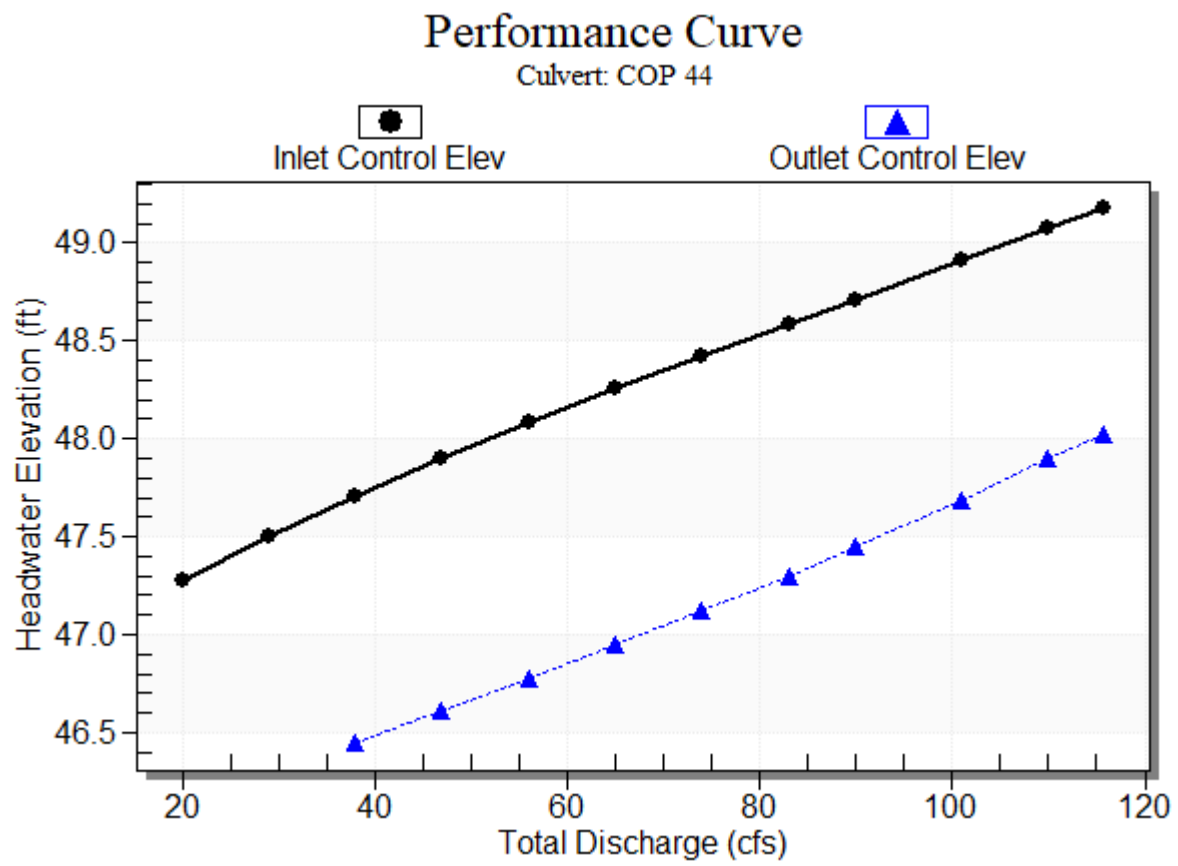
# Culvert Performance Curve Plot: COP 44

\*\*\*\*\*  
Straight Culvert  
Inlet Elevation (invert): 46.43 ft,    Outlet Elevation (invert): 45.55 ft  
Culvert Length: 39.91 ft,    Culvert Slope: 0.0221  
\*\*\*\*\*

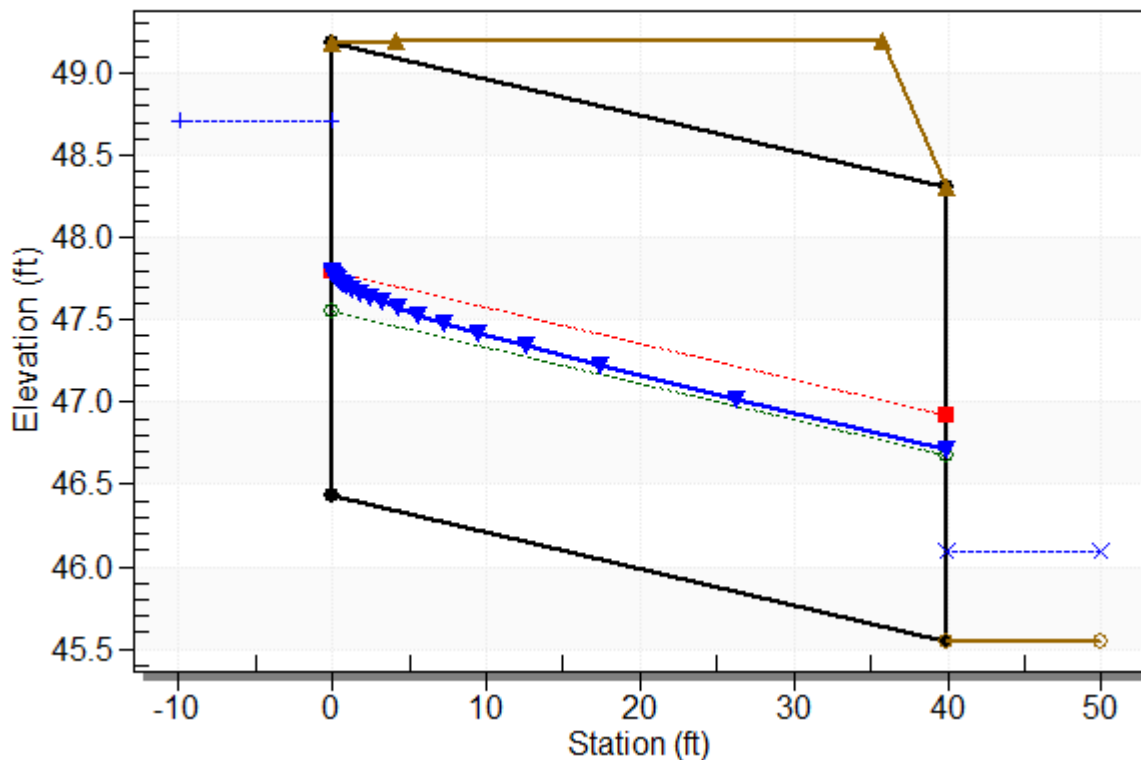
## Water Surface Profile Plot for Culvert: COP 44

Crossing - Existing Combined, Design Discharge - 90.0 cfs

Culvert - COP 44, Culvert Discharge - 31.4 cfs

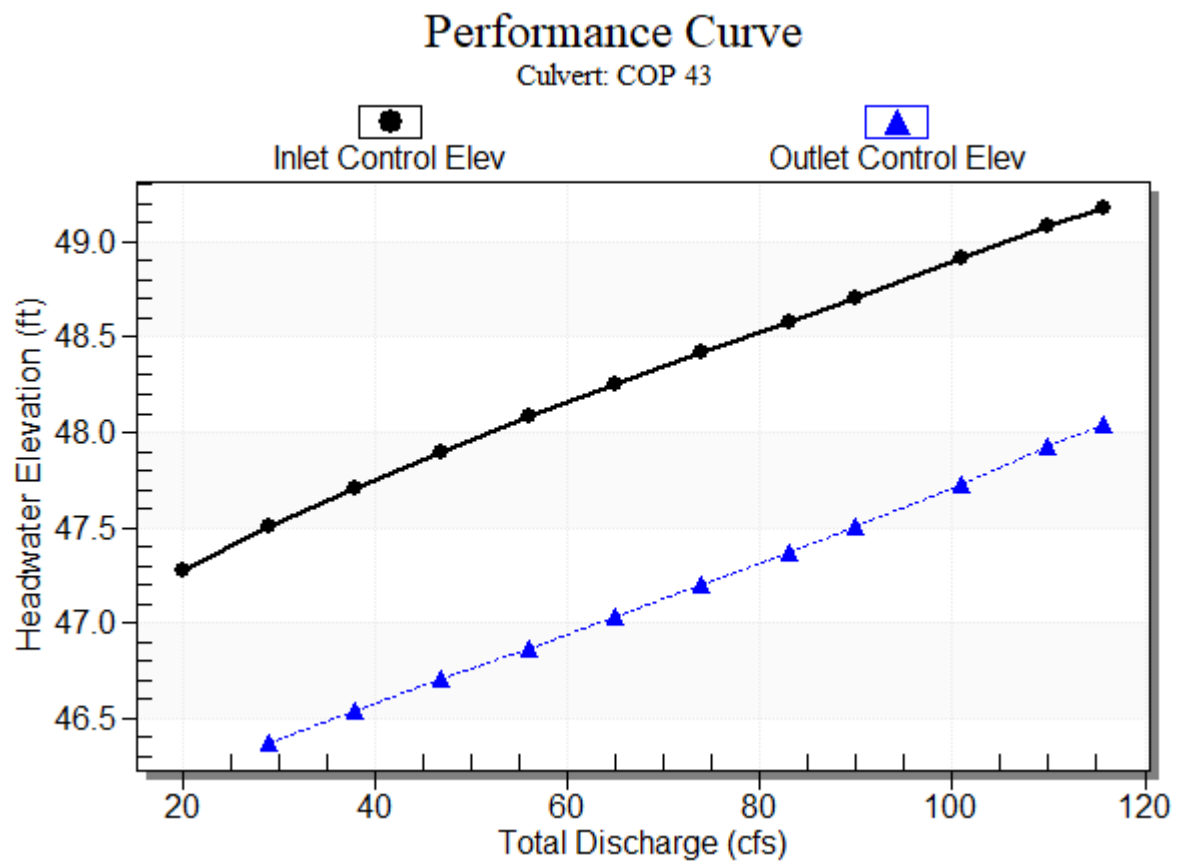
# Culvert Performance Curve Plot: COP 43

\*\*\*\*\*  
Straight Culvert  
Inlet Elevation (invert): 46.36 ft,    Outlet Elevation (invert): 45.55 ft  
Culvert Length: 40.01 ft,    Culvert Slope: 0.0203  
\*\*\*\*\*

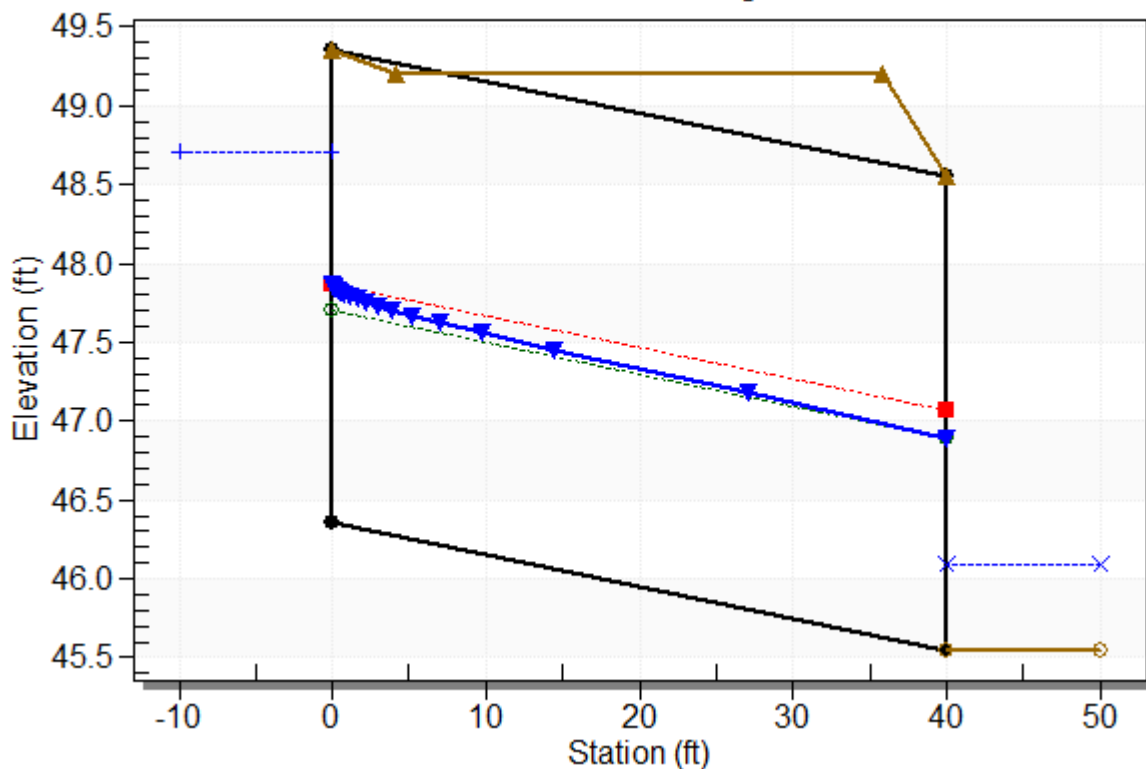
## Water Surface Profile Plot for Culvert: COP 43

Crossing - Existing Combined, Design Discharge - 90.0 cfs

Culvert - COP 43, Culvert Discharge - 22.2 cfs

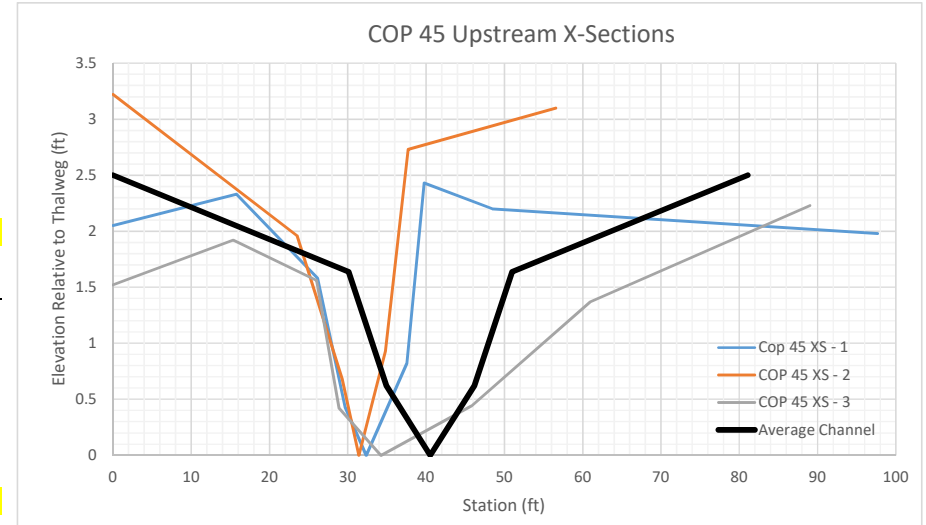
COP 45 Average BFW Cross Section						AVG Slope		0.008
	Width	Depth	Station	Elevation				
Ground	81.09	2.50	G	0.00		2.50		
BF El	20.90	1.64	TOB	30.09		1.64		
EOW	11.27	0.62	EOW	34.91		0.62 Bankfull Flow El	1.64	
			T	40.54		0 <b>Bankfull Flow (cfs)</b>	<b>51</b>	
			EOW	46.18		0.62 Bankfull Velocity (fps)	2.56	
			TOB	50.99		1.64		
			Ground	81.09		2.50

Note: Bankfull Flows calculated using HY-8 Tailwater rating curve calculator. Based on Manning's open channel flow with channel n = .05 and overbank n=.08

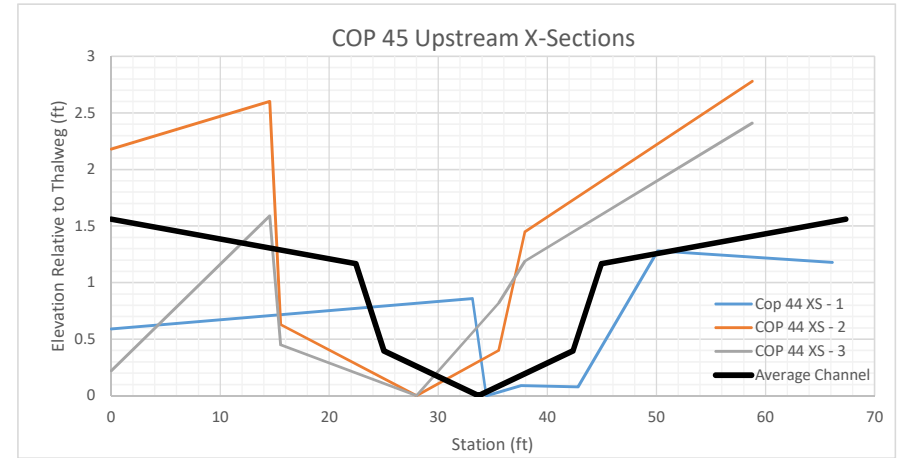
COP 44 Average BFW Cross Section						AVG Slope	0.010
	Width	Depth	Station	Elevation			
Ground	67.35	1.56	G	0.00		1.56	
BF El	22.53	1.17	TOB	22.41		1.17	
EOW	17.36	0.40	EOW	24.99		0.40 Bankfull Flow El	1.17
			T	33.68		0 <b>Bankfull Flow (cfs)</b>	<b>49</b>
			EOW	42.36		0.40 Bankfull Velocity (fps)	2.61
			TOB	44.94		1.17	
			Ground	67.35		1.56

Note: Bankfull Flows calculated using HY-8 Tailwater rating curve calculator. Based on Manning's open channel flow with channel n = .05 and overbank n=.08

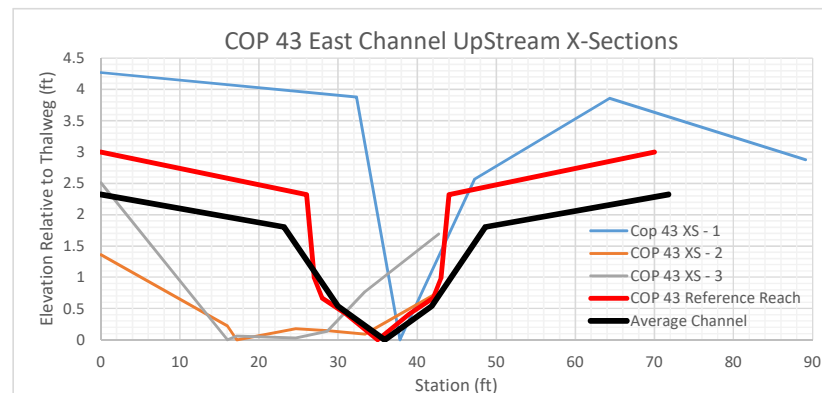
COP 43 Average BFW Cross Section						AVG Slope	0.007
	Width	Depth	Station	Elevation			
Ground	71.78	2.32	G	0.00		2.32	
EOV	25.47	1.80	EoV	23.16		1.80	
CH	11.85	0.54	EOW	29.96		0.54 Bankfull Flow El	1.80
			T	35.89		0 <b>Bankfull Flow (cfs)</b>	<b>69</b>
			EOW	41.82		0.54 Bankfull Velocity (fps)	2.58
			TOB	48.63		1.80	
			Ground	71.78		2.32

Note: Bankfull Flows calculated using HY-8 Tailwater rating curve calculator. Based on Manning's open channel flow with channel  $n = .05$  and overbank  $n = .08$

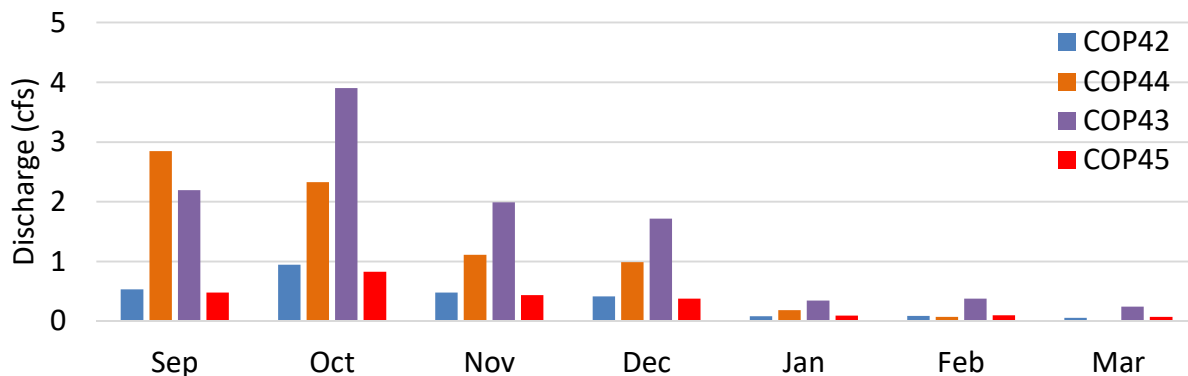
Figure 1. Average monthly discharge at COP 42, 43, 44 and 45 from mean daily discharge data.

The lowest flows were observed in January, February and March (Figure 1) where flows <0.1 cfs were observed at all four sites (Figure 2). The lowest mean daily flows for the months of September and October may be a good low design flow for fish movement (Figure 2). Between COP42, 43 and 45 the lowest daily mean flow for the months of September and October ranged from 0.2 - 1 cfs, while COP44 had a higher low flow during those months at 1.2 cfs. Low flow fish passage channel design could potentially be 0.2 cfs for COP 45, and approximately 1 cfs for both COP43 and COP44.

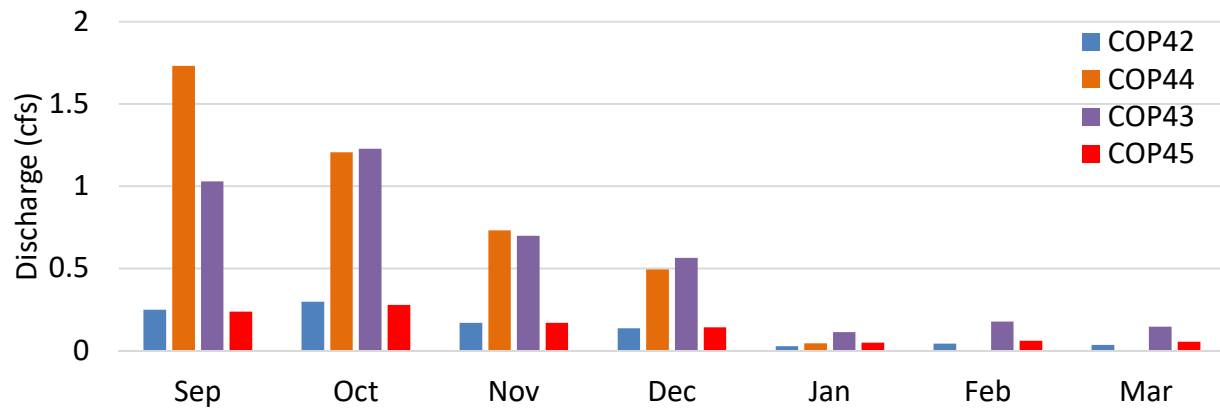
Figure 2. Lowest mean daily discharge at sites COP42, 43, 44 and 45 in each month.

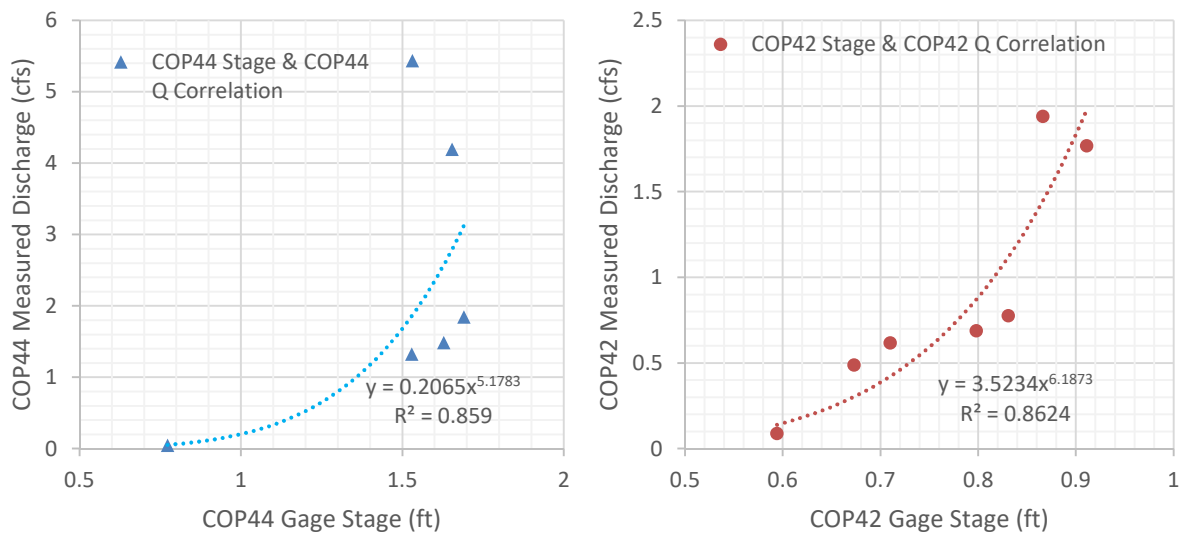
Figure 3. Correlations between the COP 42 and COP 44 gage stage (ft) to the measured discharge (cfs) at each site to create a record of continuous discharge (Figure 4 & 5).

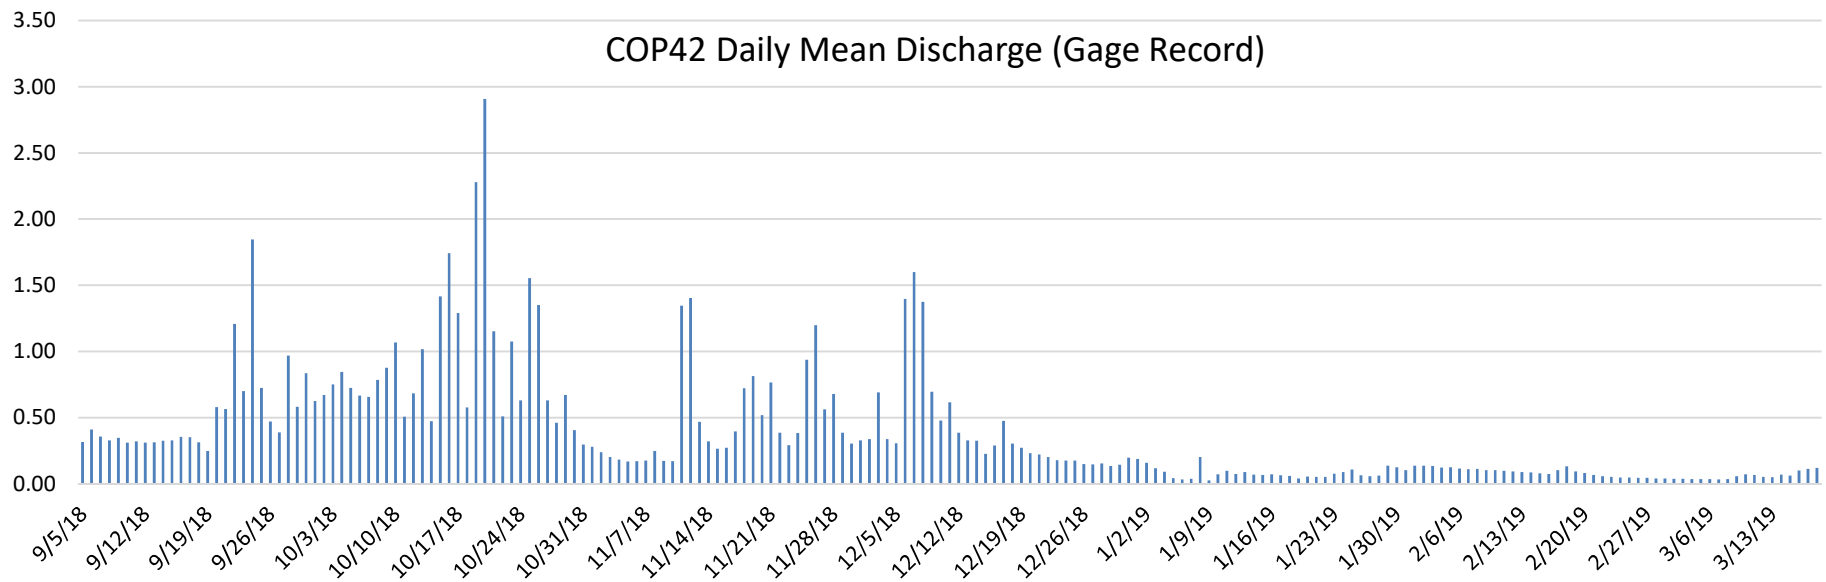
Figure 4. Mean daily discharge for COP42 derived from the COP42 pressure transducer gage and seven flow measurements. The gage indicated the highest daily mean flow was on 10/20/2018 (2.91 cfs) and the lowest was on 1/6/2019 (0.03 cfs).

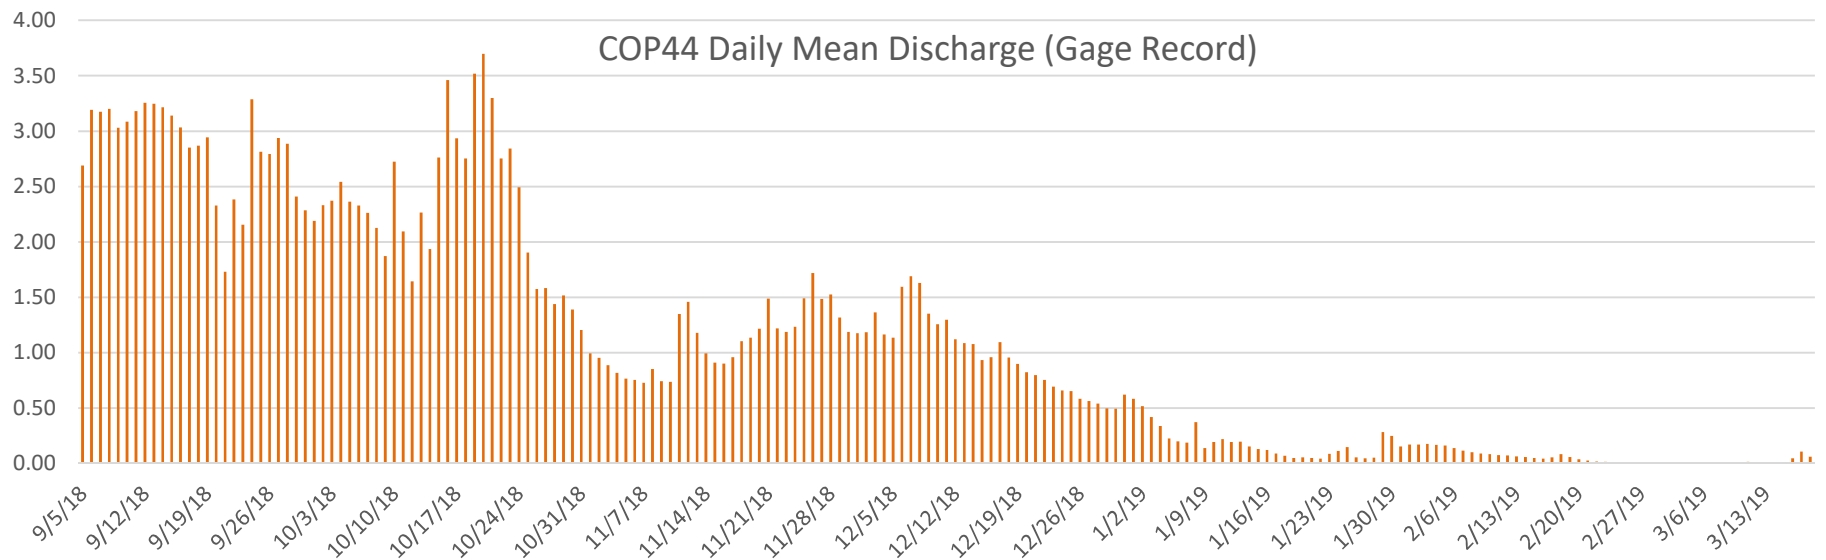
Figure 5. Mean daily discharge for COP44 derived from the COP44 pressure transducer gage and six flow measurements. The gage indicated the highest daily mean flow was on 10/20/2018 (3.70 cfs) and the lowest were in February and March (0.0 cfs).

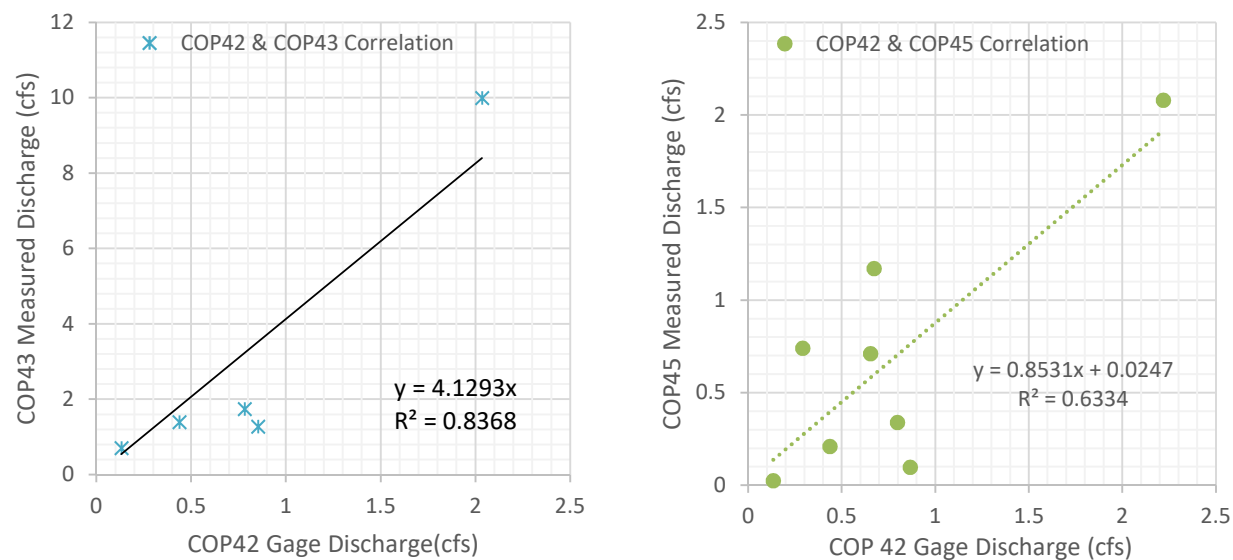
Figure 6. Correlations between the COP 42 gage discharge record and the flow measurements collected at COP43 and COP45. The regression equations were used to create continuous flow records for both ungaged sites (Figure 7 & 8).
