# Hydraulic and Hydrologic Report

Copper River Watershed Fish Passage  
Improvement Project

*Copper River Highway, Cordova, Alaska*  
July 17, 2019

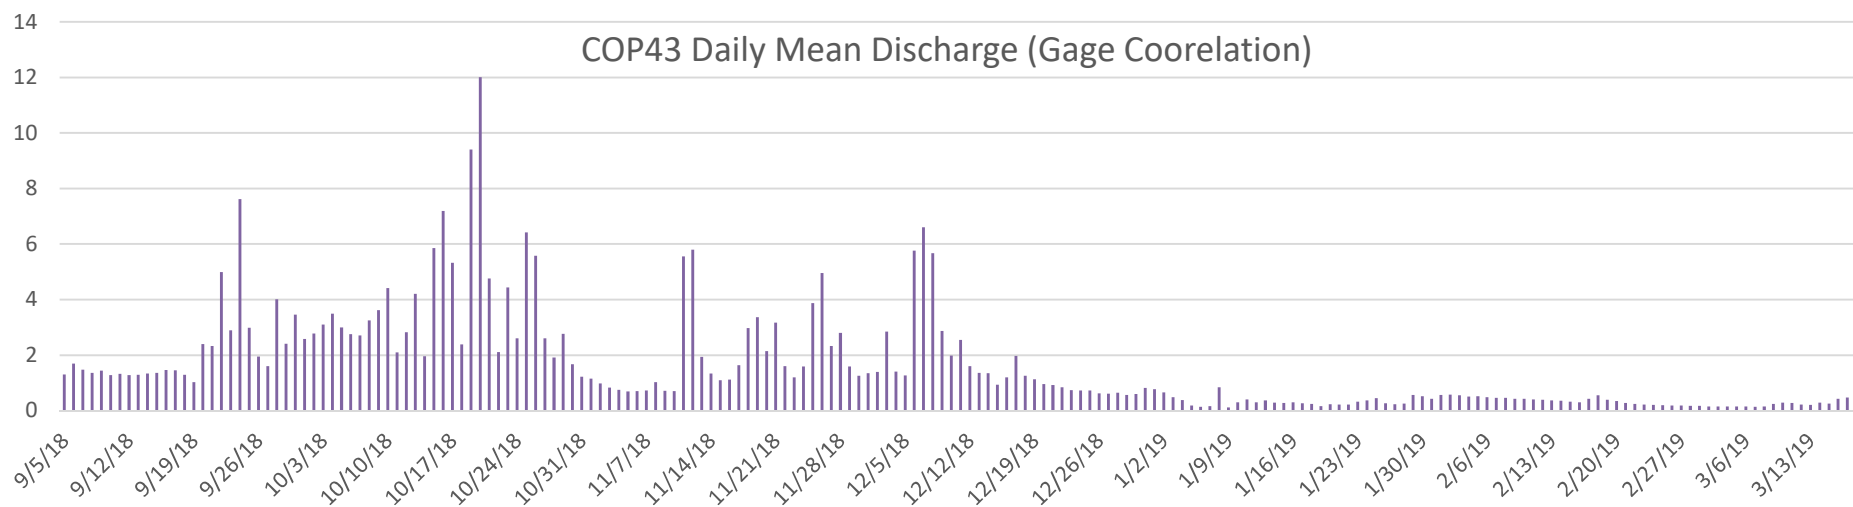
Figure 7. Mean daily discharge for COP43 derived from the COP42 pressure transducer gage record and the 6 flow measurements taken at COP43. Flow measurements ranged from 1.5 to 9.99 cfs (when flow was not blocked by beaver activity), but the gage correlation indicated the highest daily mean flow was on 10/20/2018 (11.8 cfs) and the lowest was on 1/9/2019 (0.6 cfs).

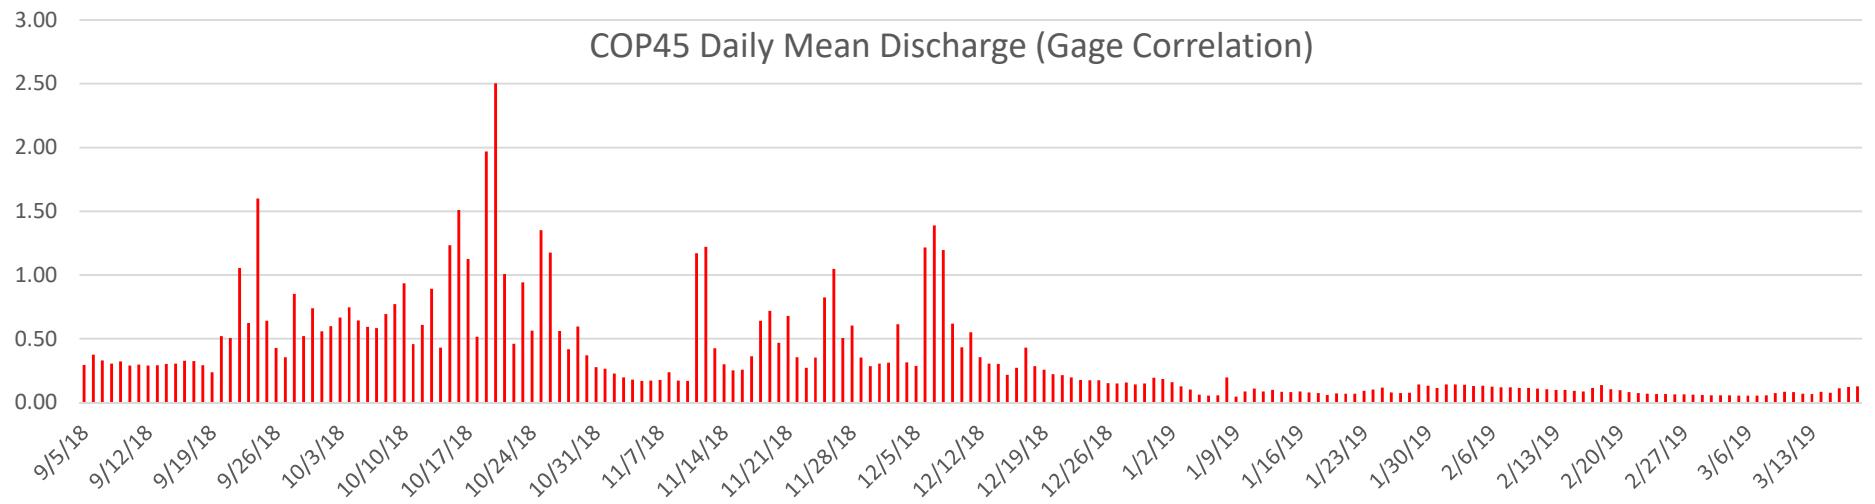
Figure 8. Mean daily discharge for COP45 derived from the COP42 pressure transducer gage record and the 8 flow measurements taken at COP45. Flow measurements ranged from 0.025 to 2.08 cfs, but the gage correlation indicated the highest daily mean flow was on 10/20/2018 (2.5 cfs) and the lowest was on 3/7/2019 (0.05 cfs).

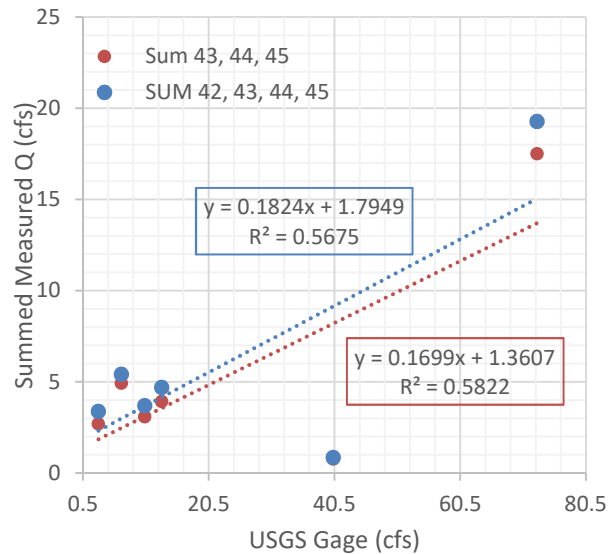
Figure 9. The correlation between the summed site discharges and the USGS Gage. Six flow measurements were included between 9/5/2018 to 3/18/2019. The relationship is strongly influenced by the single large flow measured on 12/7/2018. Also, if the observation from 3/18/2019, which plots below the trend line, is removed the  $R^2$  improves to 0.9.

To develop peak flow estimates, I took the sum of discharge for the 3 sites slated for replacement (COP43, 44, & 45) and correlated their combined flow to the USGS "Glacier River Trib" gage # 15215900 record (Figure 9, Table 2). Summing the 3 sites was meant to eliminate the problems caused by the shifting flow between sites. For comparison I also made peak flow estimates by summing all 4 sites investigated (COP42, 43, 44, 45) as it appears they are all related (Table 2). The USGS gage record provides 7 years of peak flows. I have low confidence in the peak flow estimates until data is collected on additional high flow events.
