# Hydraulic and Hydrologic Report

Copper River Watershed Fish Passage  
Improvement Project

*Copper River Highway, Cordova, Alaska*  
July 24, 2019

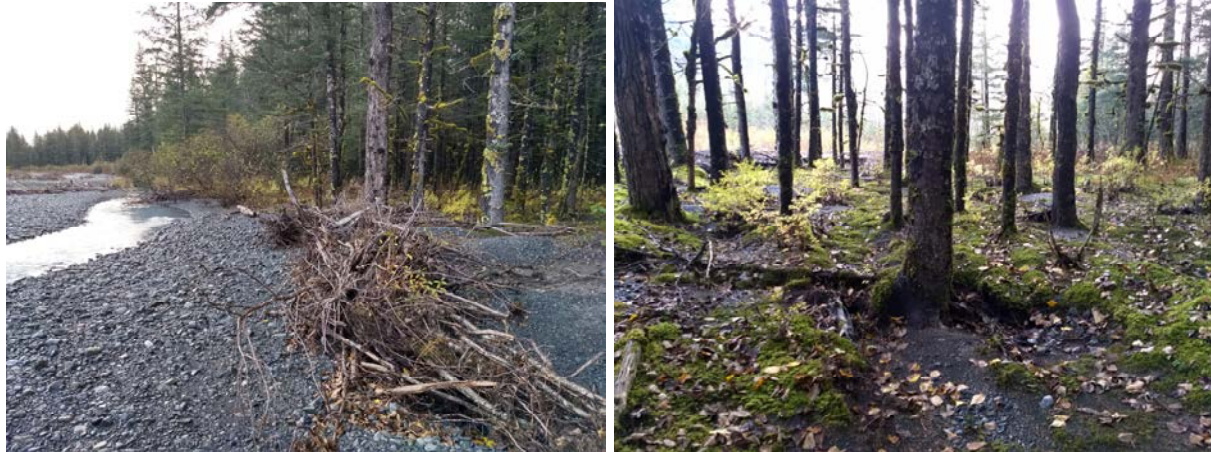
**Photographs 1 and 2: Saddlebag River overtopping point**

The first tipping point is an outside bend in the Saddlebag River where high flows jump the bank and course into the adjacent wooded area to join channels that cross back into the site basin. A field reconnaissance of the area confirmed that this is a relatively common occurrence but photo records appear to indicate that the Saddlebag River has never been completely rerouted at this point, at least since 1907. Such an event would have washed out the rail bed, and the three small trestles seen in the 1950 aerial would have been replaced with a larger river crossing. The Saddlebag River has not always been contained entirely within its current banks and channel. In fact, these aerial images show that the river has historically had multiple active side channels that run parallel to the existing U.S. Forest Service (USFS) Saddlebag Glacier road that is adjacent to the project area. However, none of these channels have rerouted the river permanently, and it continues to hug the west side of the valley and carry most of the larger flows to the larger existing bridge west of the culvert sites.

The point at the river bend is still active and shows evidence of overtopping in the past summer; however, once the waters subsided, the river went back to its main channel. The following photographs are of this river bend and the sediment deposits in the adjacent forest. Note that

there is no high bank for the flood waters to overcome, with high flow events flooding into the forest. Although the forest floor trends downhill toward the east from this point, it appears that the gradient of the existing thalweg is steeper than the alternative routing into the forest, and the river has historically settled back to the westerly channel after significant flood events.

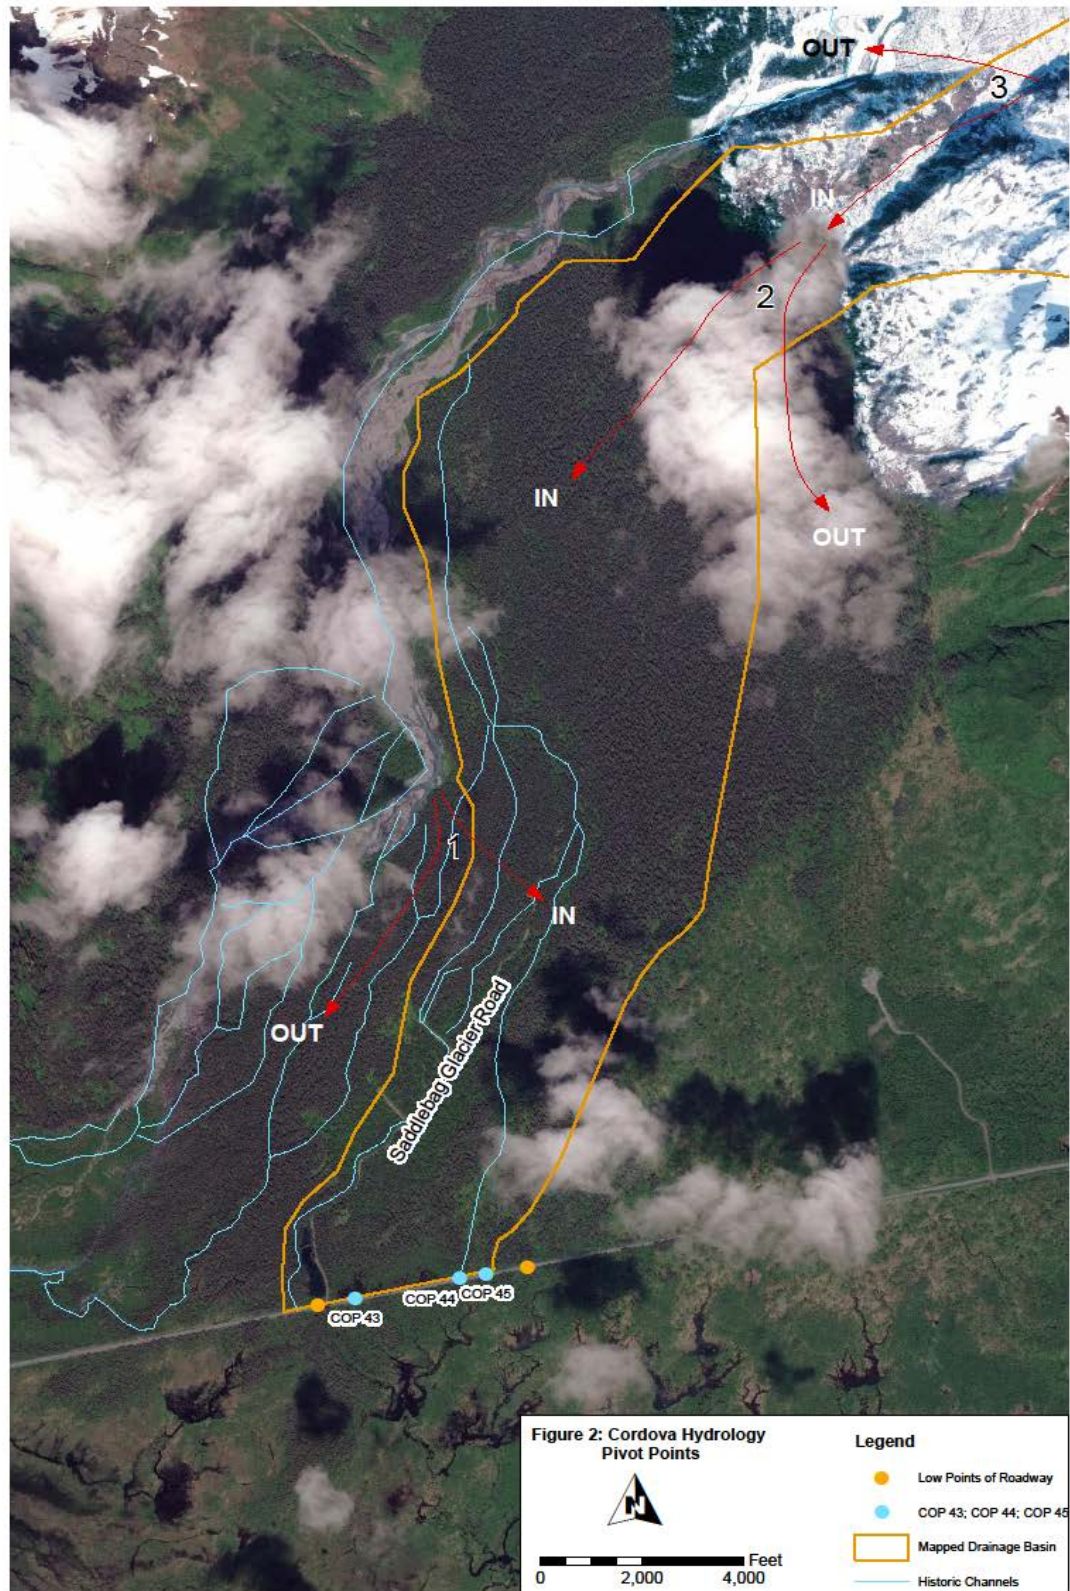
Figure 2: Drainage Basin Mapping

Looking at the delineated basin as a whole, there are three points of uncertainty where there is either insufficient data to determine drainage flows or alluvial fan features have led to different drainage paths over time. The inclusion or exclusion of drainage above these “tipping points” significantly alters the area of drainage basins and subsequent flows. The Saddlebag River of which these smaller drainages are sub-basins contains a large active glacier, glacial lake, and significant alluvial features. It is these alluvial fan features that, through continued sediment deposition over time, have moved the basins flows between channels and have altered the geometry of the basins feeding the three crossings. Figure 2 shows the larger basin and tipping points. It also shows the complexity of the historic stream channels digitized from available aerial photography dated 1950, 1976, 1983 and the present. The following paragraphs describe the tipping points in more detail.

In summary, for flood flow analysis the delineation of the project basin includes the smaller additions to the basin represented by the two latter unknowns but does not include flood flows from the Saddlebag River. Saddlebag River flows are known to occur, but their frequency and volume have not been included here.

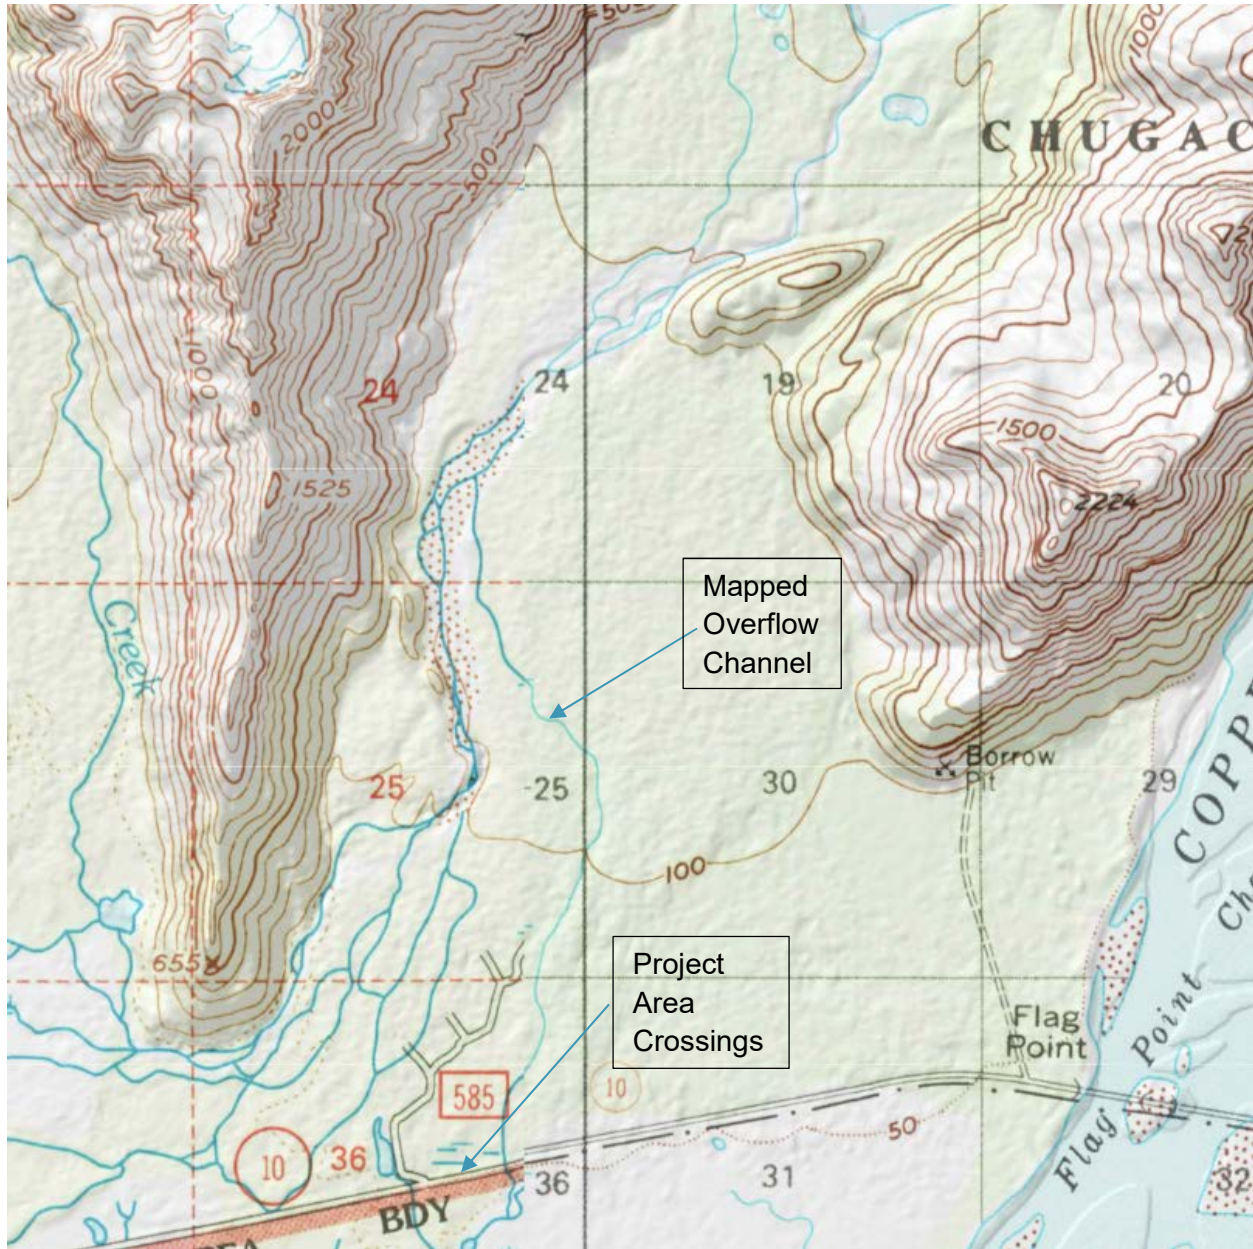
Figure 3: USGS Drainage Mapping

Additionally, the USGS topographic mapping of this area shows a small side channel of the Saddlebag River diverting from the main river even further upstream and making its way to the sites COP 46 east of the project area (Figure 3). HDR found this channel during their field investigation but were unable to walk to its upstream connection point due to time constraints. Field observations show it to be well grown in, and it contained no sustained flow or evidence, in the form of sediment deposition, of recent flooding events.

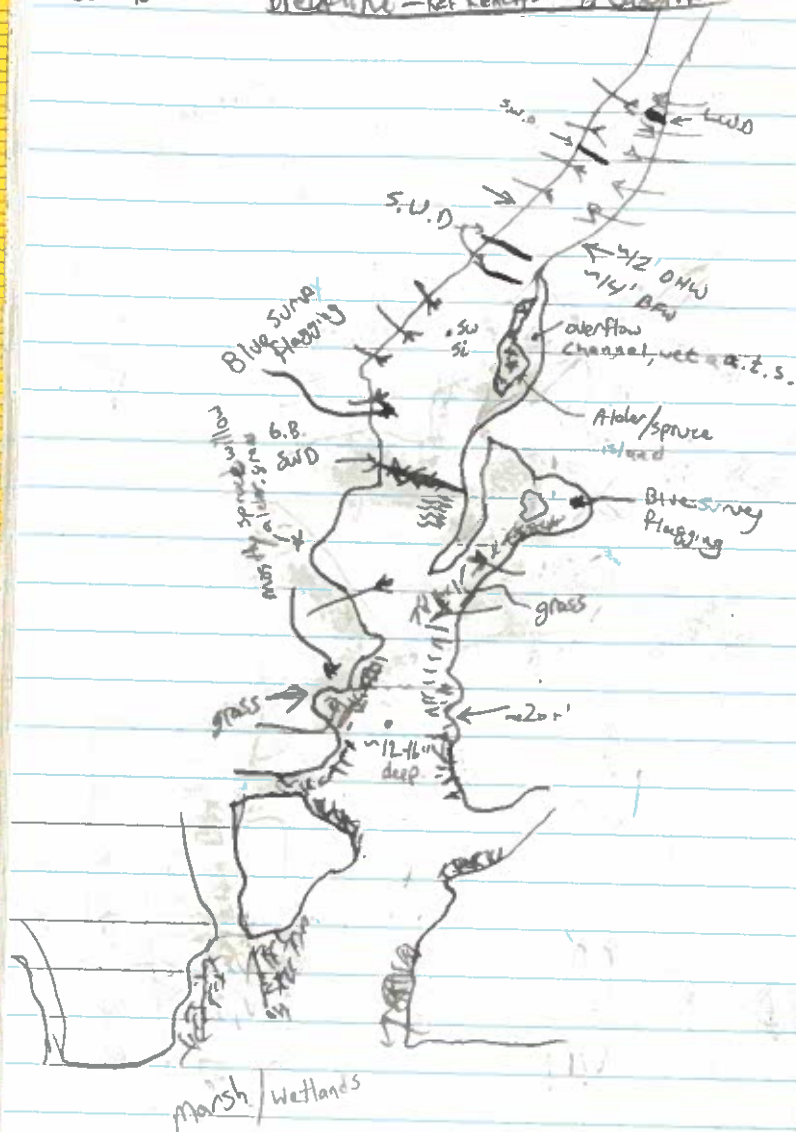
COP 43 Ref. Reach Sketch

No PEBBLE GWT, Bottom MUD/SAND

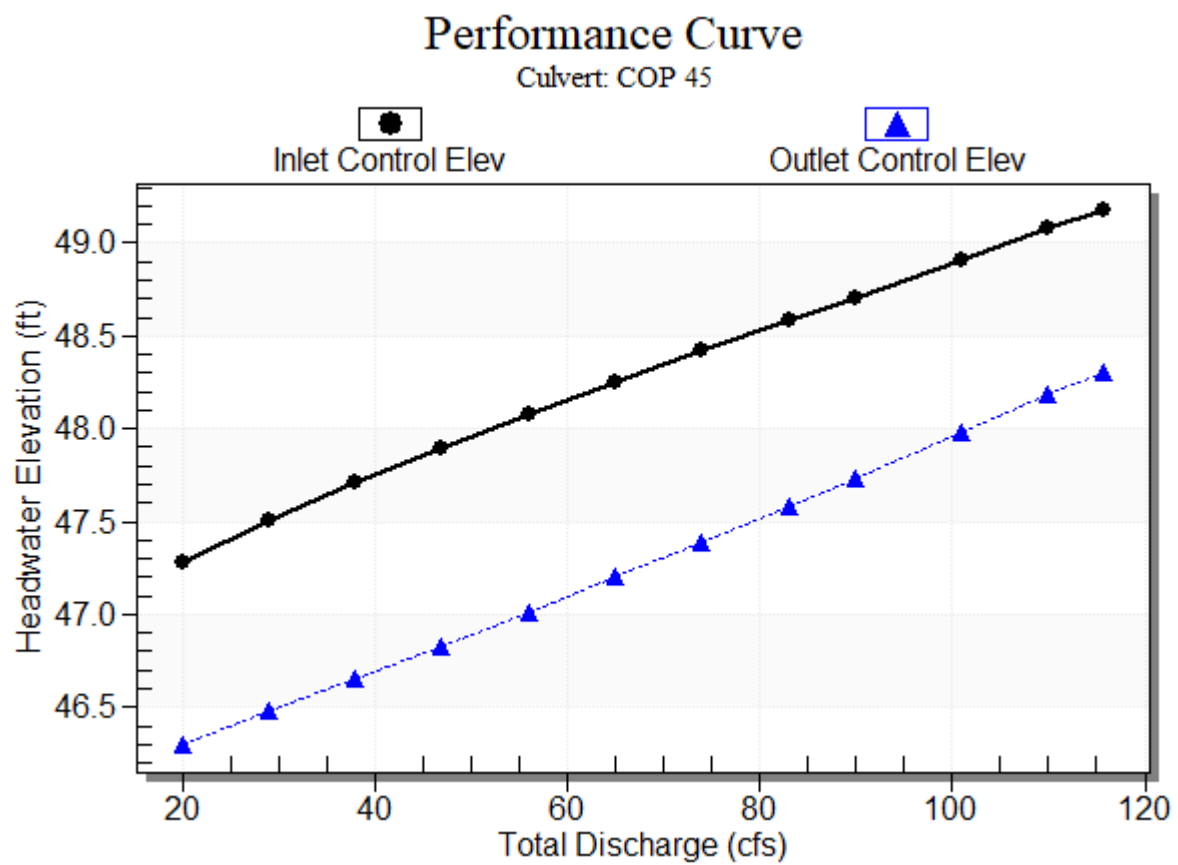
# Culvert Performance Curve Plot: COP 45

\*\*\*\*\*  
Straight Culvert  
Inlet Elevation (invert): 46.18 ft,    Outlet Elevation (invert): 45.55 ft  
Culvert Length: 38.51 ft,    Culvert Slope: 0.0164  
\*\*\*\*\*

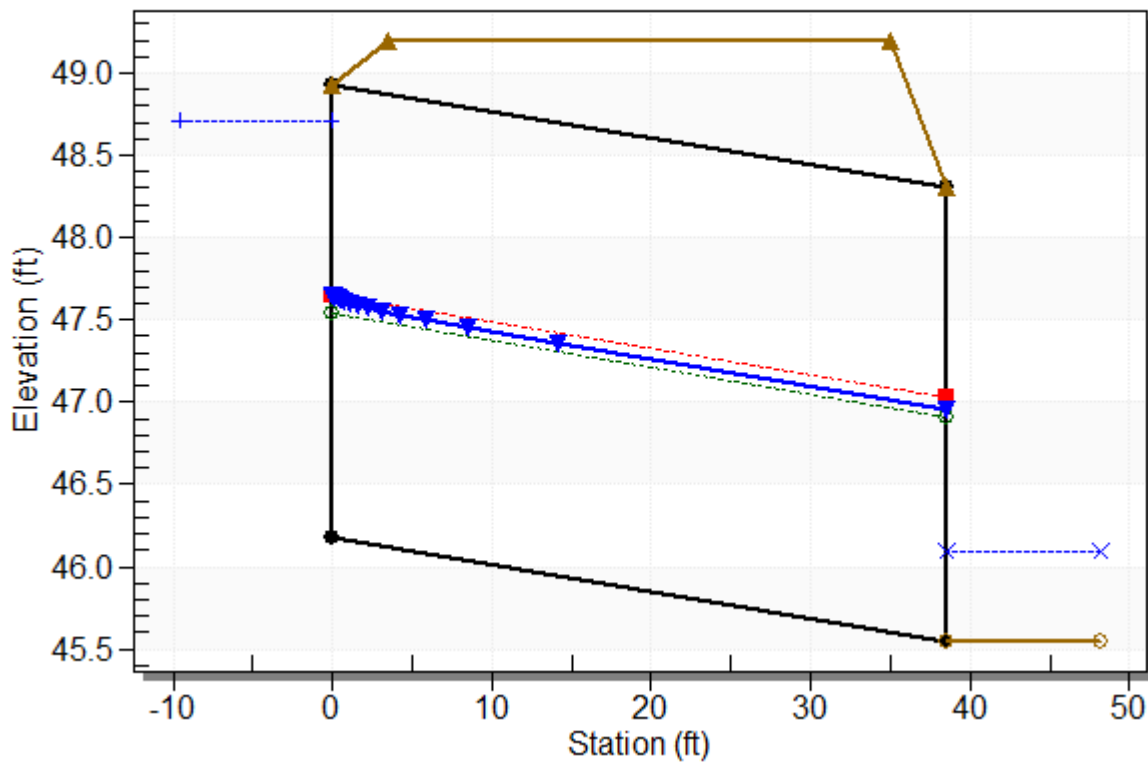
## Water Surface Profile Plot for Culvert: COP 45

Crossing - Existing Combined, Design Discharge - 90.0 cfs

Culvert - COP 45, Culvert Discharge - 36.2 cfs

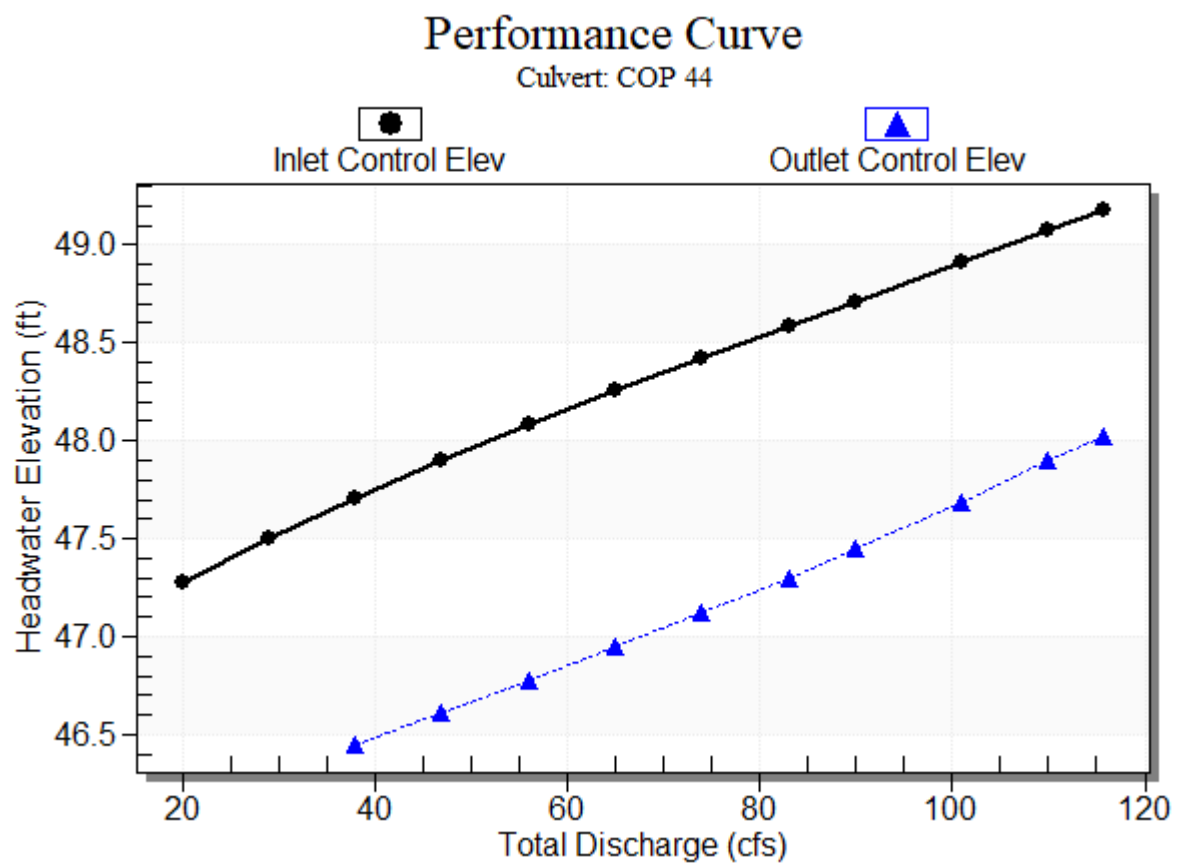
# Culvert Performance Curve Plot: COP 44

\*\*\*\*\*  
Straight Culvert  
Inlet Elevation (invert): 46.43 ft,    Outlet Elevation (invert): 45.55 ft  
Culvert Length: 39.91 ft,    Culvert Slope: 0.0221  
\*\*\*\*\*

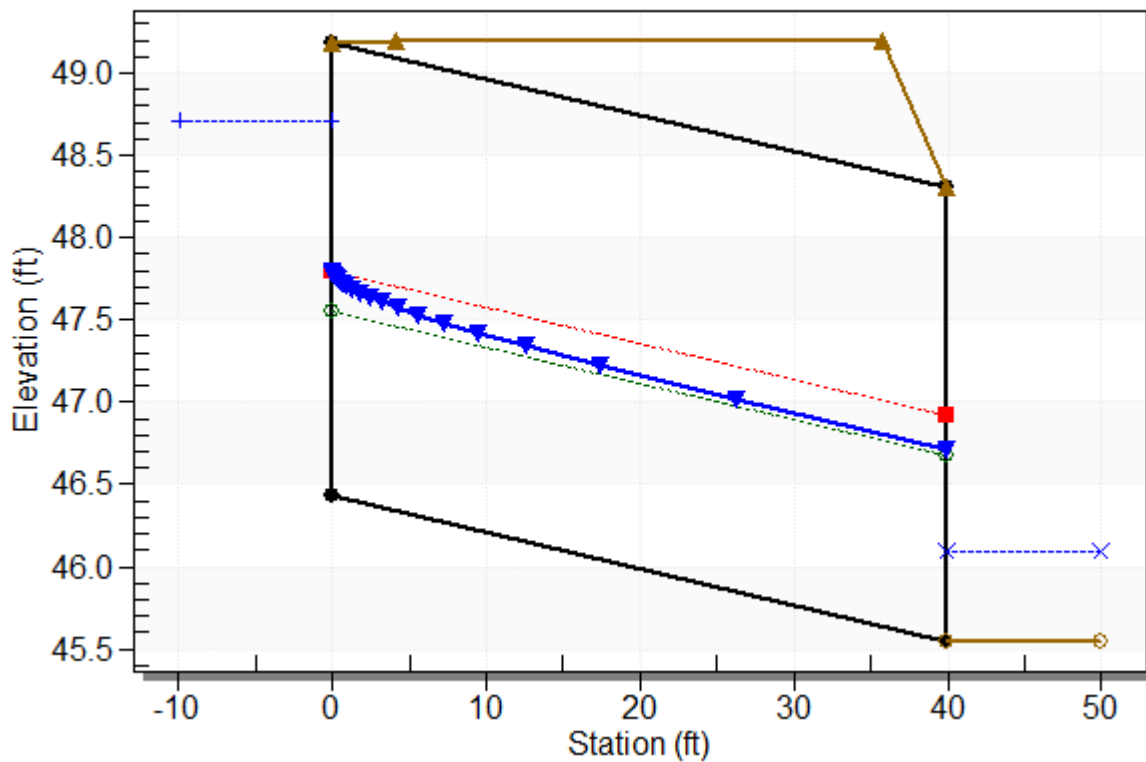
## Water Surface Profile Plot for Culvert: COP 44

Crossing - Existing Combined, Design Discharge - 90.0 cfs

Culvert - COP 44, Culvert Discharge - 31.4 cfs

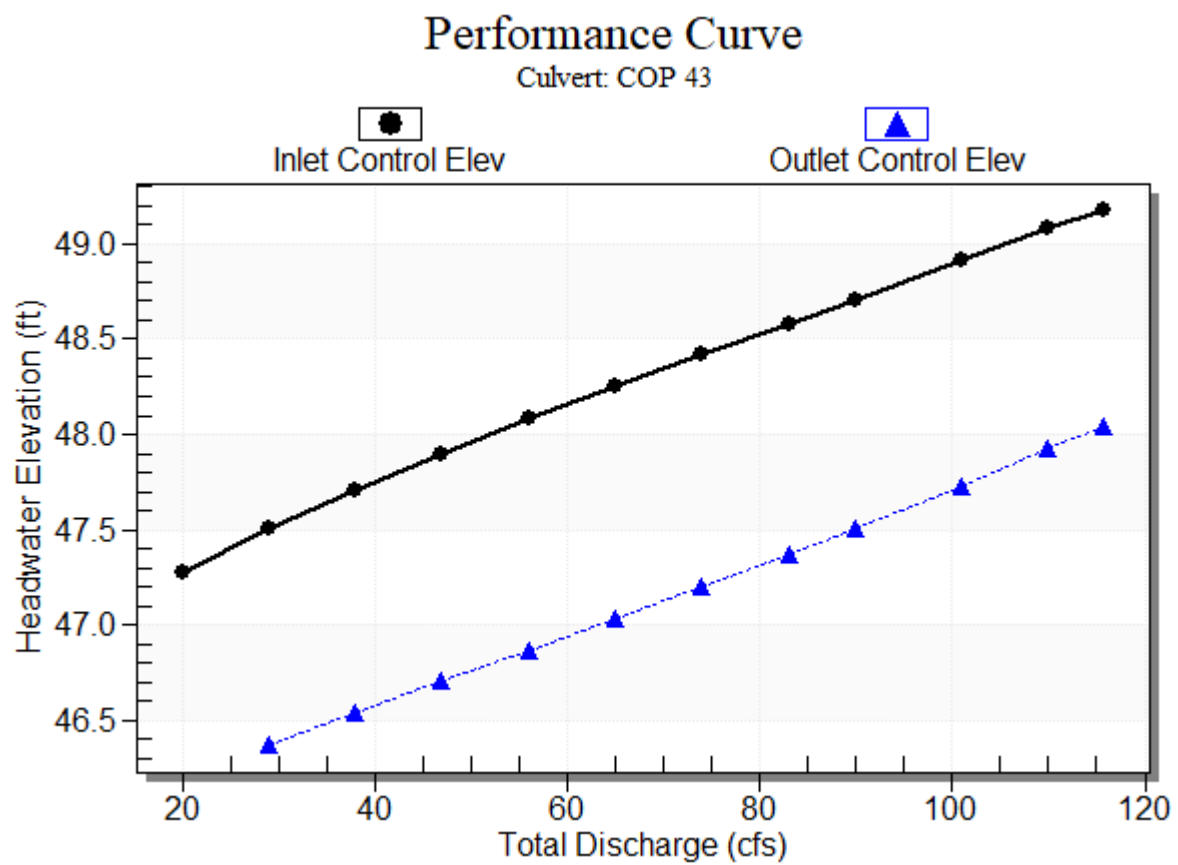
# Culvert Performance Curve Plot: COP 43

\*\*\*\*\*  
Straight Culvert  
Inlet Elevation (invert): 46.36 ft,    Outlet Elevation (invert): 45.55 ft  
Culvert Length: 40.01 ft,    Culvert Slope: 0.0203  
\*\*\*\*\*

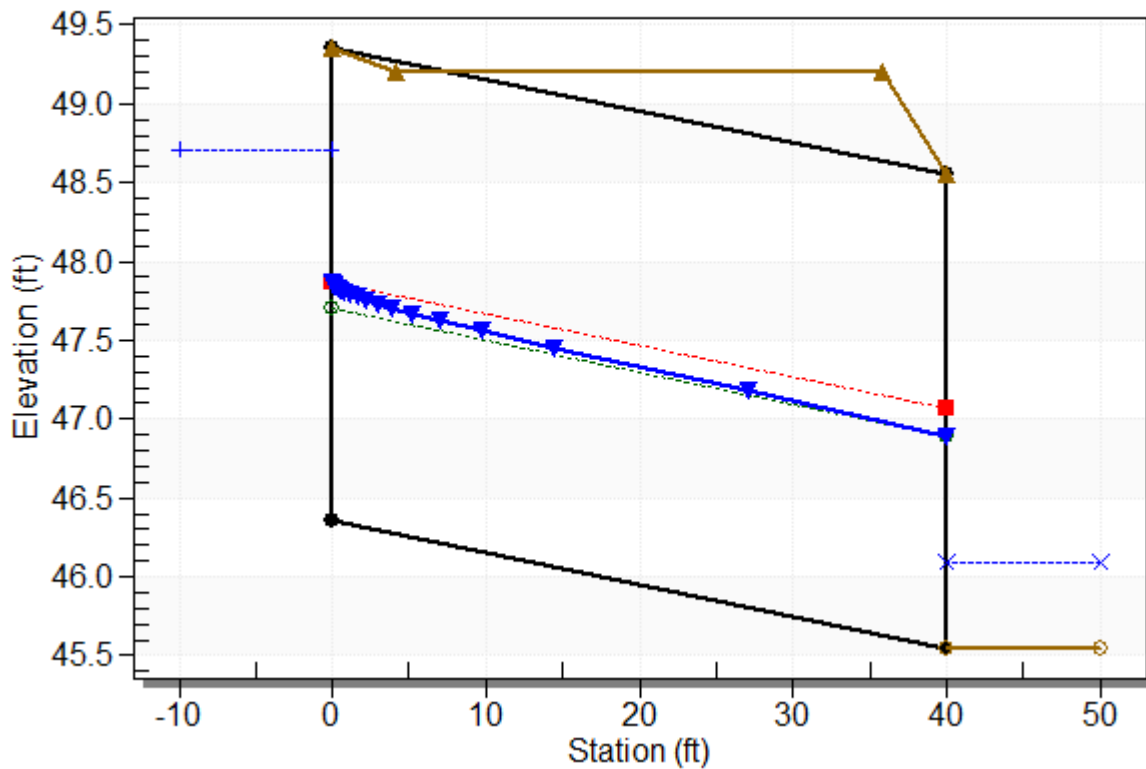
### Water Surface Profile Plot for Culvert: COP 43

Crossing - Existing Combined, Design Discharge - 90.0 cfs

Culvert - COP 43, Culvert Discharge - 22.2 cfs

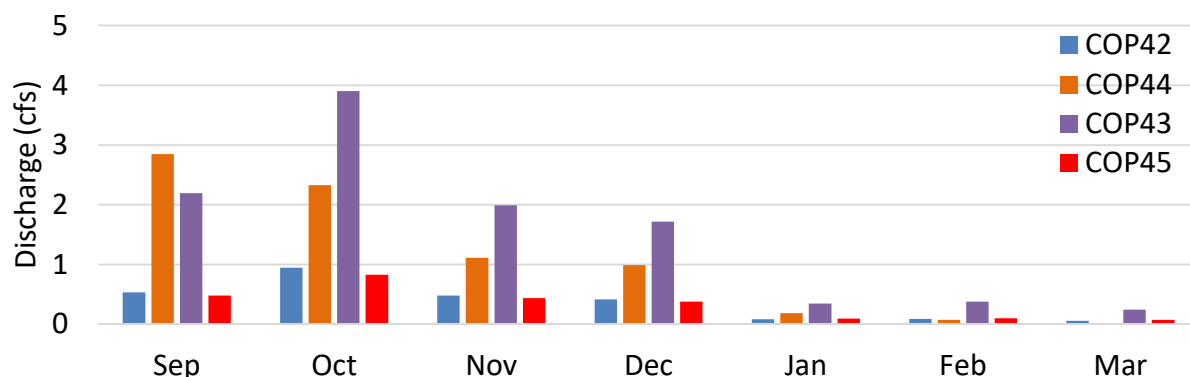
Figure 1. Average monthly discharge at COP 42, 43, 44 and 45 from mean daily discharge data.

The lowest flows were observed in January, February and March (Figure 1) where flows <0.1 cfs were observed at all four sites (Figure 2). The lowest mean daily flows for the months of September and October may be a good low design flow for fish movement (Figure 2). Between COP42, 43 and 45 the lowest daily mean flow for the months of September and October ranged from 0.2 - 1 cfs, while COP44 had a higher low flow during those months at 1.2 cfs. Low flow fish passage channel design could potentially be 0.2 cfs for COP 45, and approximately 1 cfs for both COP43 and COP44.

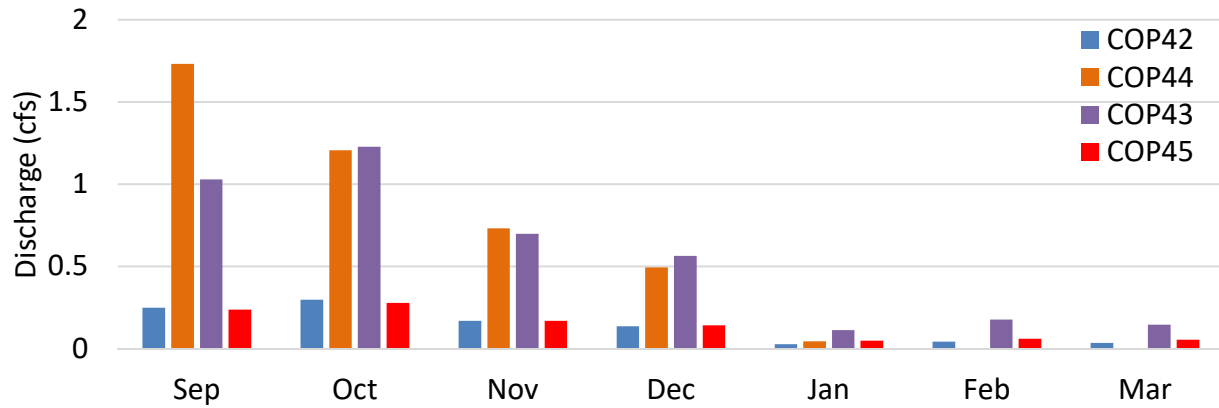
Figure 2. Lowest mean daily discharge at sites COP42, 43, 44 and 45 in each month.

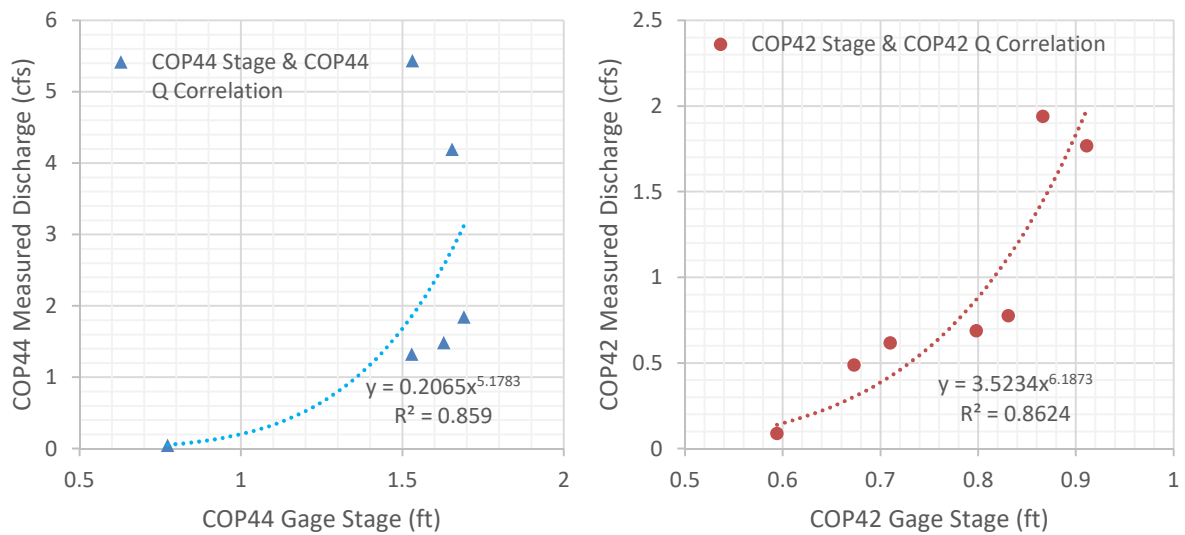
Figure 3. Correlations between the COP 42 and COP 44 gage stage (ft) to the measured discharge (cfs) at each site to create a record of continuous discharge (Figure 4 & 5).

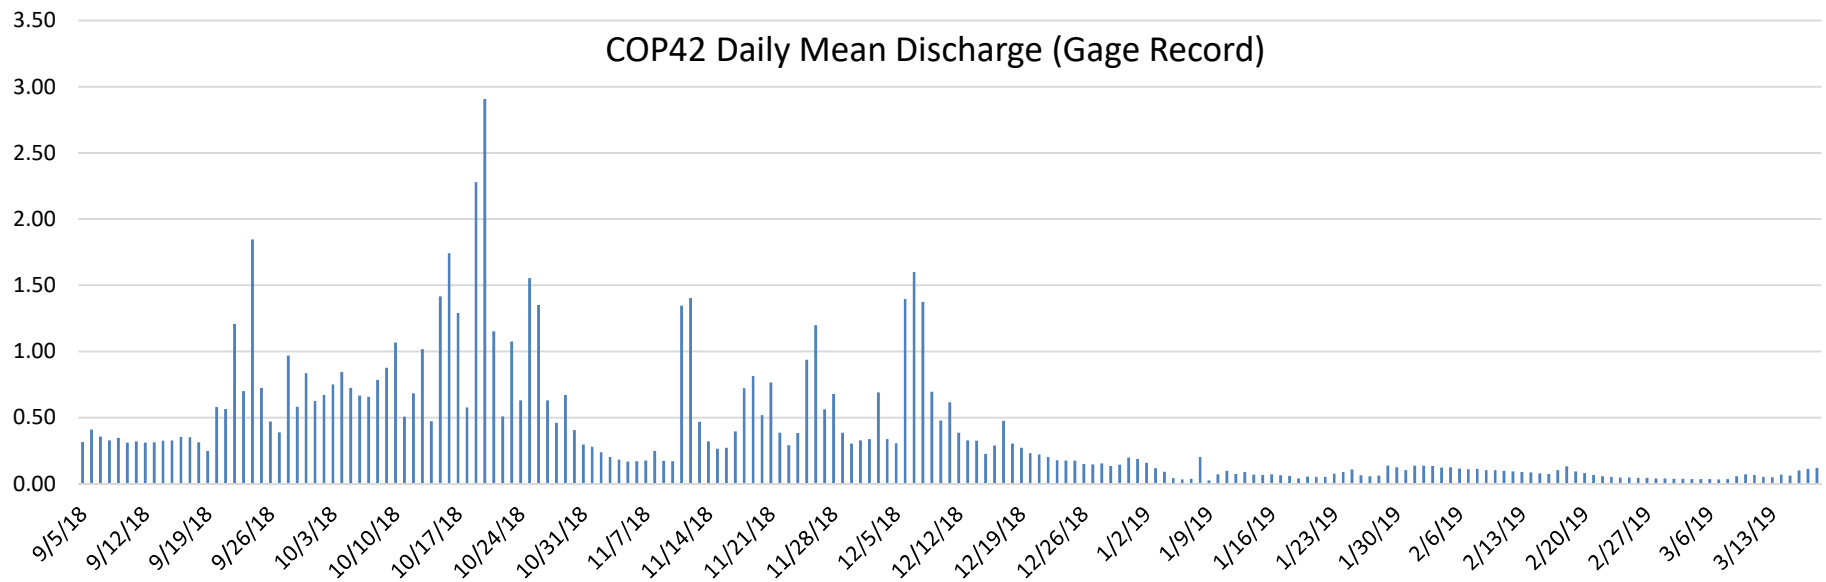
Figure 4. Mean daily discharge for COP42 derived from the COP42 pressure transducer gage and seven flow measurements. The gage indicated the highest daily mean flow was on 10/20/2018 (2.91 cfs) and the lowest was on 1/6/2019 (0.03 cfs).

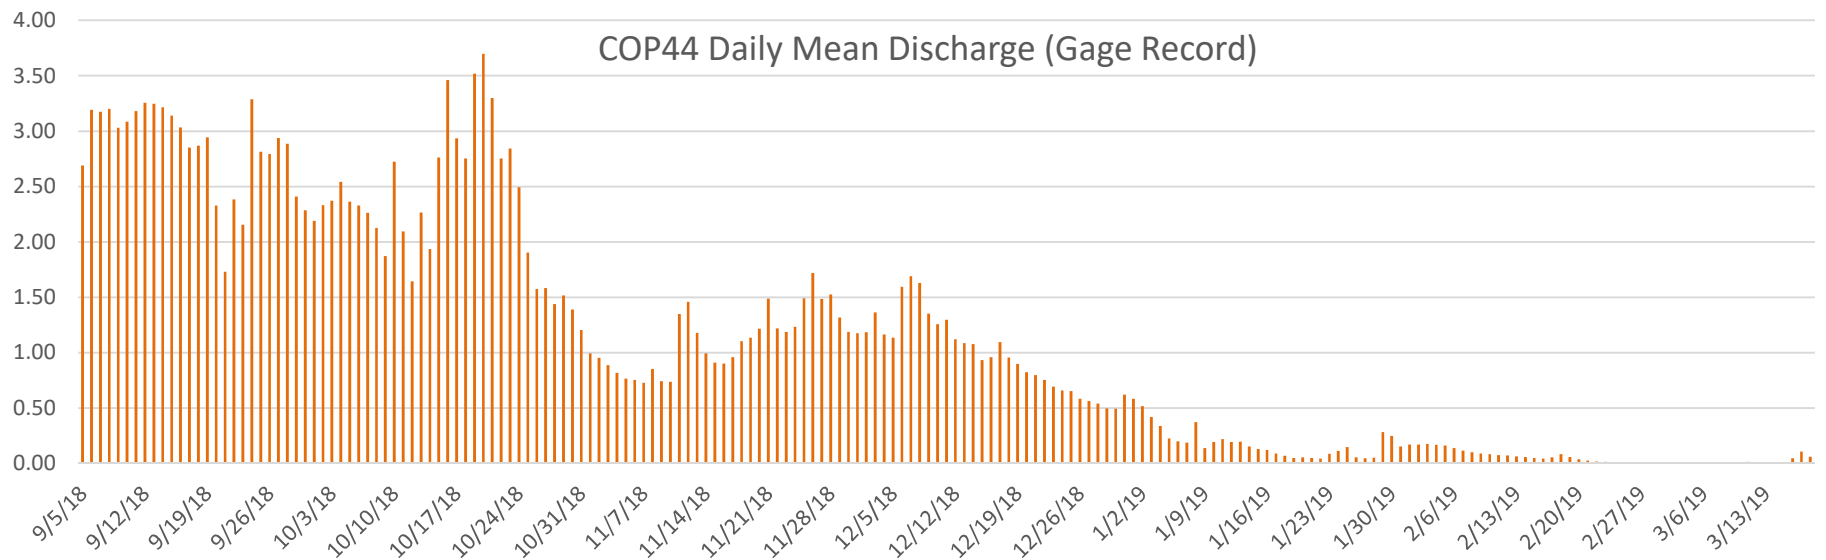
Figure 5. Mean daily discharge for COP44 derived from the COP44 pressure transducer gage and six flow measurements. The gage indicated the highest daily mean flow was on 10/20/2018 (3.70 cfs) and the lowest were in February and March (0.0 cfs).

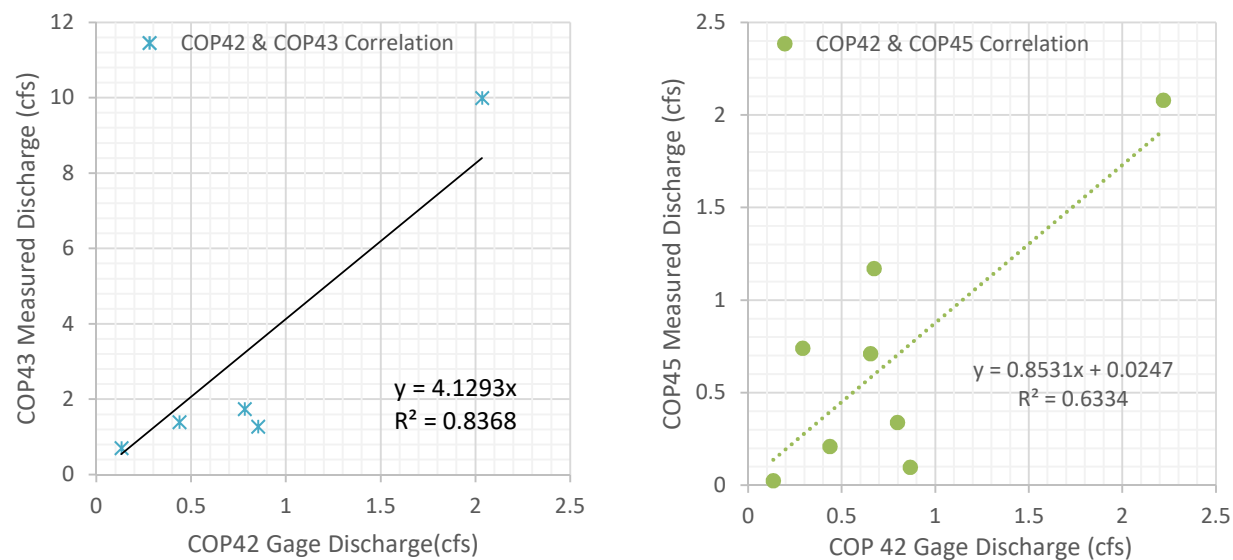
Figure 6. Correlations between the COP 42 gage discharge record and the flow measurements collected at COP43 and COP45. The regression equations were used to create continuous flow records for both ungaged sites (Figure 7 & 8).

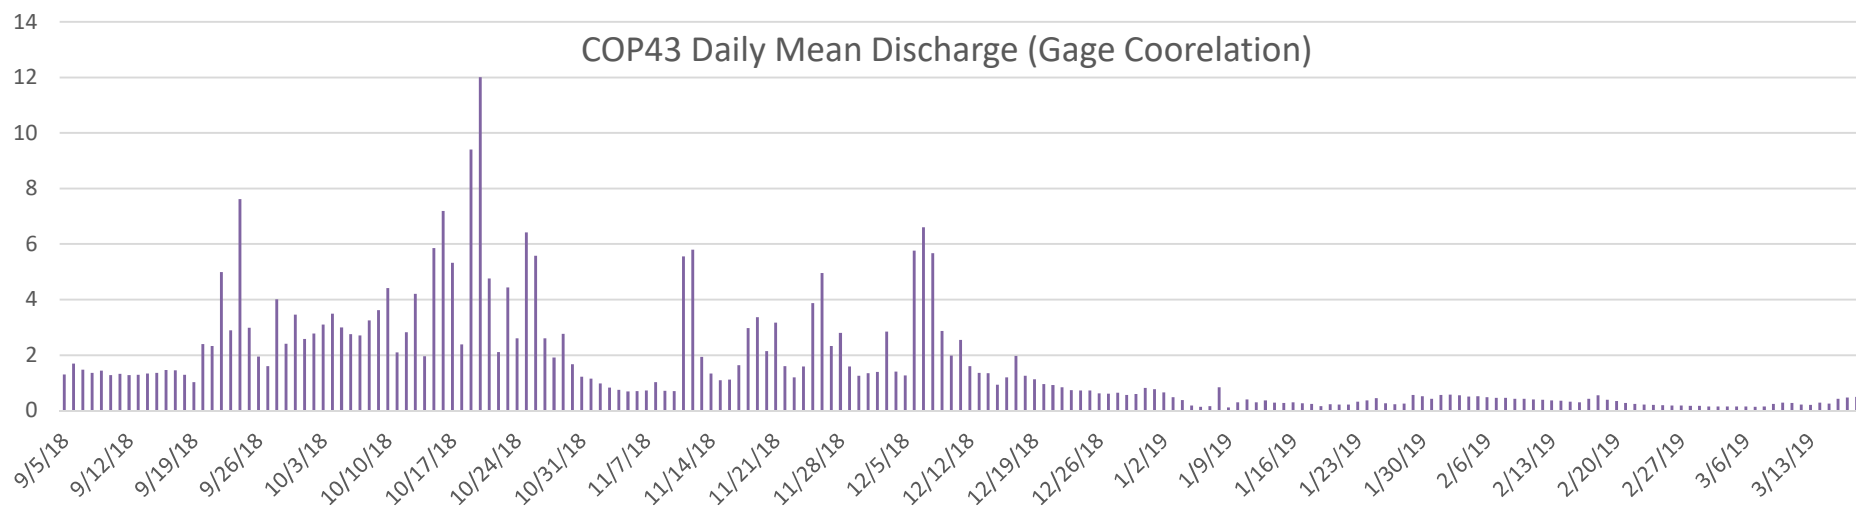
Figure 7. Mean daily discharge for COP43 derived from the COP42 pressure transducer gage record and the 6 flow measurements taken at COP43. Flow measurements ranged from 1.5 to 9.99 cfs (when flow was not blocked by beaver activity), but the gage correlation indicated the highest daily mean flow was on 10/20/2018 (11.8 cfs) and the lowest was on 1/9/2019 (0.6 cfs).

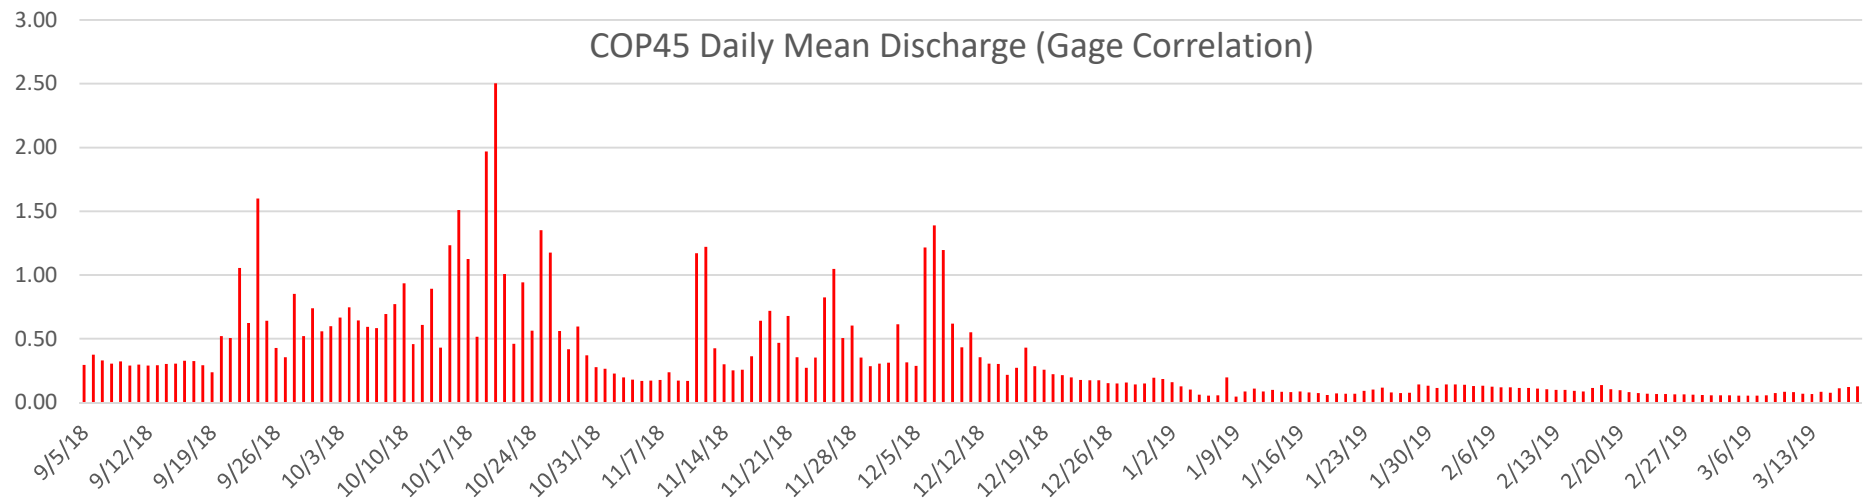
Figure 8. Mean daily discharge for COP45 derived from the COP42 pressure transducer gage record and the 8 flow measurements taken at COP45. Flow measurements ranged from 0.025 to 2.08 cfs, but the gage correlation indicated the highest daily mean flow was on 10/20/2018 (2.5 cfs) and the lowest was on 3/7/2019 (0.05 cfs).

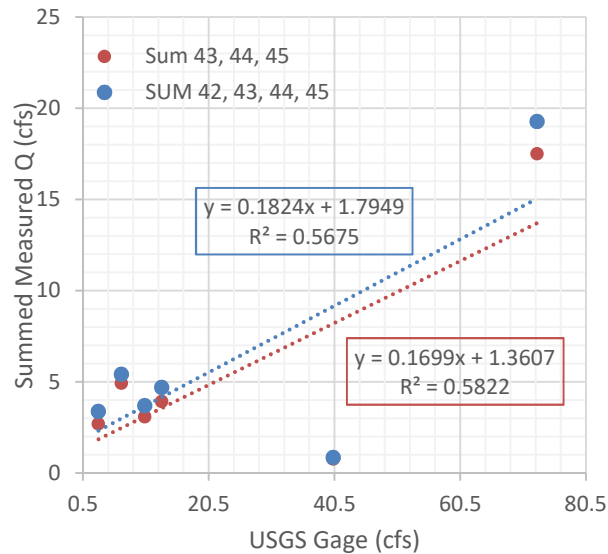
Figure 9. The correlation between the summed site discharges and the USGS Gage. Six flow measurements were included between 9/5/2018 to 3/18/2019. The relationship is strongly influenced by the single large flow measured on 12/7/2018. Also, if the observation from 3/18/2019, which plots below the trend line, is removed the  $R^2$  improves to 0.9.

To develop peak flow estimates, I took the sum of discharge for the 3 sites slated for replacement (COP43, 44, & 45) and correlated their combined flow to the USGS "Glacier River Trib" gage # 15215900 record (Figure 9, Table 2). Summing the 3 sites was meant to eliminate the problems caused by the shifting flow between sites. For comparison I also made peak flow estimates by summing all 4 sites investigated (COP42, 43, 44, 45) as it appears they are all related (Table 2). The USGS gage record provides 7 years of peak flows. I have low confidence in the peak flow estimates until data is collected on additional high flow events.
