**Little Tonsina Tributary ATV Trail  
Hydraulic and Hydrology Report  
ADF&G no. 20103687**

Prepared On:  
November 2023

Prepared by:  
U.S. Fish and Wildlife Service  
Anchorage Field Office  
4700 BLM Road  
Anchorage, AK 99507

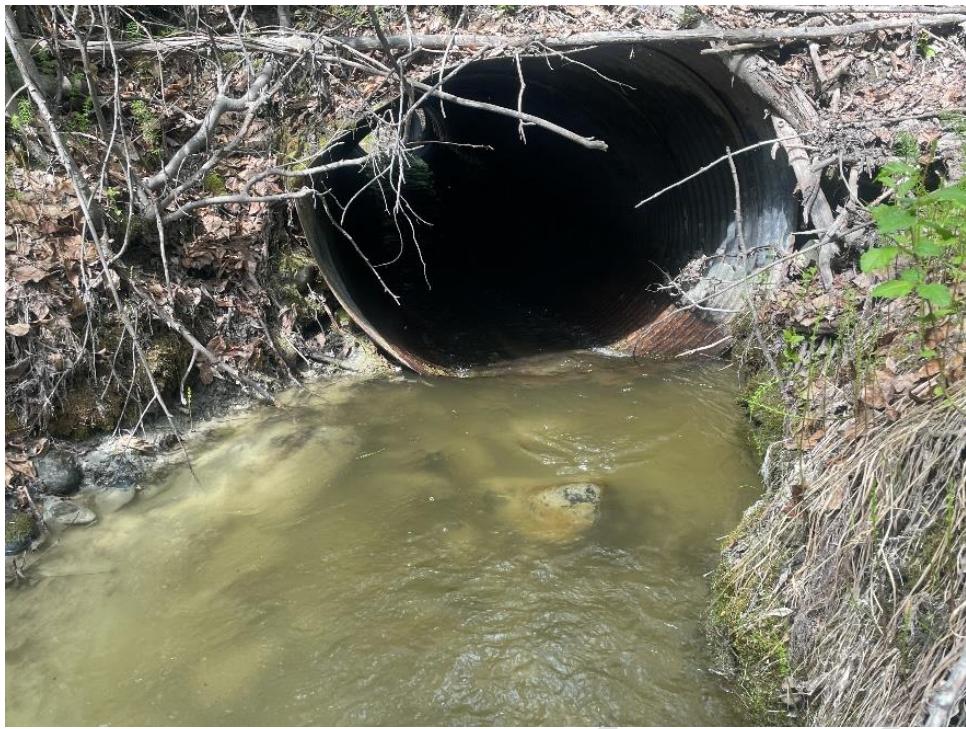
*View: Looking downstream at culvert inlet.*

The existing crossing is a severely damaged culvert, 5ft round CMP, that acts as a total barrier to juvenile and adult salmon. The undersized culvert has a slope of 6.5%, a hydraulic jump at the inlet, a perched outlet with a detached/deformed outlet apron and is in poor condition. The site is experiencing a head cut, causing channel incision directly upstream of the crossing. Directly downstream of the crossing is a large scour pool and an over-widened channel.

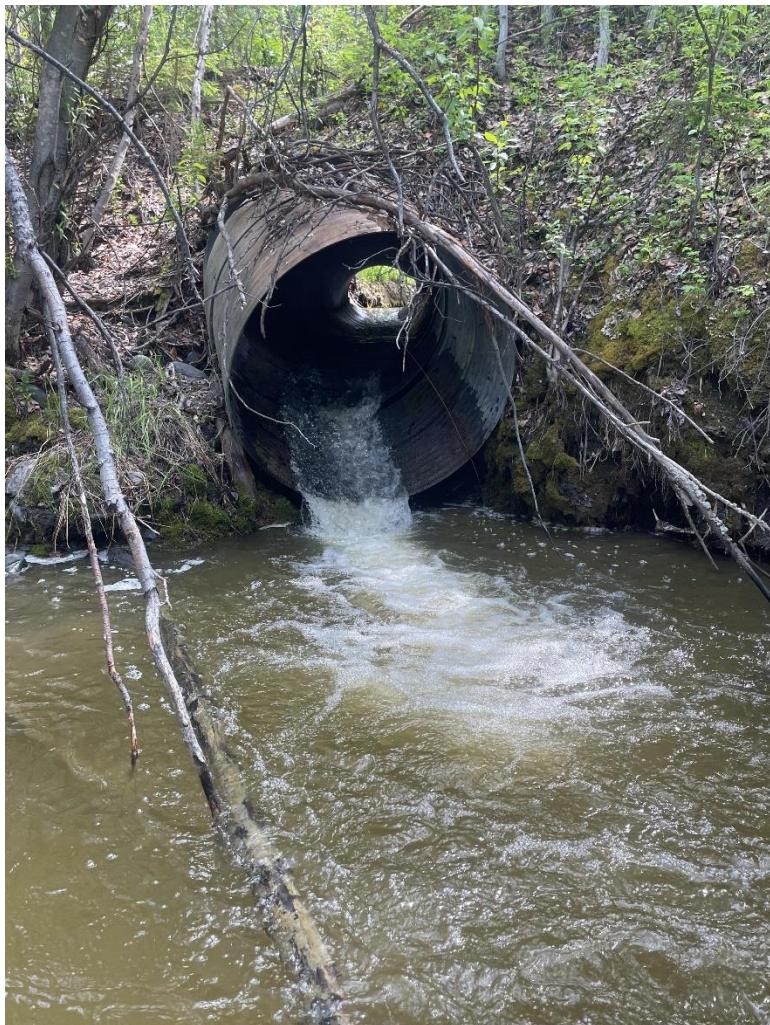
*View: Looking upstream at culvert outlet.*

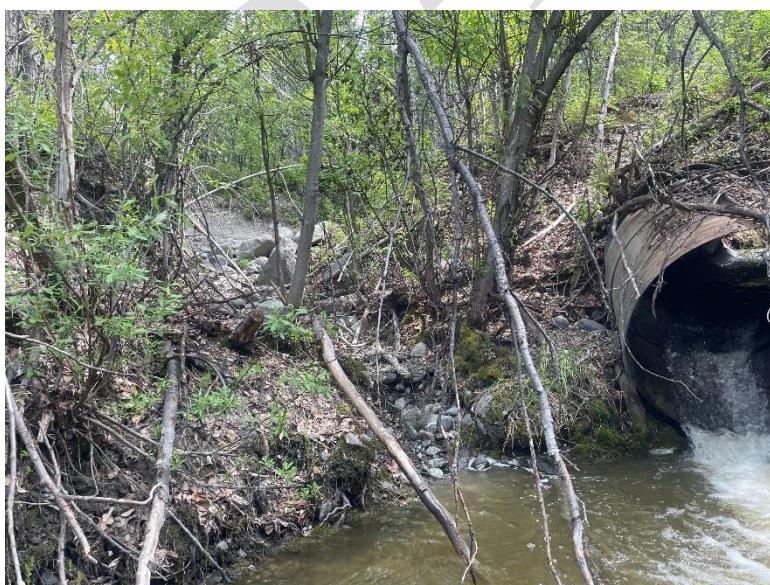
*View: Looking upstream at washout next to outlet.*
