Eyak Lake Weir Assessment

This photo report was prepared by Luca Adelfio, Hydrologist, and Will Schreck, Hydrology Technician, on April 8, 2020.

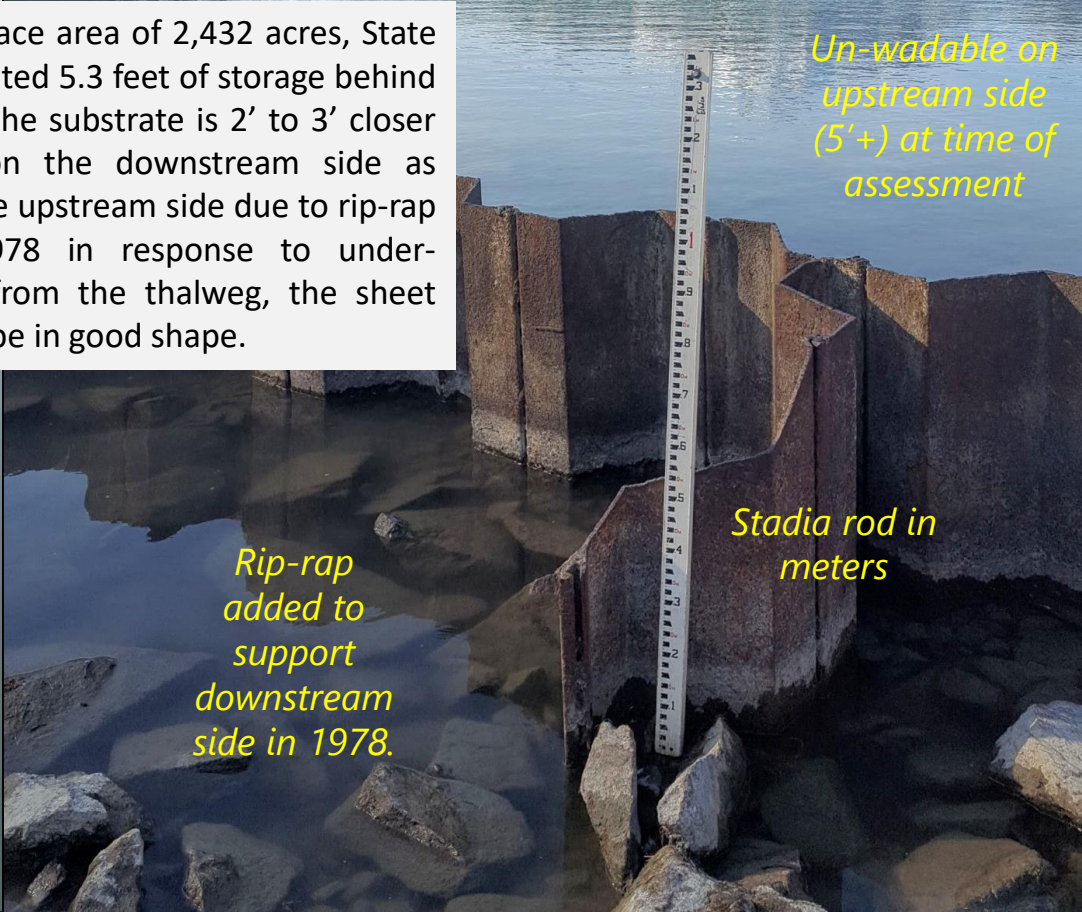
Un-wadable on upstream side (5'+) at time of assessment

Rip-rap added to support downstream side in 1978.

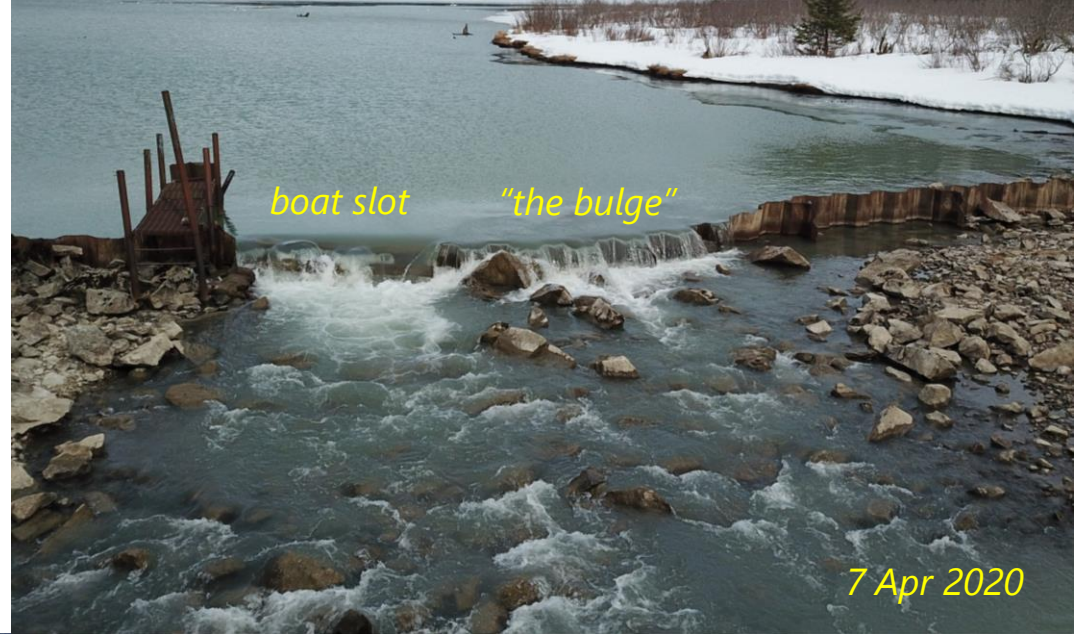
2 Apr 2020

The weir was designed to provide a 1.5' deep, 12' wide boat passage slot with an adjacent platform. Small boat operators could walk the platform, dragging their skiff up and down this slot with the motor tilted up. Two large square timbers, possibly old railroad ties, are mounted onto the weir crest to protect boat hulls. The large rip-rap installed in 1978 appeared to render the boat passage feature largely inoperable, but nonetheless, this slot captured the thalweg and remains important for upstream adult salmon passage. The platform, also damaged by ice, is now a popular, albeit unsafe, perch for sport fisherman.

Damage at the boat slot and the sheet pile to the east, likely caused by ice (J. Stevenson, personal communication), has displaced the weir downstream by an estimated 5' to 6' (State of Alaska 2012). Although this section was deformed before the State of Alaska's 2011 survey, the damage may have been exacerbated by a dramatic ice-out event during a large rain-on-snow event in January 2014, further lowering the lake level (working to confirm). During our assessment, we observed the sheet pile at this "bulge" is leaning against large rip-rap. We measured the damaged section to be 41 feet wide.

Repair “the bulge” and the boat slot to restore the target crest elevation at 17.5’ above MLLW. This action would raise the lake level during low flow conditions, benefitting salmon, recreation, and watershed health.
