**APPENDIX B: ADNR ALASKA DAM SAFETY PROGRAM 2012
DEREGULATION REPORT**

FIELD INSPECTION AND DEREGULATION REPORT EYAK LAKE DAM (AK00049)

Inspection Date: June 6, 2011
Report Date: March 21, 2012
Weather: Clear and Sunny
Inspection Objectives: Site visit
ADNR Personnel: Charles Cobb and Chandler Engel, ADNR
Documentation: Photos and field book notes were taken and are available for review at DNR-DMLW in Anchorage.

PERIODIC SAFETY INSPECTION REPORT No. 1

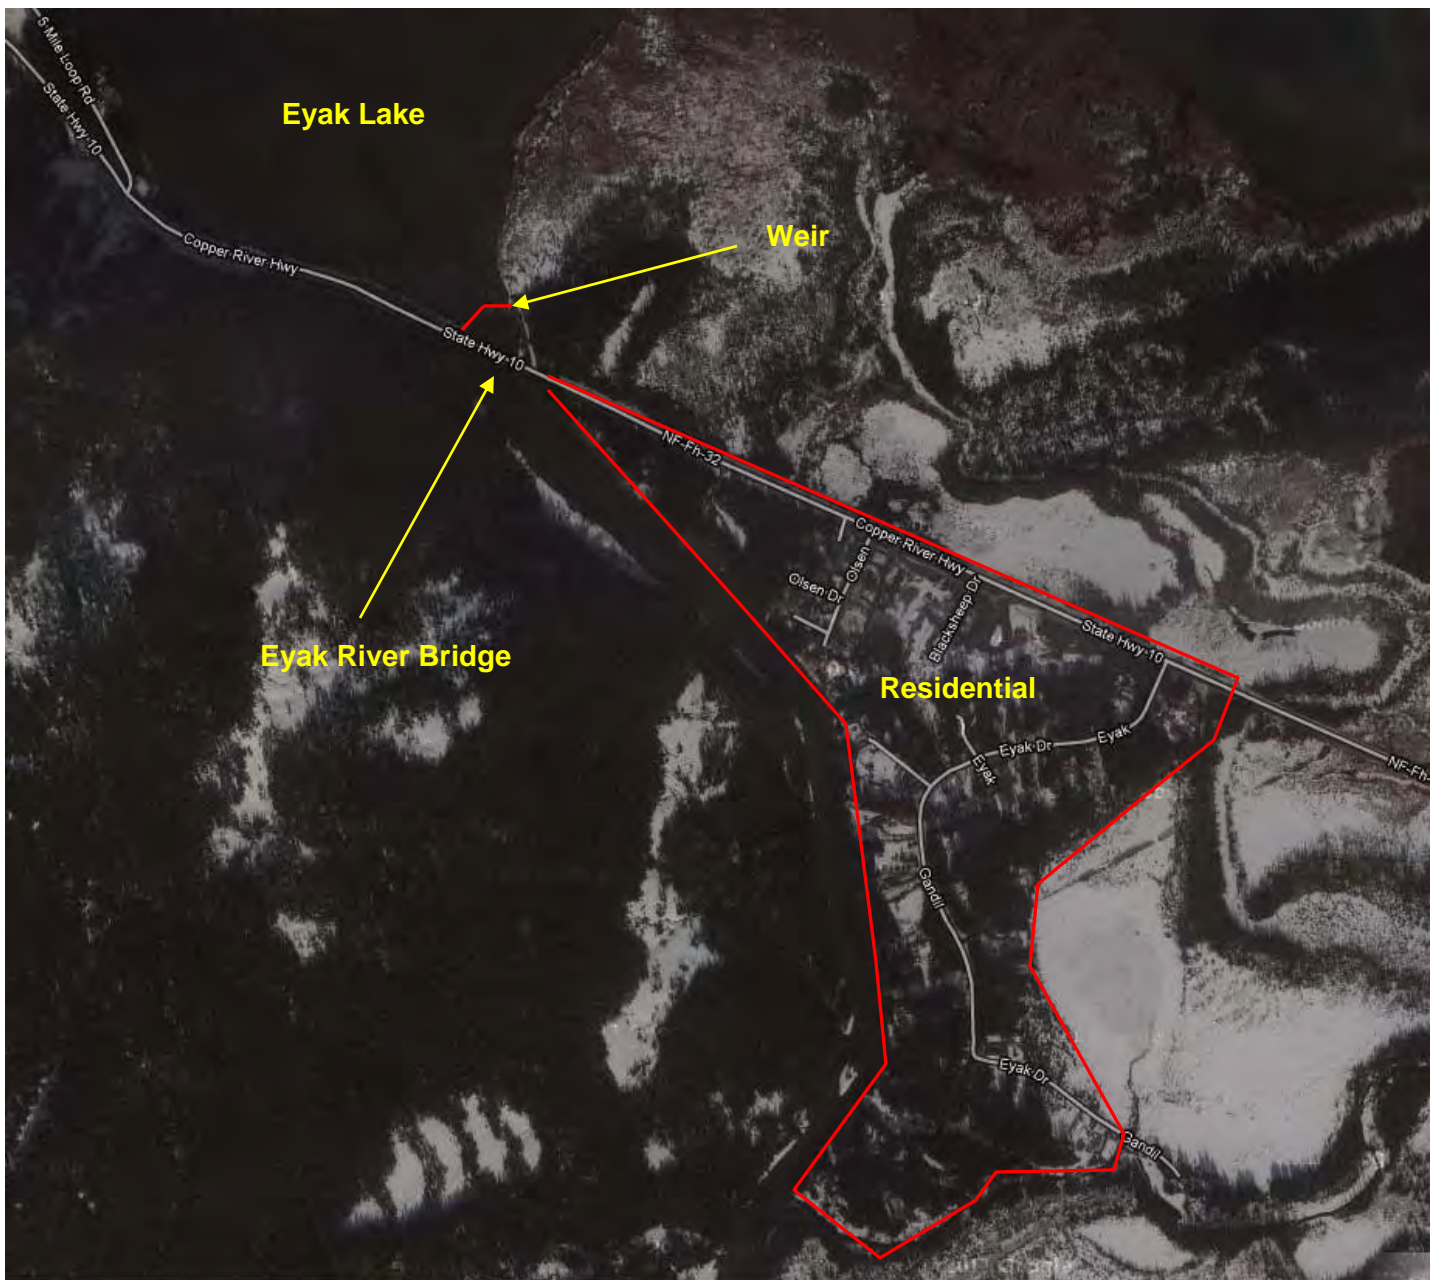
Figure 3
SATELLITE IMAGE

The Copper River Highway crosses the Eyak River directly downstream of the weir and below that is a residential neighborhood along the east bank of the Eyak River, shown in Figure 3
