# EYAK LAKE OUTLET STRUCTURE REPLACEMENT DESIGN

## Alternatives Analysis

DOWL  
4041 B St.  
Anchorage, AK 99503

July 2021

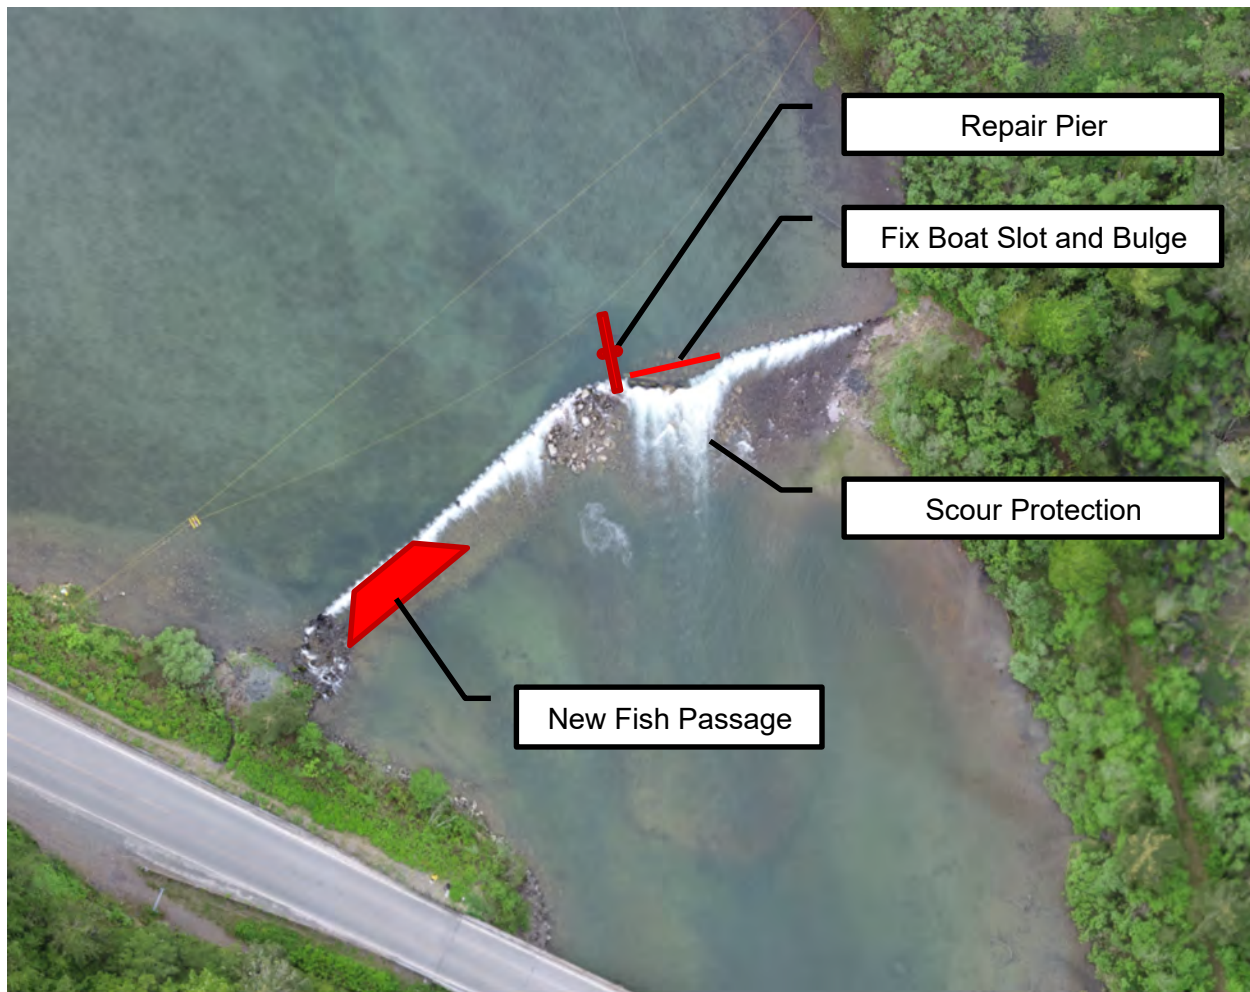
**Figure 1: Alternative 2 Concept**

The natural fishway will be constructed close to river right, shifting the fish passage from the boat slot location. The natural fishway will tie into the existing channel and be constructed as a roughened channel, step-pool, or hybrid fishway.

The rehabilitation will only extend the service life for a limited period of time compared to a newly designed structure and assumes that the bulged section of the weir can be repaired after approximately 45 years in a modified configuration.

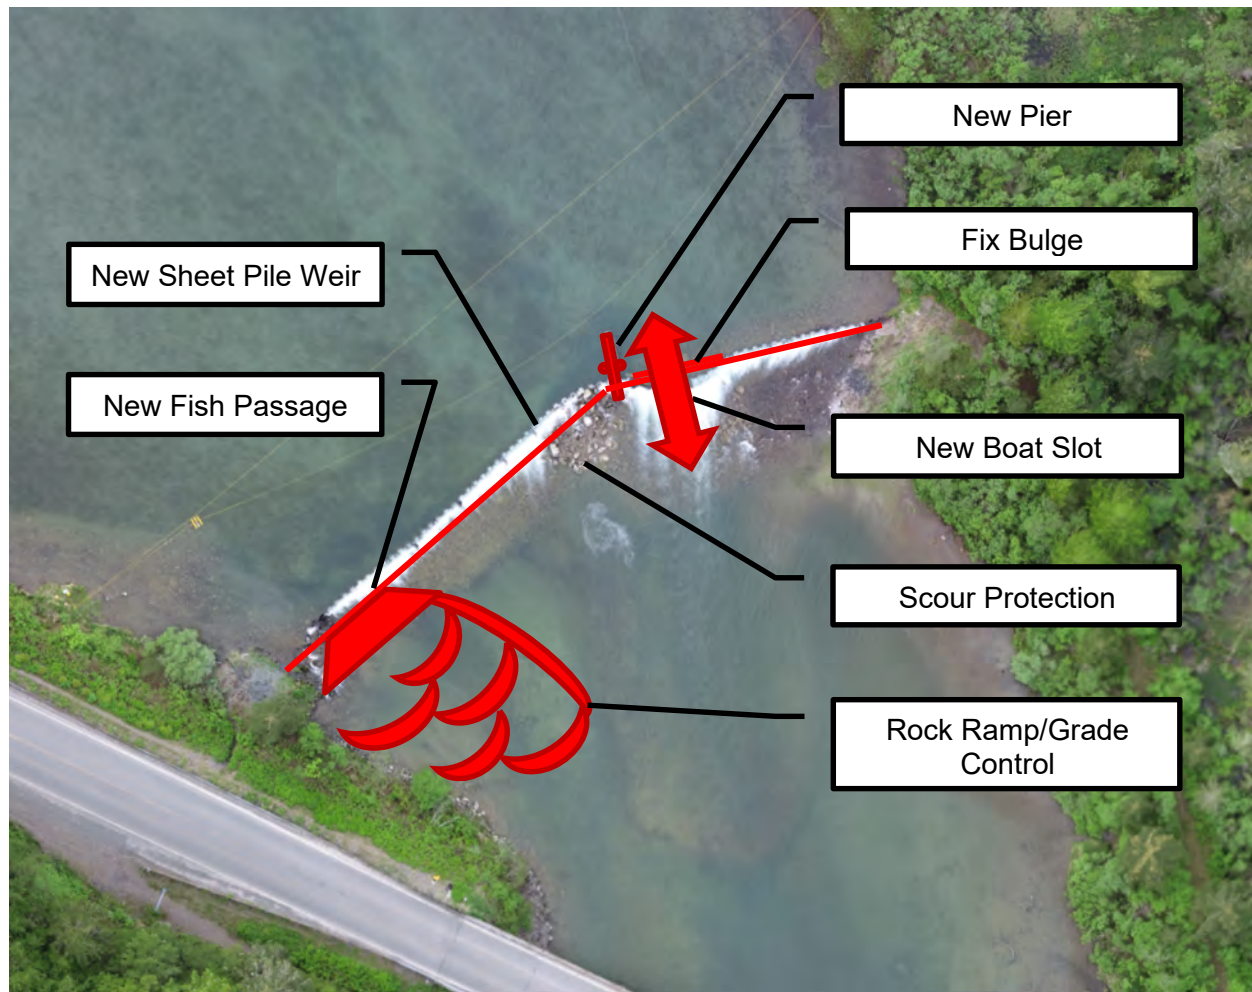
**Figure 4: Alternative 3 Concept**

Alternative 3 allows for a structurally safe weir to be installed immediately downstream of the existing outlet structure without requiring the removal of the existing structure, reducing construction costs. The annular space between the two structures will be filled with a compacted non-frost susceptible fill to create a uniform structure.

The new sheet pile structure would be configured to rehabilitate the boat slot. The boat slot will remain at the same location to prevent any confusion of regular users that traverse the weir. The approach to the new boat slot will be designed to allow passage of shallow draft boats without damage at mid to high water levels at the outlet structure.

The separation of the fish passage and the boat slot will likely create a split flow during low flow conditions. The fish passage will be designed to have a lower crest elevation than the boat slot to allow a minimum depth of water to flow over the fish passage as well as making sure that the toe of the structure has significant depth and interconnectedness to allow fish to probe the toe, looking for a suitable passage.

The alternative that best reflects the project goals and the needs of the local residents is Alternative 3, Replace in Kind with Natural Fishway. A new structure placed adjacent (downstream) of the existing weir can be designed to updated design standards allowing it to withstand the appropriate seismic, ice, and hydrodynamic forces.

The natural fishway will be designed to significantly improve the ability to pass juvenile salmon. Locating the fishway close to the river right (Copper River Highway) will allow for easy access for maintenance and monitoring. The fish passage will be designed to withstand the critical flow event that would see maximum velocities at the weir. The rock ramp/grade control structure will contain large stones keyed in to resist mobilization, protecting the natural fishway. The offset location of the fishway will reduce the likelihood of damage by ice, debris or high velocity flows.

Recreational boat passage will be continued at the weir by maintaining the location of the boat slot and restoring the existing dimensions of the boat slot by fixing the bulged section of the weir. The rehabilitation of the boat slot will be designed to minimize potential damage to the hulls of the shallow draft watercraft using it. Depending on the hydraulics of the weir flow in conjunction with the natural fishway, the boat slot will be optimized to the type of boat using the access.

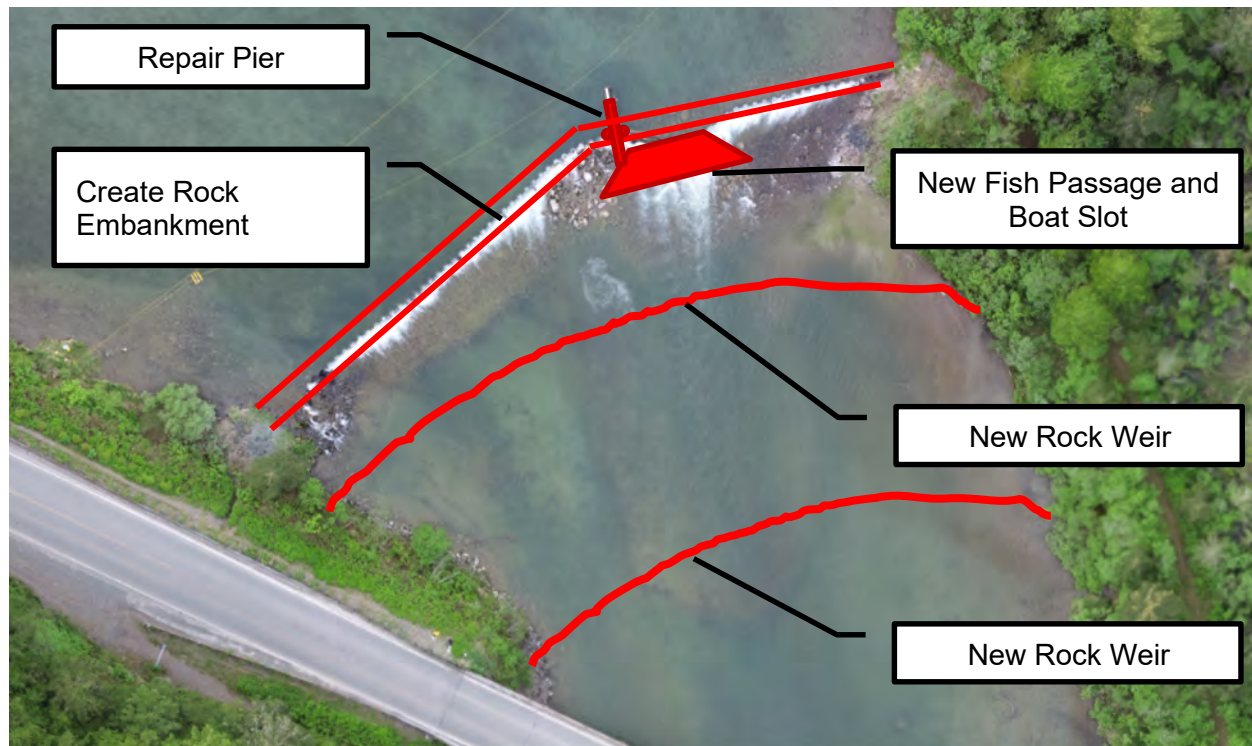
**Figure 10: Alternative 4 Concept**

Under this option there would be no significant weir structure seen by the public. The uppermost drop will be constructed of carefully placed and interlocked riprap around the existing outlet structure, supported by structural fill. The subsequent rock drops would be constructed of material consisting of quarried rock and existing bed material large enough to resist high flows.

While cost to remove the existing structure would be minimized, the quantity of quarried rock used to regrade the outlet structure would be significant.
